From: s22
To: s22 ; s22
Cc: [FOI Contact Officer](#); s22
Subject: RE: FOI 151012 - correspondence from applicant seeking information re: HMAS Adelaide scuttling – 2008/1062 [SEC=UNCLASSIFIED]
Date: Monday, 8 February 2016 10:23:56 AM
Attachments: [image001.gif](#)

Attachment B – Final Report McLennan’s Diving Service June 2015

From: s22
To: s22
Cc: s22
Subject: Ex-HMAS Adelaide Reserve: Compliance under Sea Dumping Permit (SD2008/1062) in response to east coast low weather event - June 2016
Date: Tuesday, 28 June 2016 3:24:44 PM
Attachments: [Final Structural Condition Assessment Report Ex-HMAS Adelaide June 2016.pdf](#)
[McLennans Diving Service - Post East Coast Low Divers Inspection Report - June 2016.pdf](#)

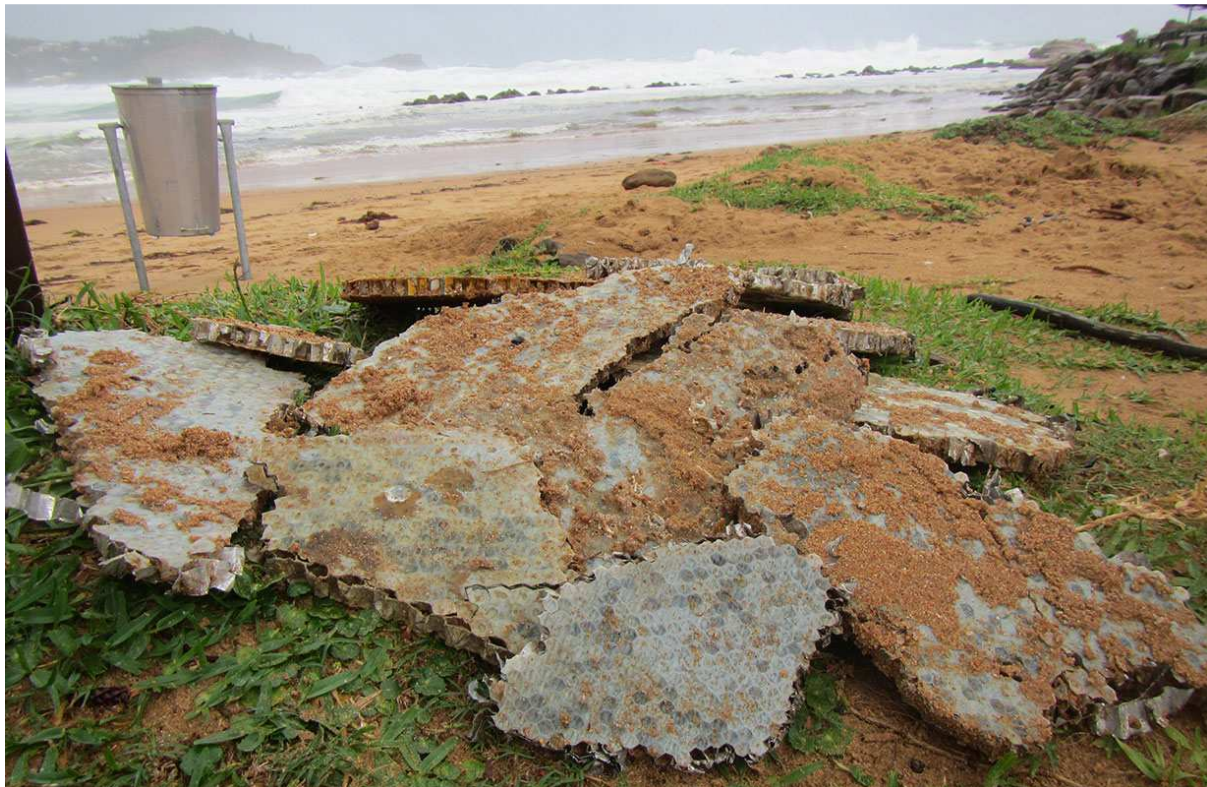
Figure 1 – beach debris removed from Avoca Beach in February 2013

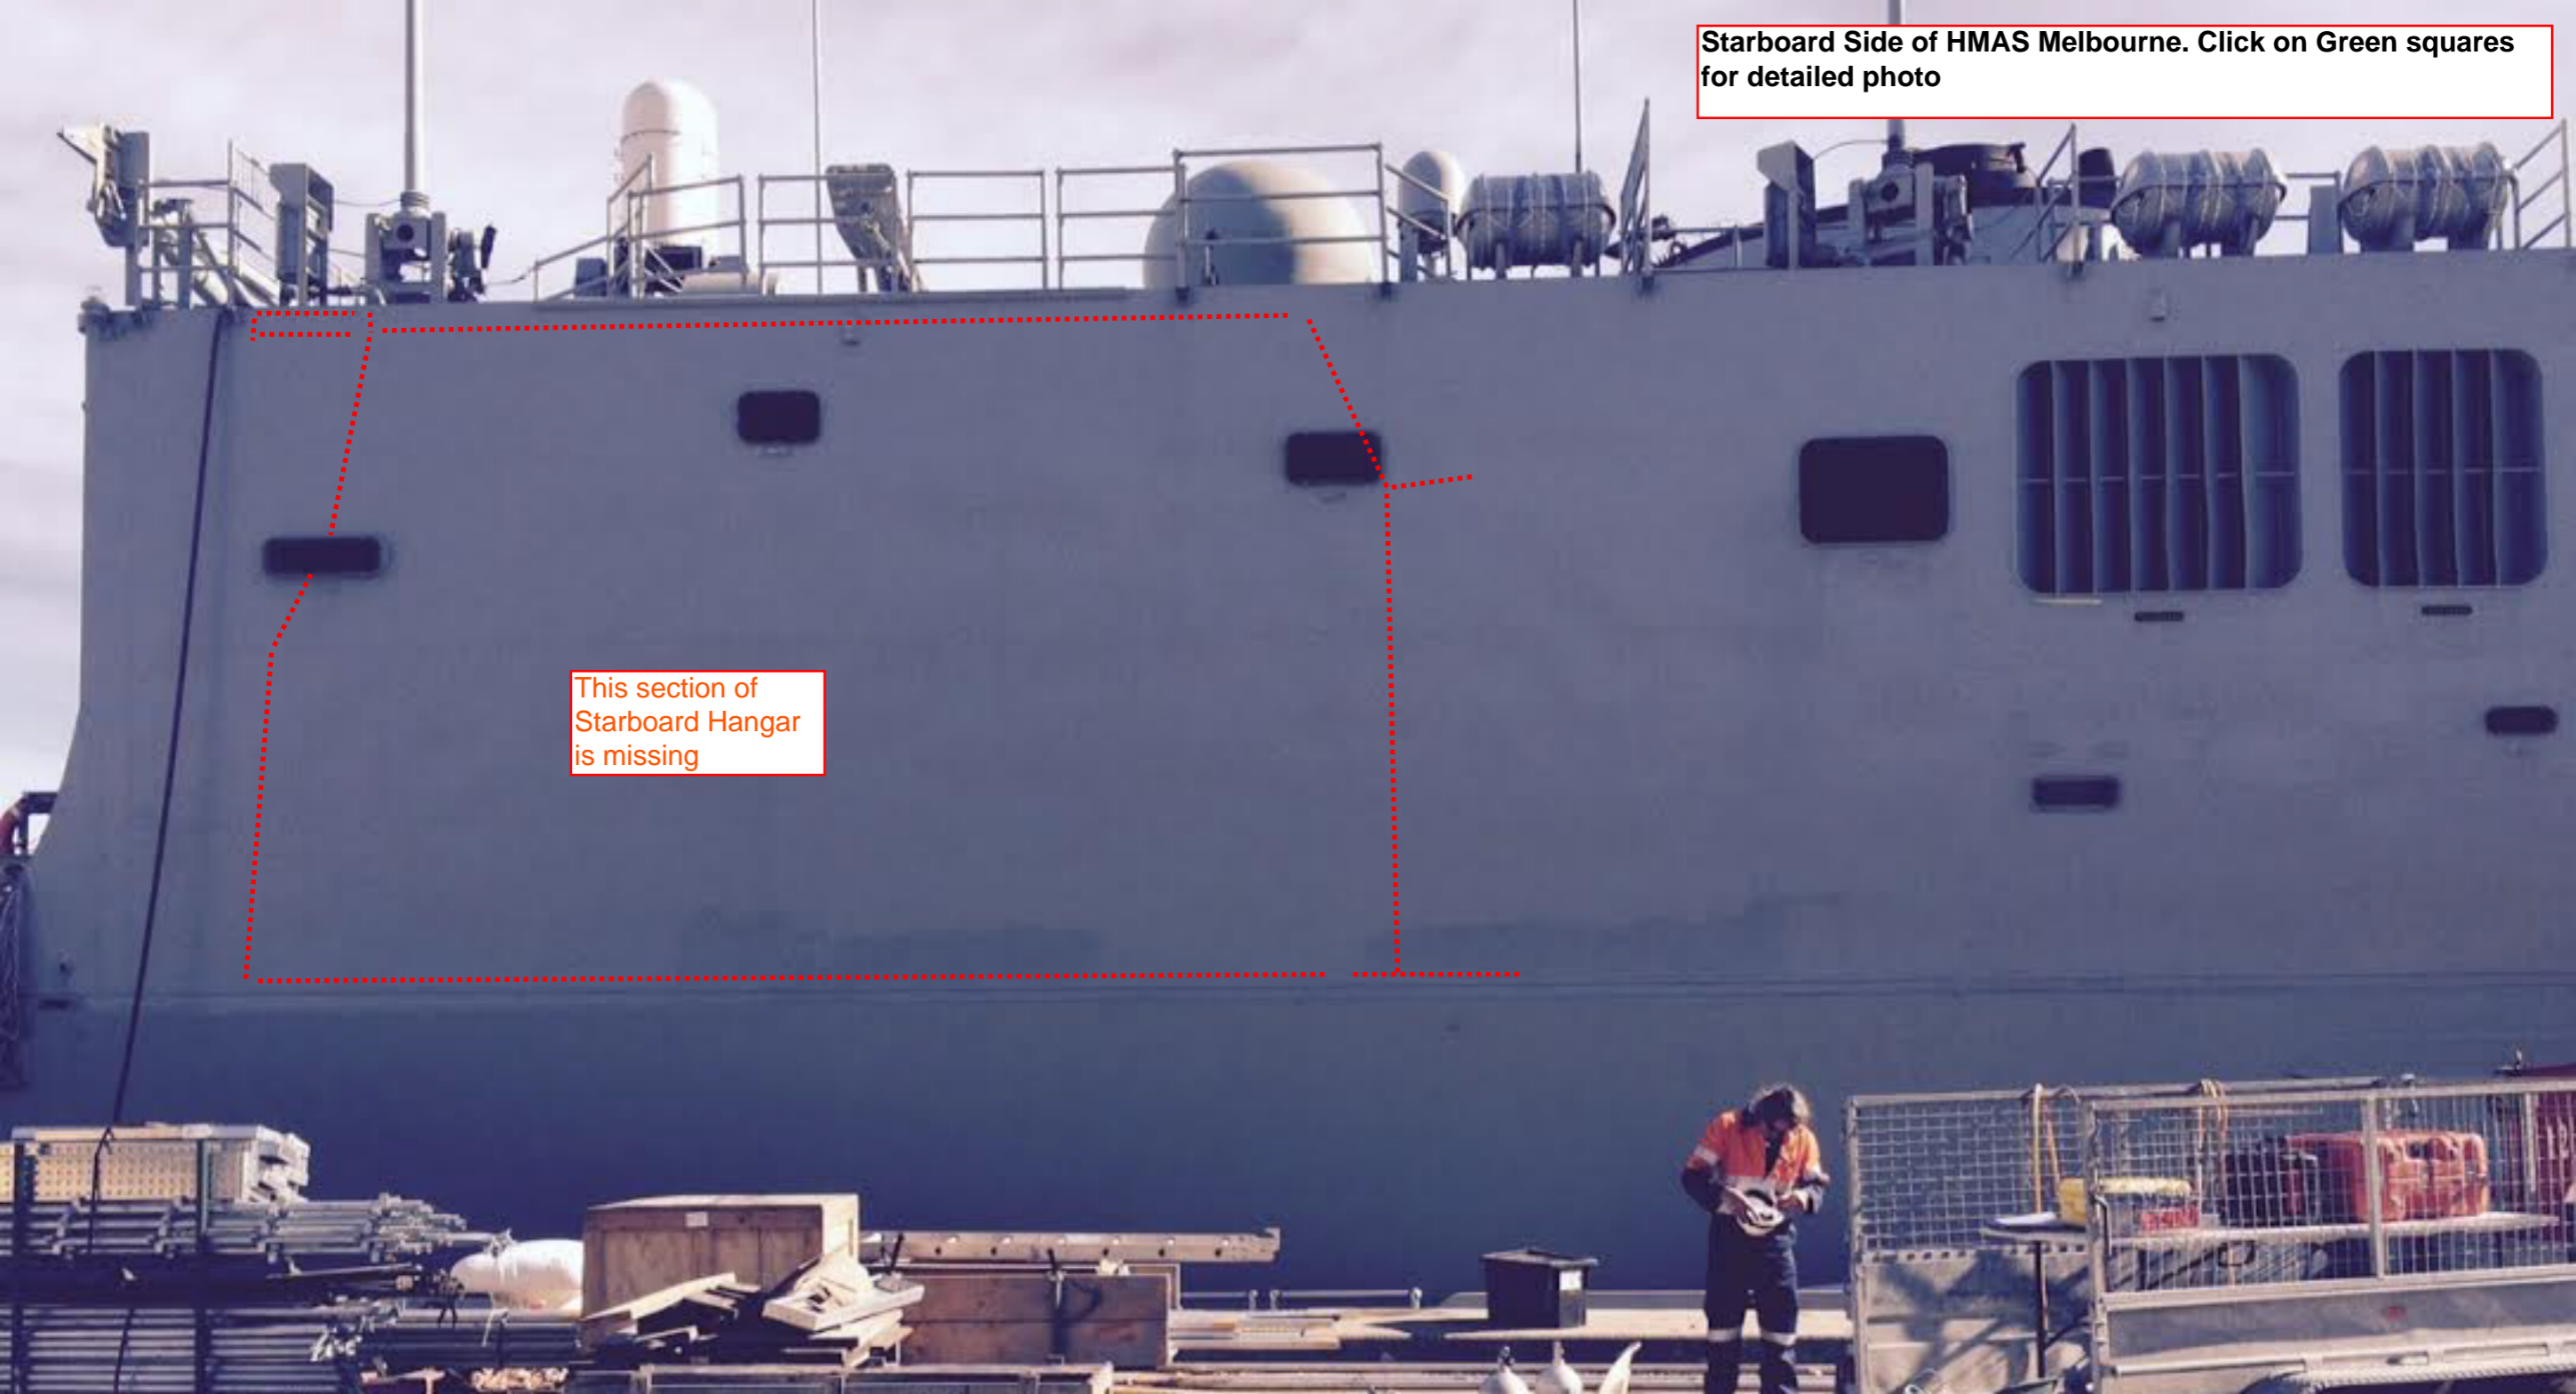
Our dive team visited the Adelaide wreck on May 18th, 2015 shortly after two significant east Coast Lows passed through. We found that the starboard hangar wall was missing for a length of 10.5m horizontally and its full height vertically.

There are four vertical frames missing which have sheared off at their weld points to the deck. At the top of the wall the frames have sheared off the corresponding roof frames, taking the knee braces with them.

Starboard Side of HMAS Melbourne. Click on Green squares for detailed photo

This section of Starboard Hangar is missing

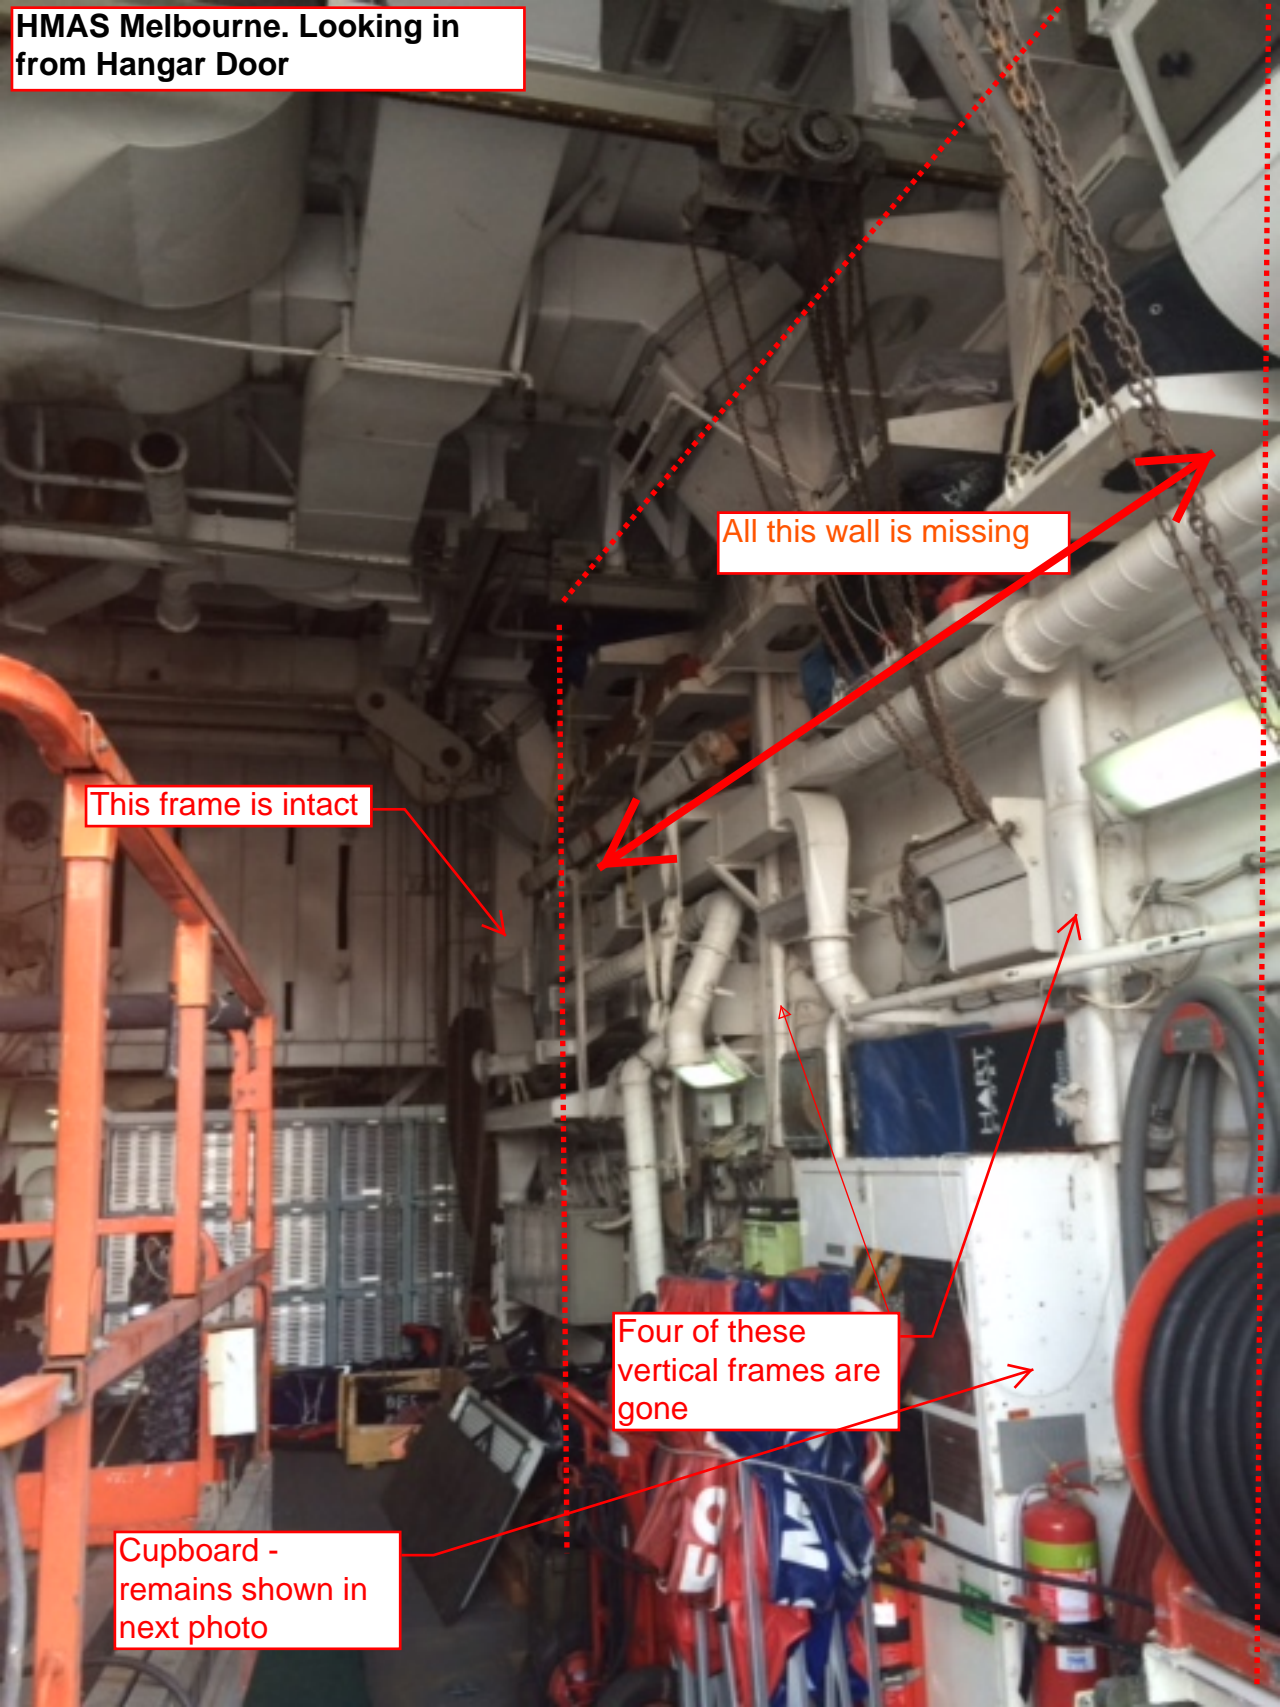
All this wall is missing

This frame is intact

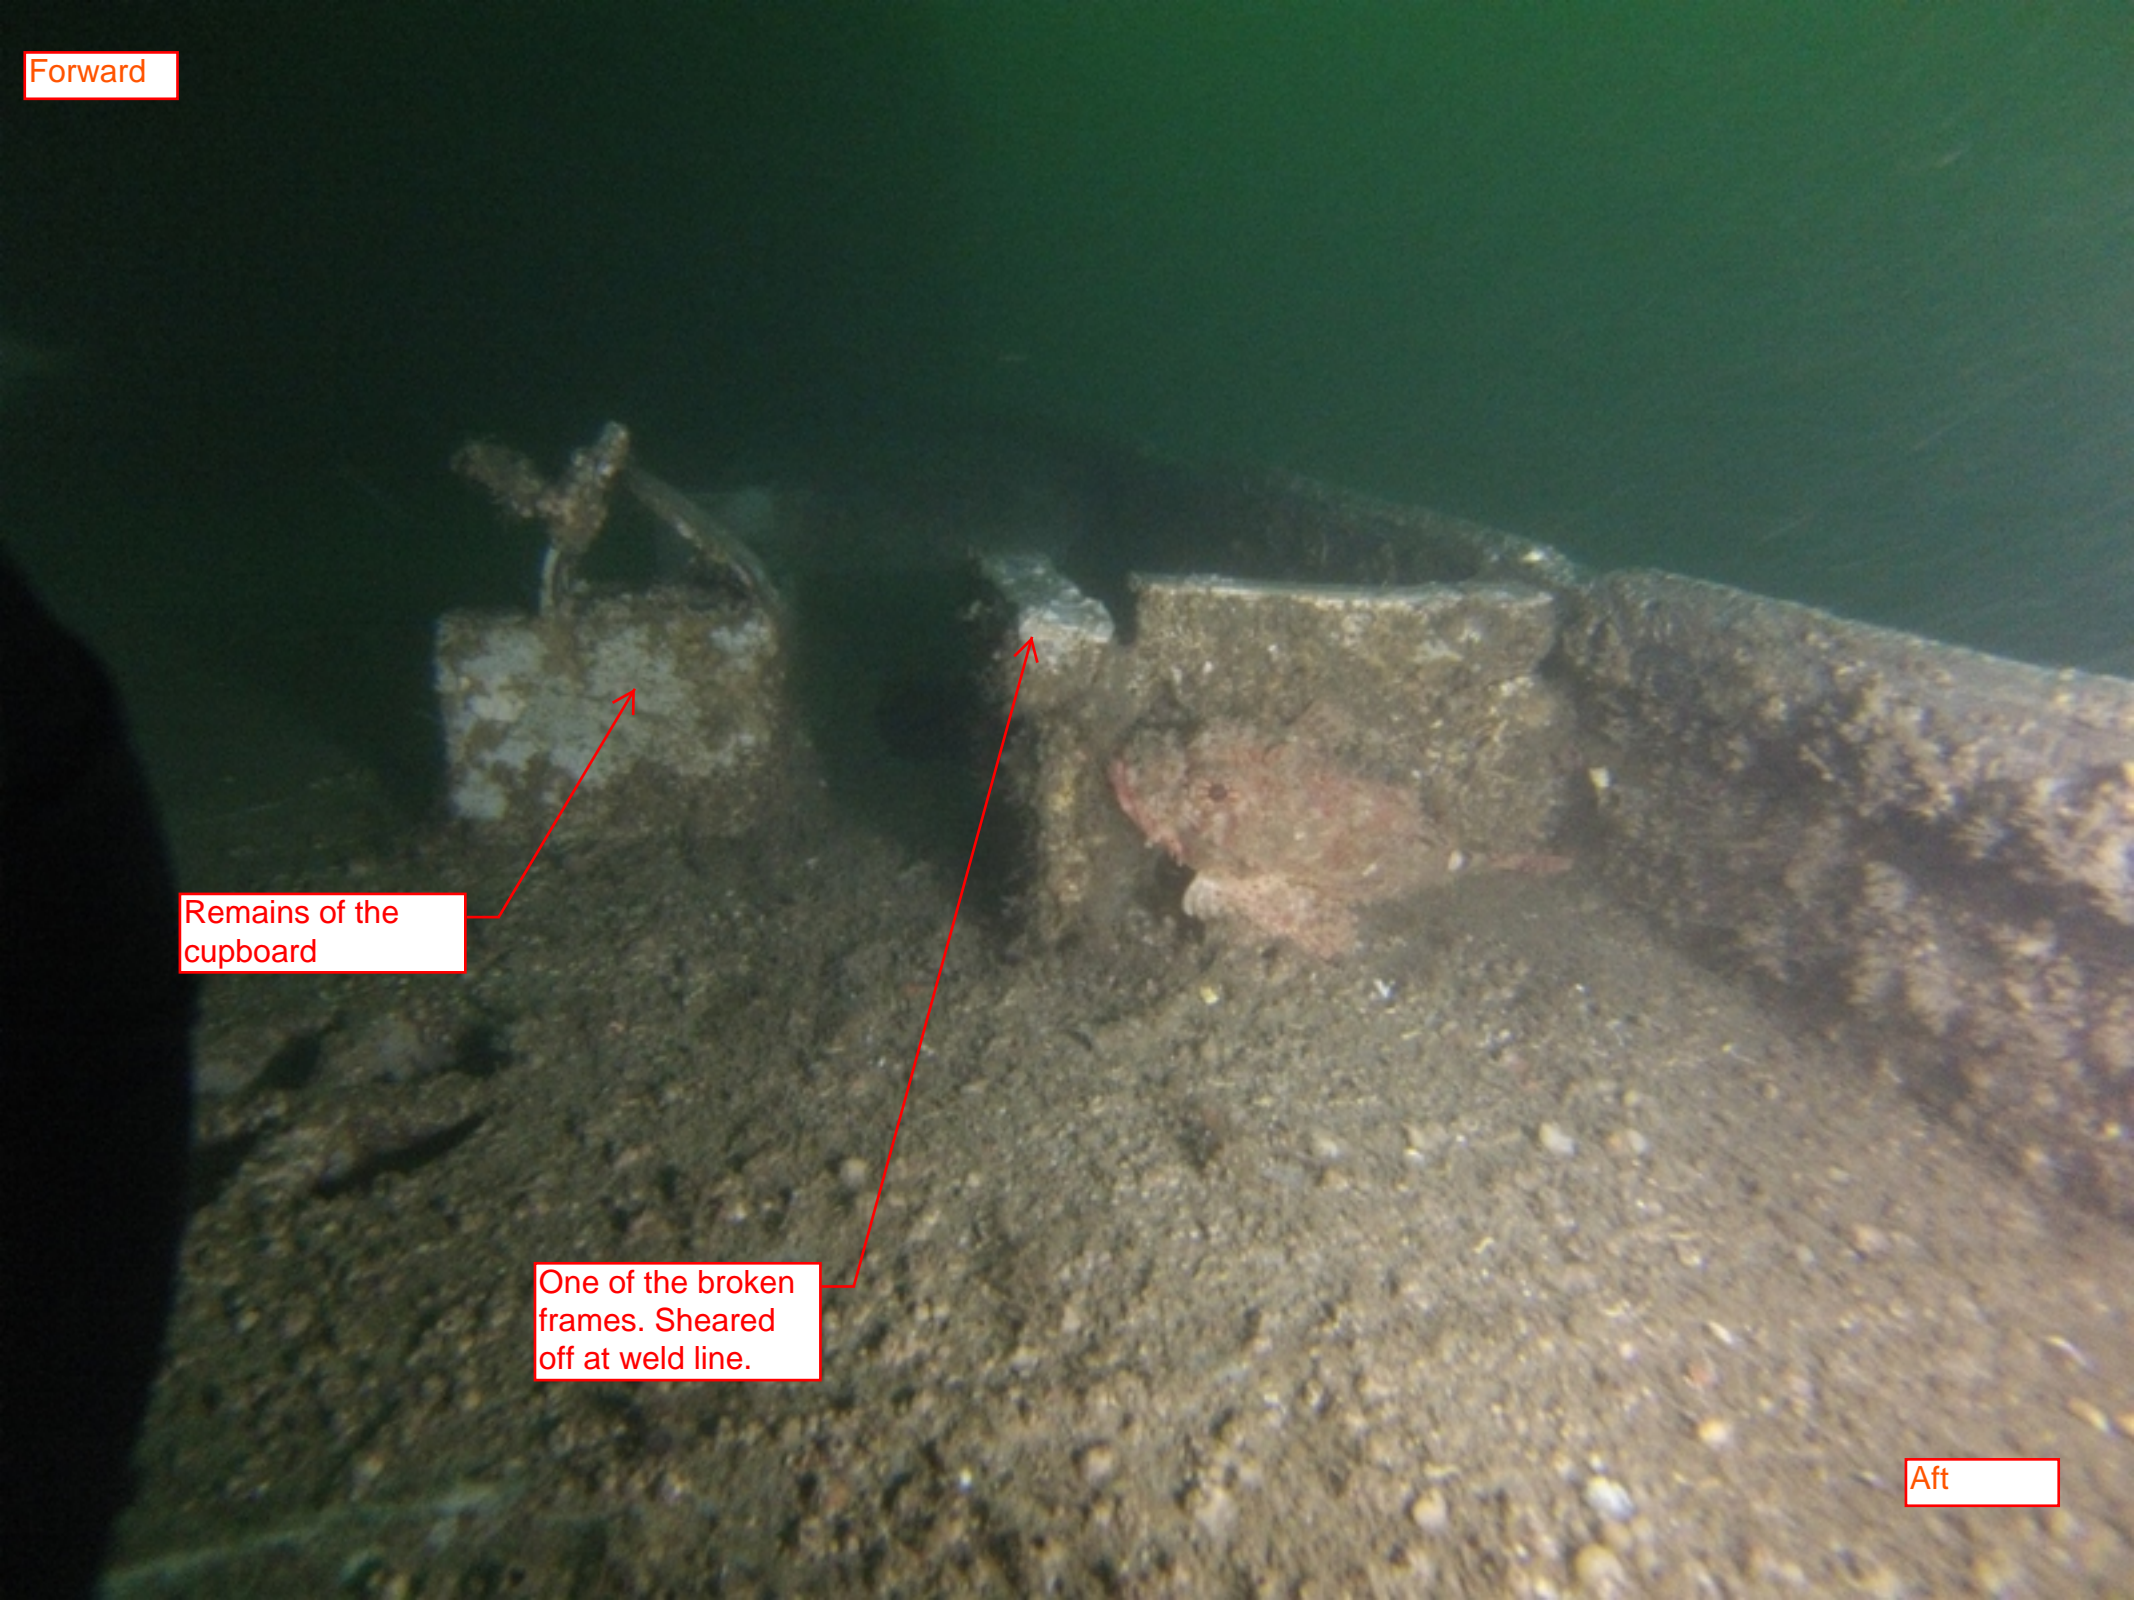
One of the broken
frames. Sheared
off at weld line.

Looking Forward
from the inside.

This is the first
intact frame forward
of the missing wall.
Note weld line
which is the weak
point that all the
frames failed at.

Crack at base of
wall. View from the
other side shown
on page 11

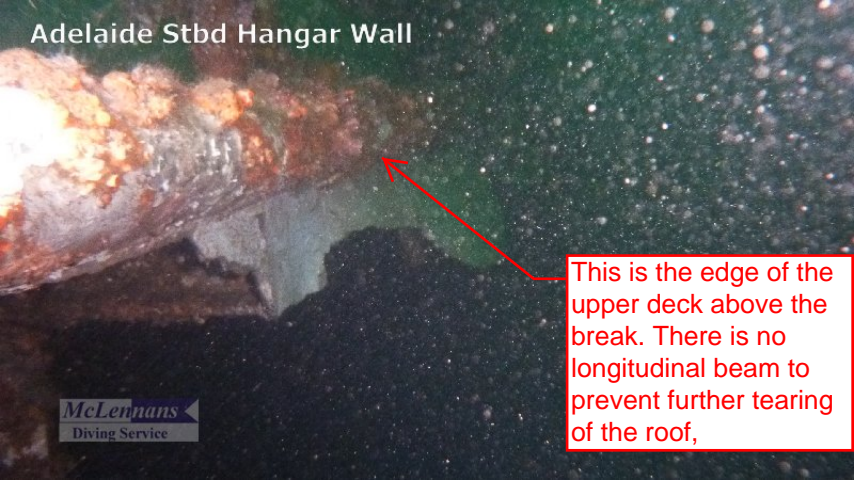
Adelaide Stbd Hangar Wall

This is the edge of the upper deck above the break. There is no longitudinal beam to prevent further tearing of the roof,

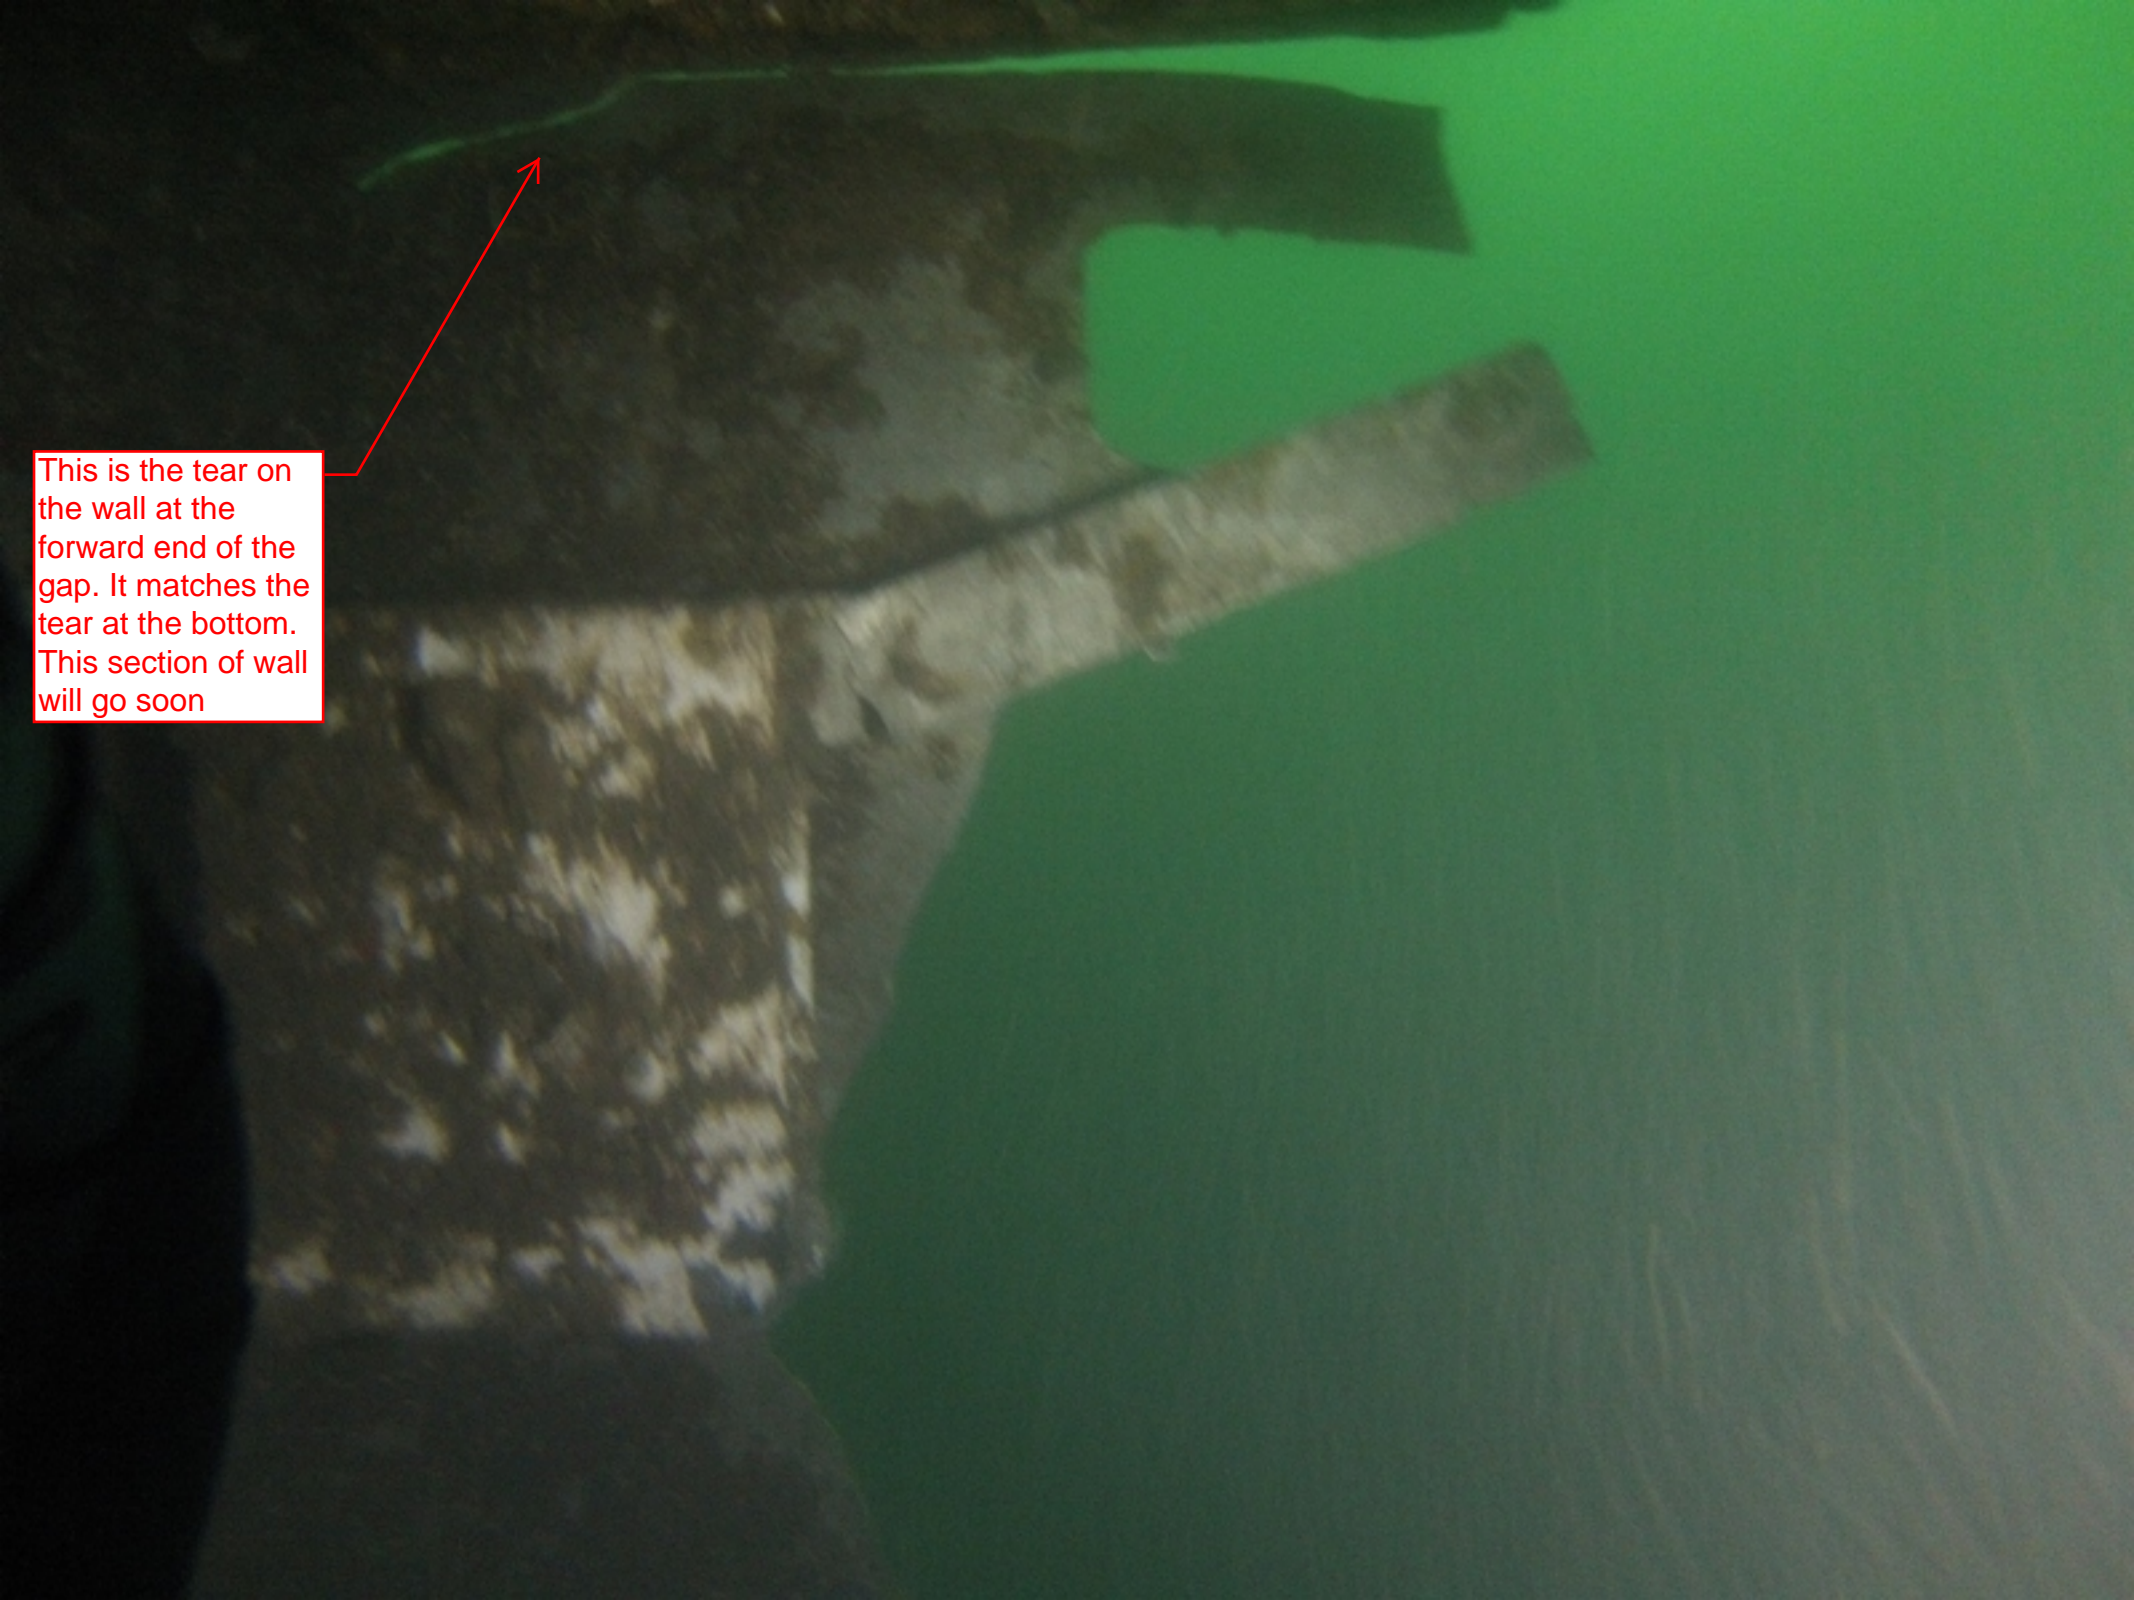
There is a loose section of wall at the forward end of the gap, which is cracked horizontally for 700mm near the top and bottom. This section was not moving in the swell, but will presumably break off in the next big swell.

This is the forward
end of the gap. This
is the crack at the
base of the
remaining wall.
There is a
corresponding gap
above it shown in
the next photo

This is the tear on the wall at the forward end of the gap. It matches the tear at the bottom. This section of wall will go soon

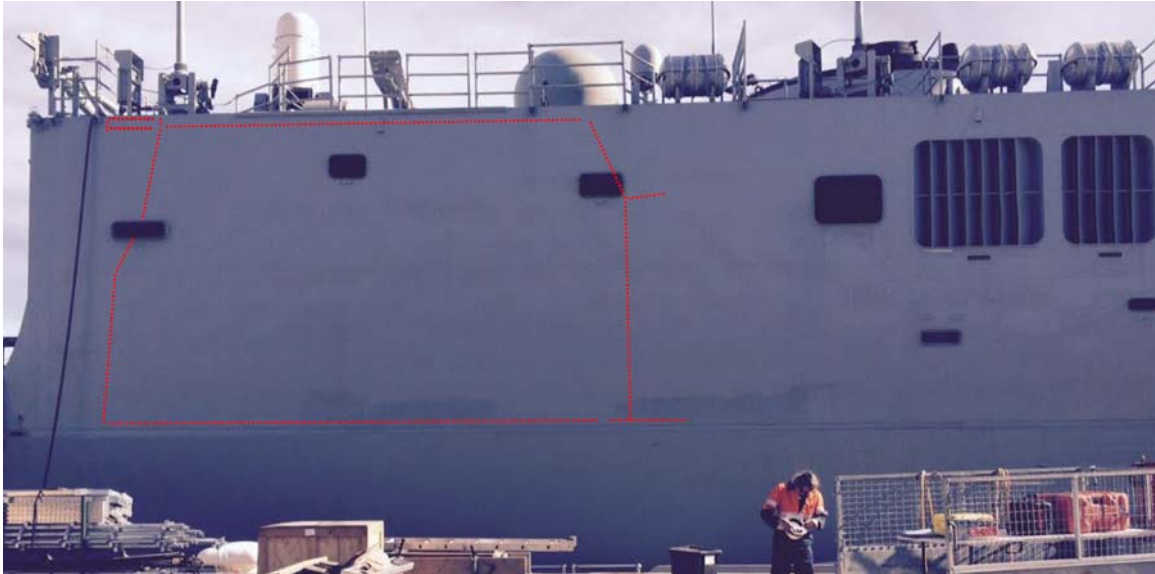
The underwater inspection of the vessel found that the starboard helicopter hanger side structure was damaged. The details of the inspection can be found in the diver's report "Ex-HMAS Adelaide Starboard Hanger Wall Report". The inspection report stated that there was damage to the helicopter hanger in way of the starboard side structure and that the damage had caused part of the side shell and its supporting structure to separate from the main hanger structure.

Photo 1: This photo of a similar vessel to the Ex-HMAS Adelaide demonstrates the location of the section of the starboard hanger structure that has separated from the vessel. It is marked in red.

It is my opinion that, the structure forward of the helicopter hanger transverse bulkhead is structurally sound. However, the starboard hanger top structure may deteriorate over time due to lack of support on the outboard side, therefore this area should be monitored over time.

It is also my opinion any diving activities around the starboard hanger should be suspended and all the visiting divers warned to stay clear of that area due to the risks associated with jagged metal from the failed areas.

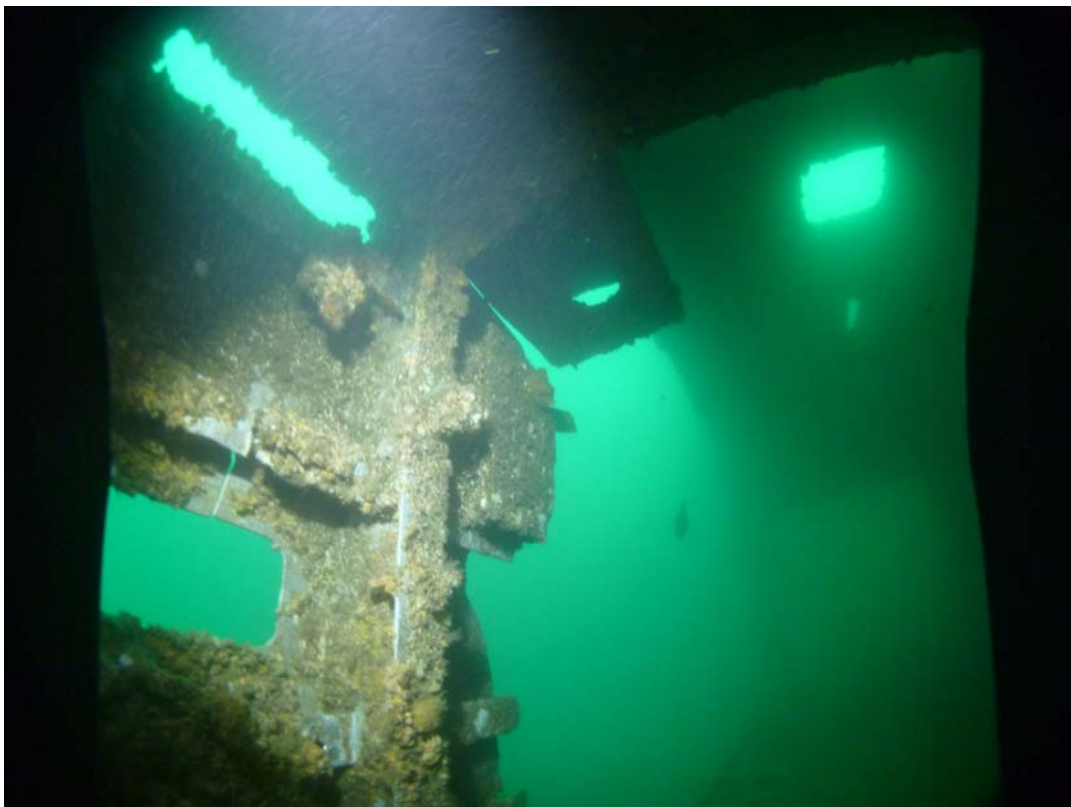
Photo 2: This photo of the EX-HMAS Adelaide is looking aft from inside the starboard hanger, it shows the area of the hanger side whereby the side has parted from the main structure

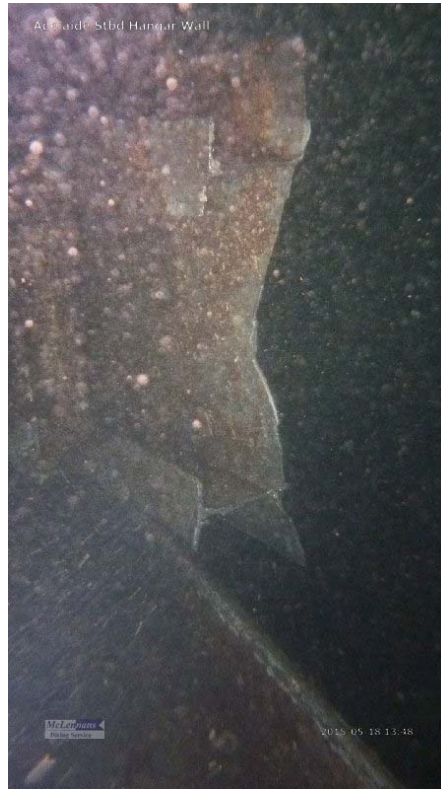
The remaining starboard hanger side plating up to the forward transverse hanger bulkhead was found to have buckled. Photo 3 shows the area of buckled plating.

Photo 3: This photo shows the buckled starboard hanger side plating forward to the parted structure.

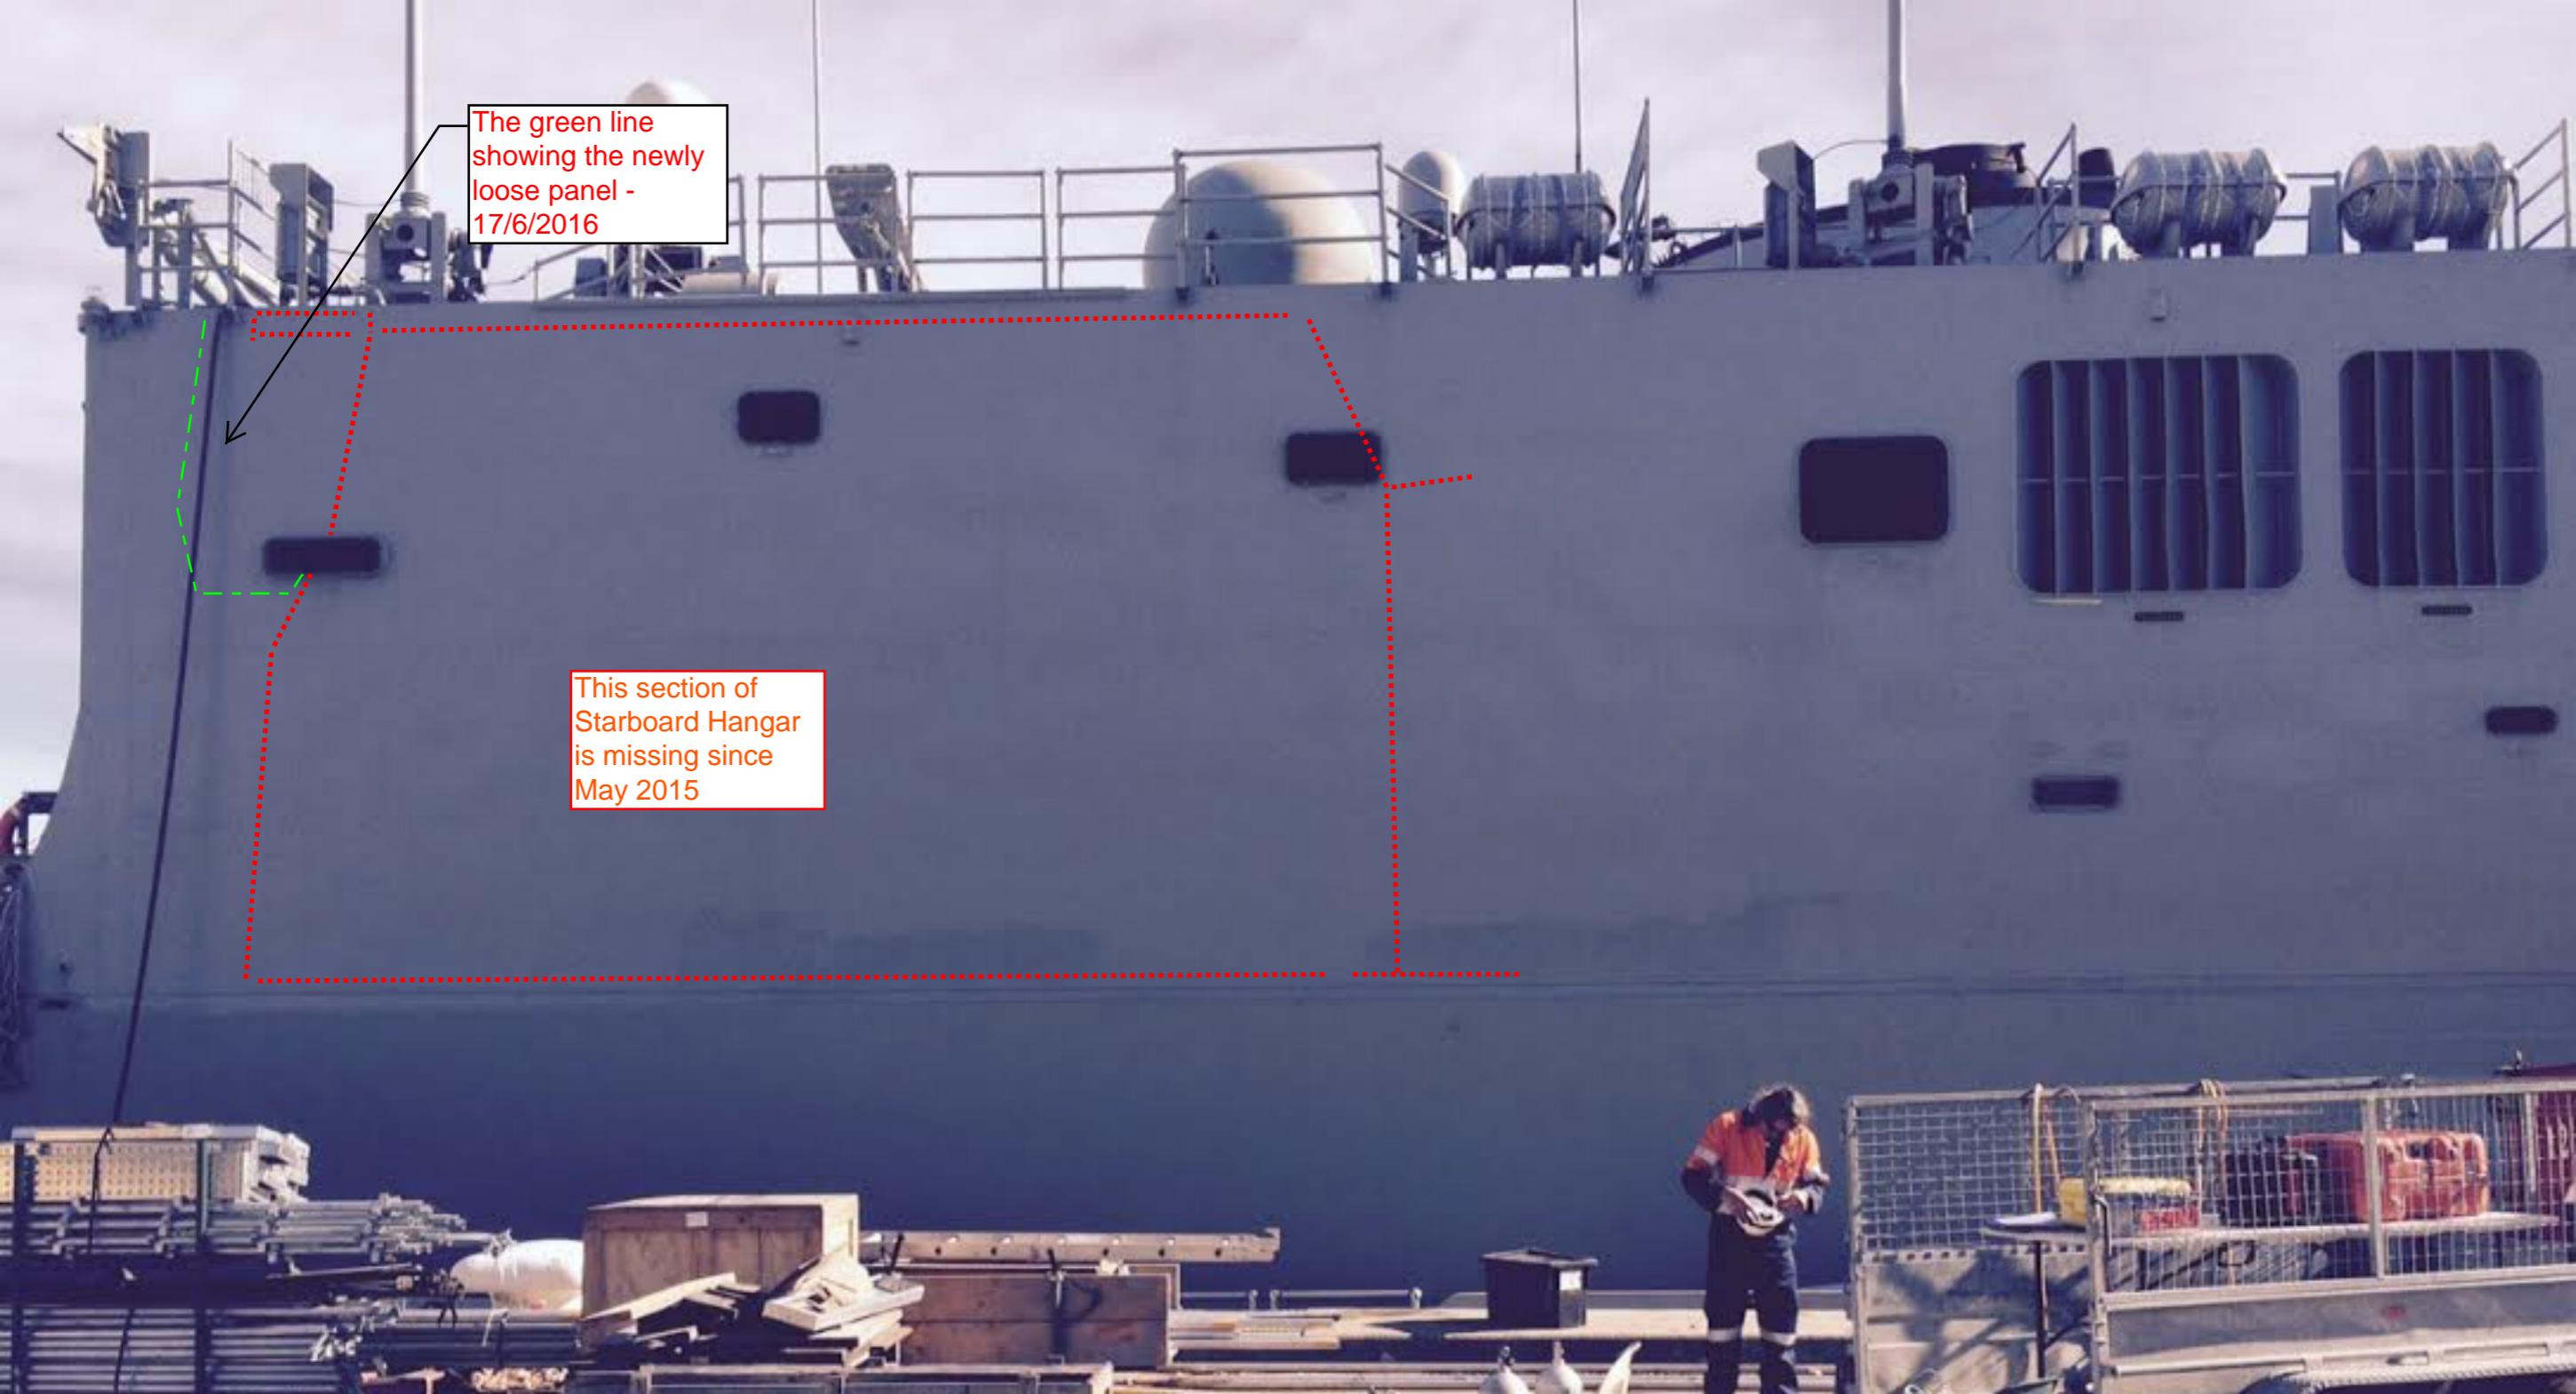
- a one metre section of the starboard hangar wall (which was mostly lost in May 2015) has broken free and is moving backwards and forwards slightly. It does not appear to be a trap hazard for divers but it does have sharp edges. This is true of the entire starboard hangar wall.
- A ventilator on top of 02 deck amidships has broken off leaving some jagged aluminium poking out of the deck. This is a small structure about 1000mm by 500mm footprint. The remains of it would not be a danger to divers.
- Handrails - numerous handrails have been broken off and now lie strewn about the decks. We did not see any which created an entanglement or exit hazard for divers.

The green line showing the newly loose panel - 17/6/2016

This section of Starboard Hangar is missing since May 2015

- 2.4 A one metre section of the starboard hangar side plating (which was mostly lost in May 2015) had broken free and was moving backwards and forwards slightly. It did not appear to the divers to be a trap hazard for recreational divers but it does have sharp edges.
- 2.5 A ventilator on top of 02 deck amidships has broken off leaving some jagged aluminium poking out of the deck. This is a small structure with about a 1000mm by 500mm footprint. The remains of it in the opinion of the diving company would not be a danger to recreational divers.
- 2.6 A number of handrails have been broken off and now lie strewn about the decks. The divers stated in their report that they did not see any which in their opinion created an entanglement or exit hazard for recreational divers.

To manage this hazard it is proposed to advise all dive operators of the new risk associated with sharp edges and request that the hazard be included in the dive tub talk. The area will continue to be monitored in accordance with the recommendations of the Structural Condition Assessment Report.

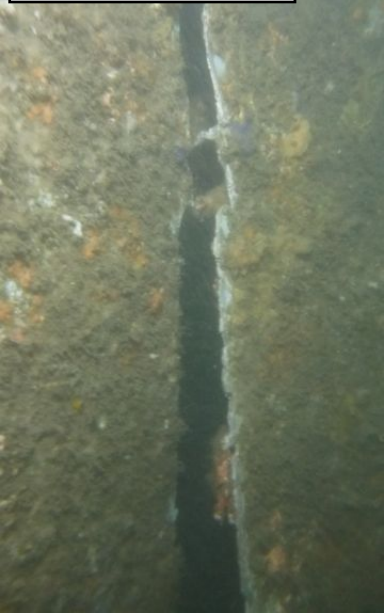
The top of the loose panel on
stbd hangar

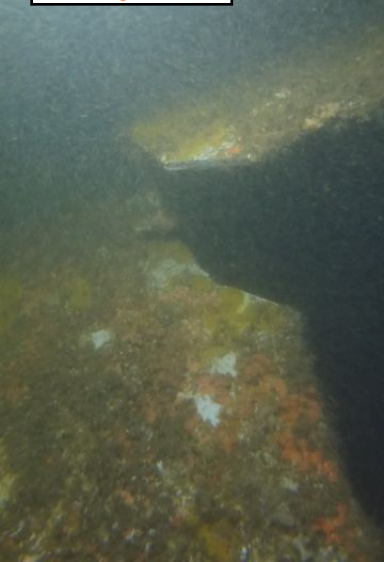
Looking up from
main deck at loose
panel on aft end of
stbd hangar

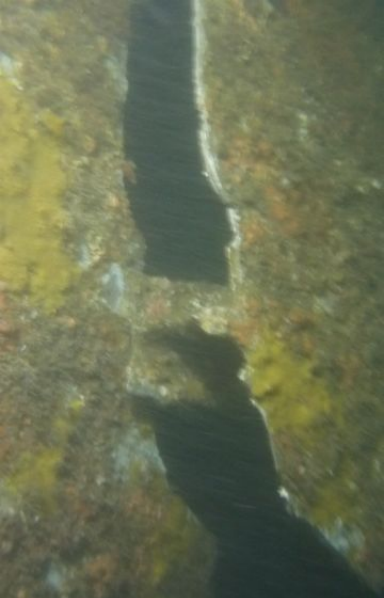
The loose panel on stbd hangar. Its is on aft end of the hangar

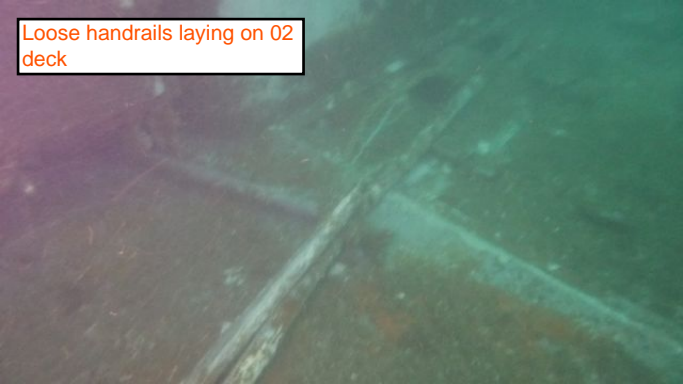
Broken handrails
laying against the
Bridge windows

Loose handrails laying on 02 deck

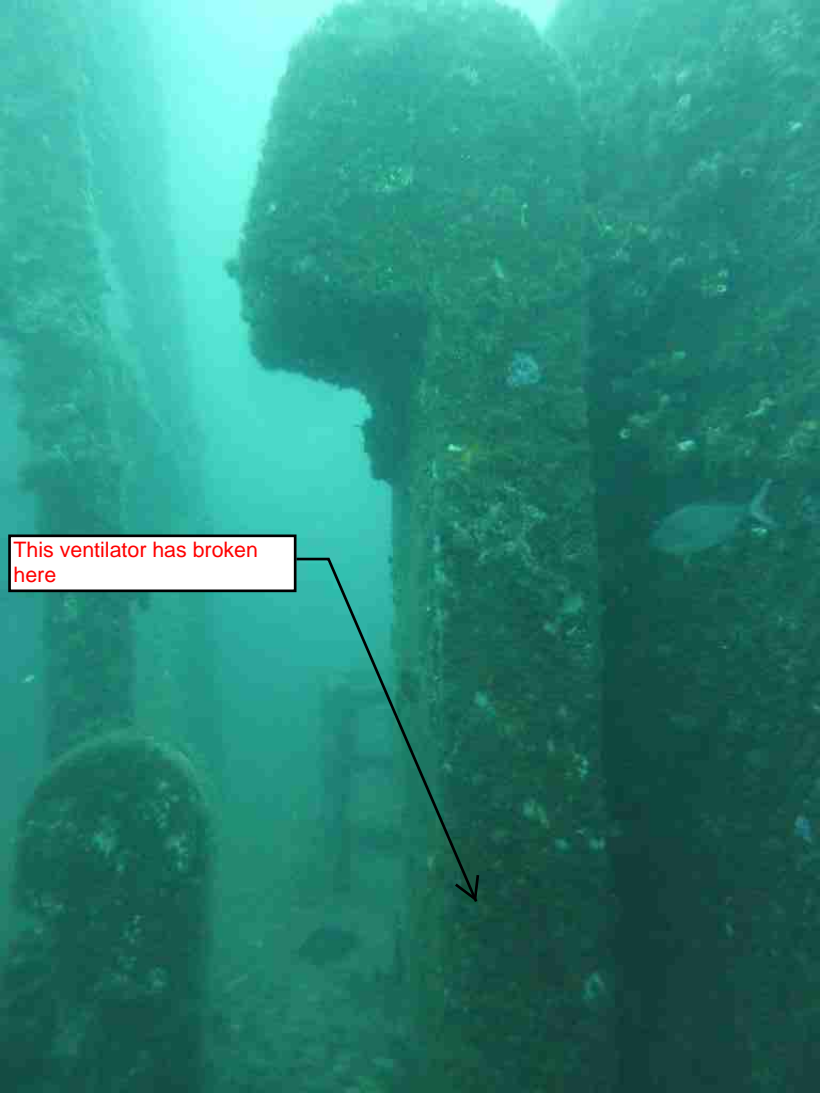
This ventilator has broken here

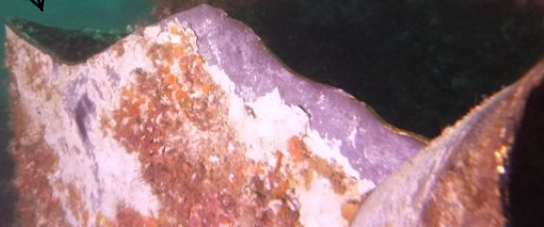
Remains of the ventilator
