From: s22
To: s22 ; s22
Cc: [FOI Contact Officer](#); s22
Subject: RE: FOI 151012 - correspondence from applicant seeking information re: HMAS Adelaide scuttling – 2008/1062 [SEC=UNCLASSIFIED]
Date: Monday, 8 February 2016 10:23:56 AM
Attachments: [image001.gif](#)

Attachment B – Final Report McLennan’s Diving Service June 2015

From: s22
To: s22
Cc: s22
Subject: Ex-HMAS Adelaide Reserve: Compliance under Sea Dumping Permit (SD2008/1062) in response to east coast low weather event - June 2016
Date: Tuesday, 28 June 2016 3:24:44 PM
Attachments: [Final Structural Condition Assessment Report Ex-HMAS Adelaide June 2016.pdf](#)
[McLennans Diving Service - Post East Coast Low Divers Inspection Report - June 2016.pdf](#)

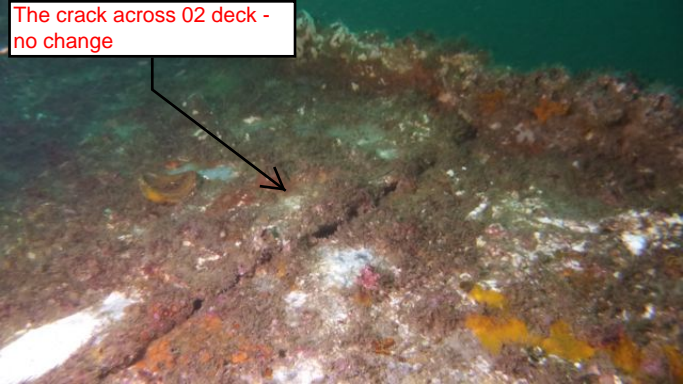
The crack across 02 deck -
no change

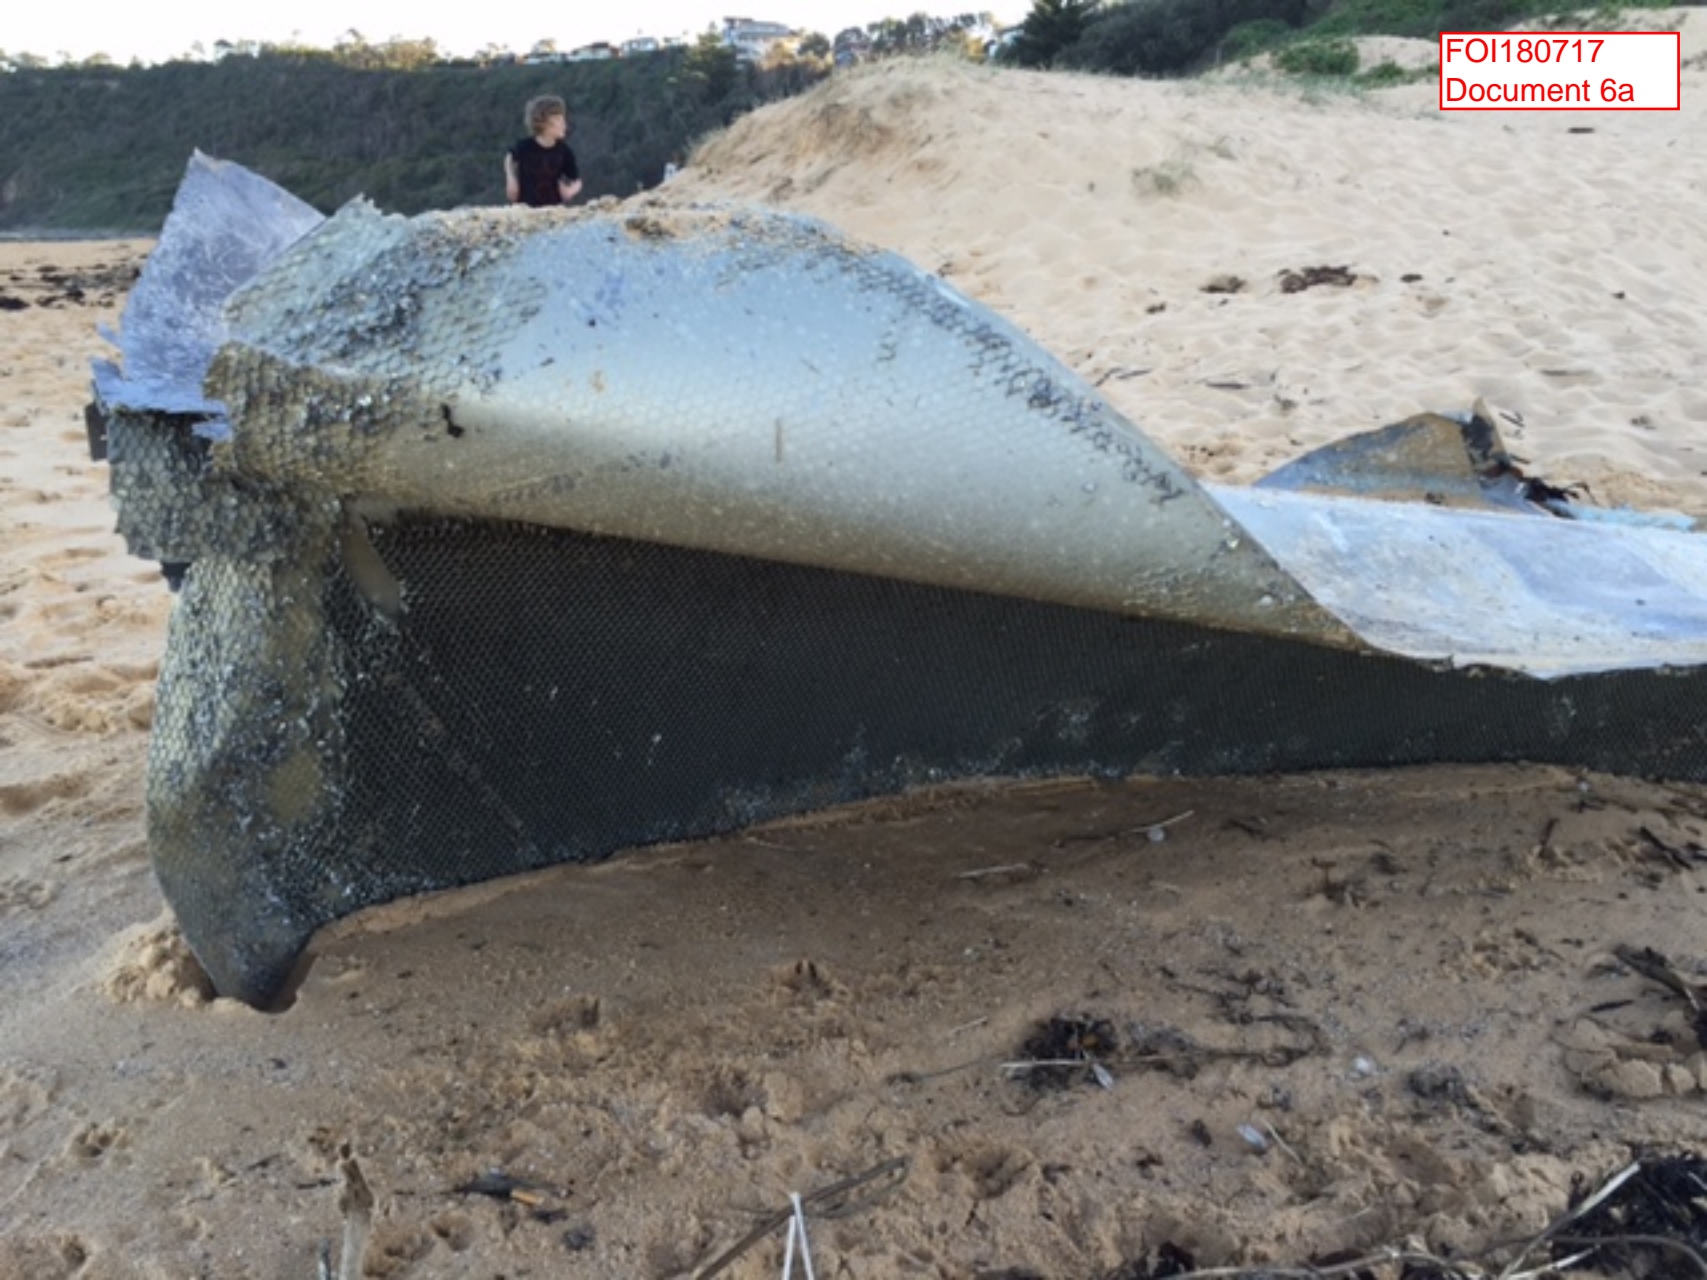
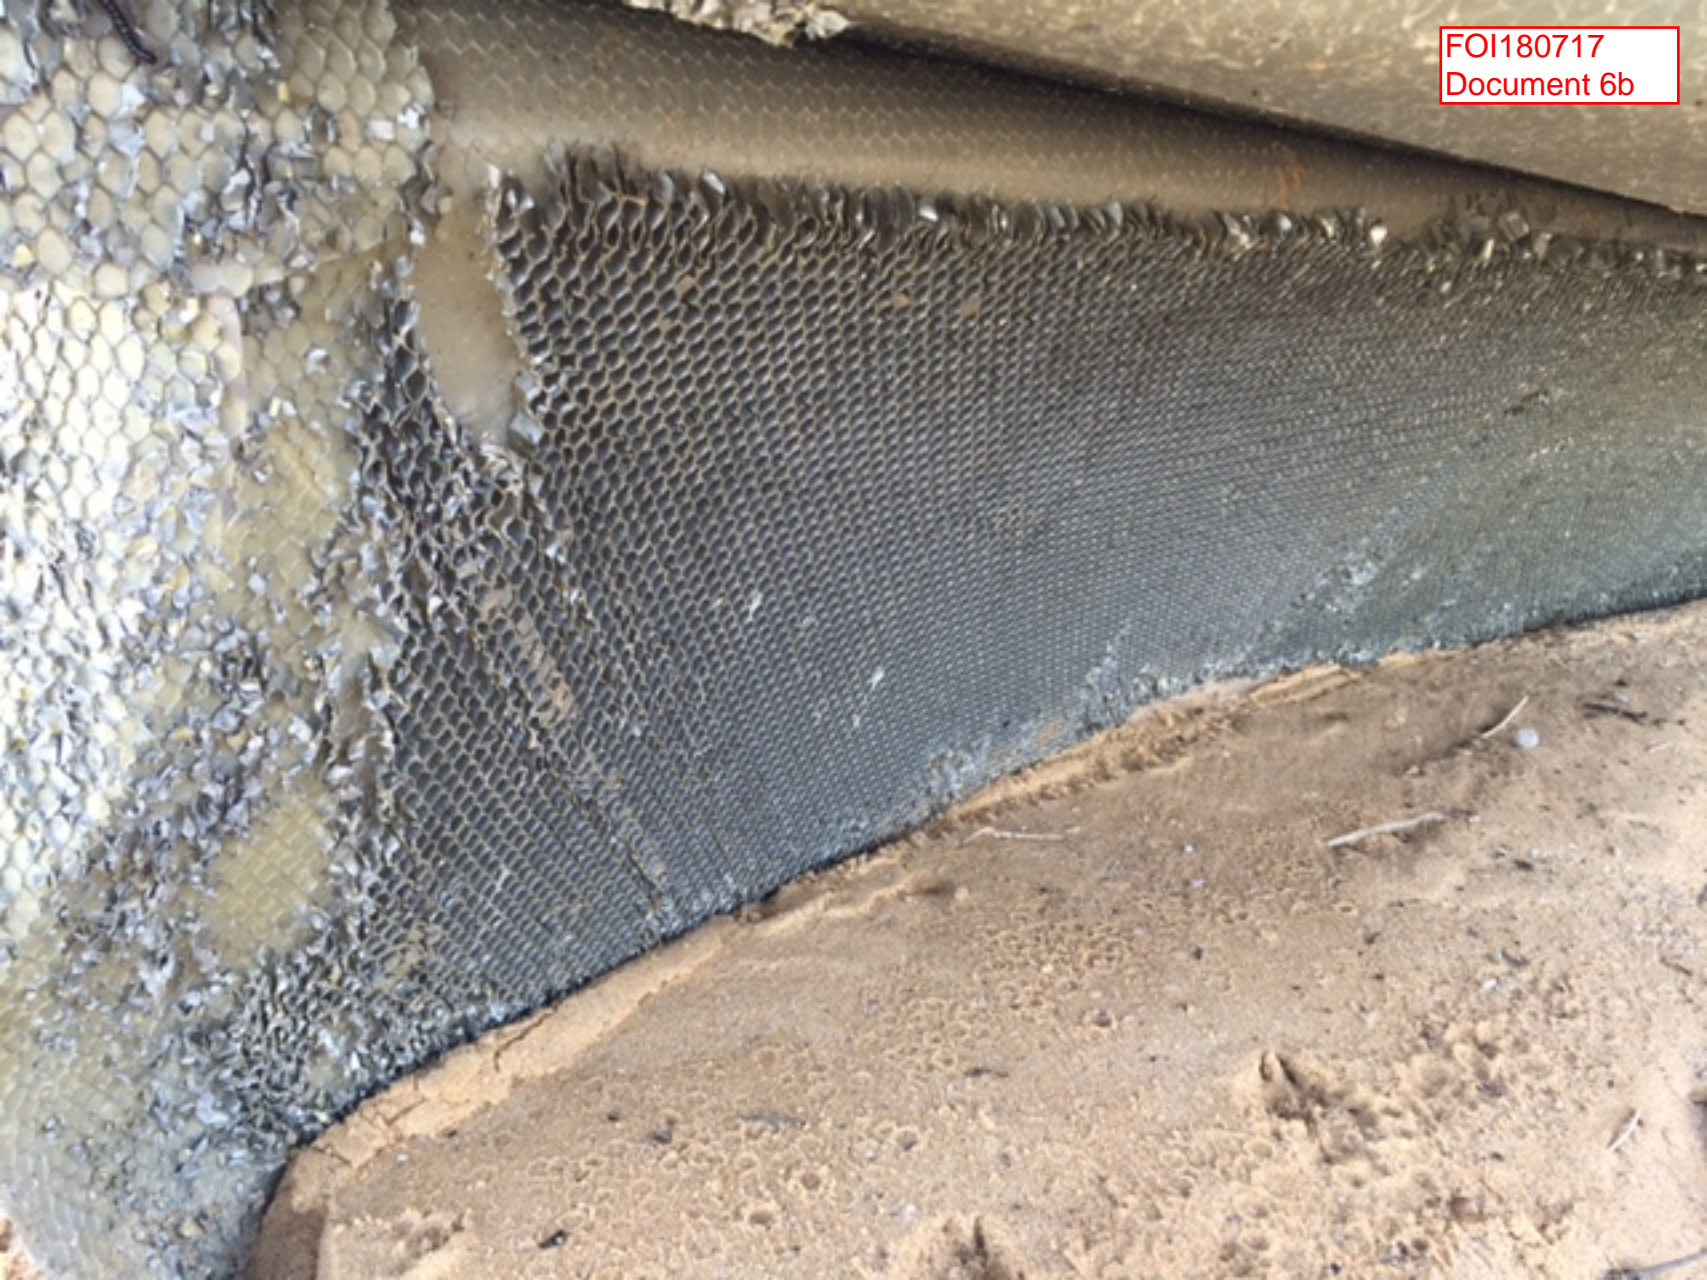
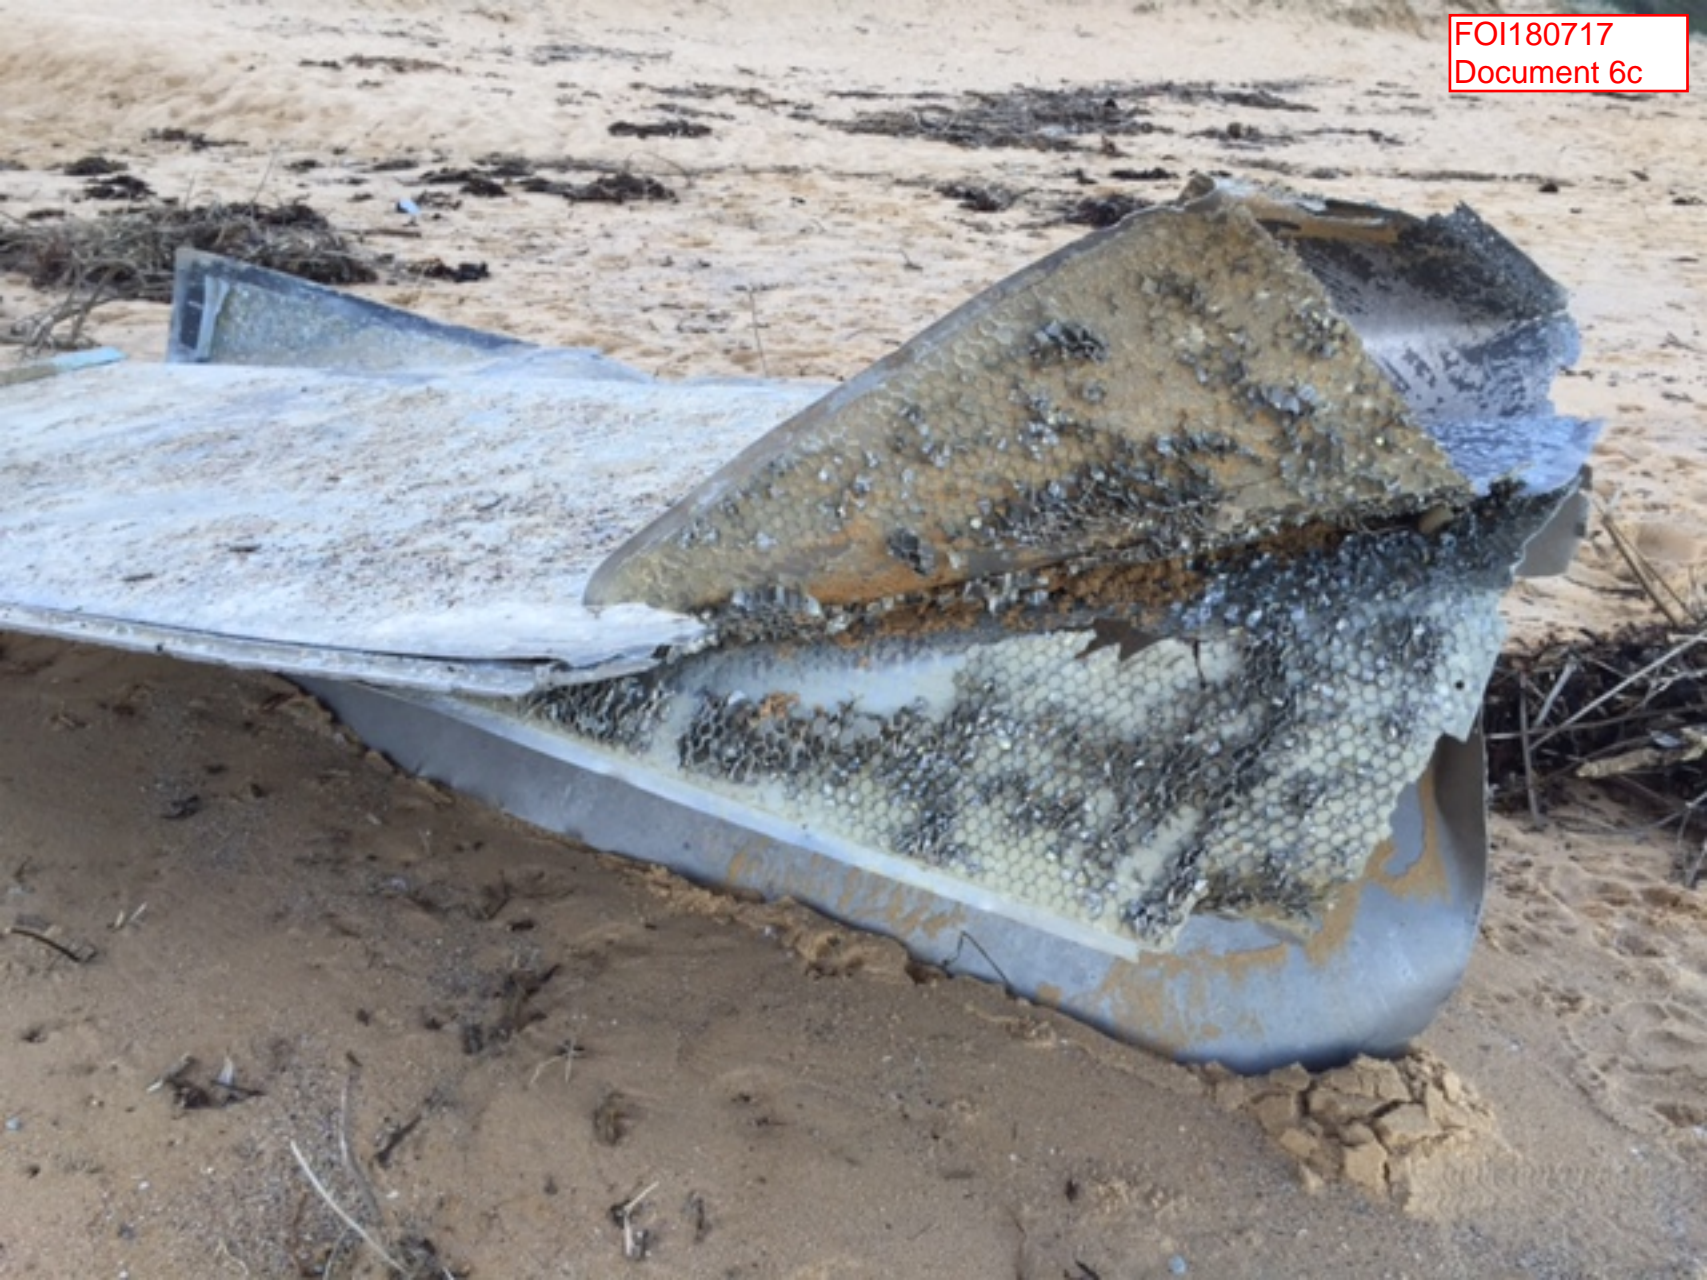
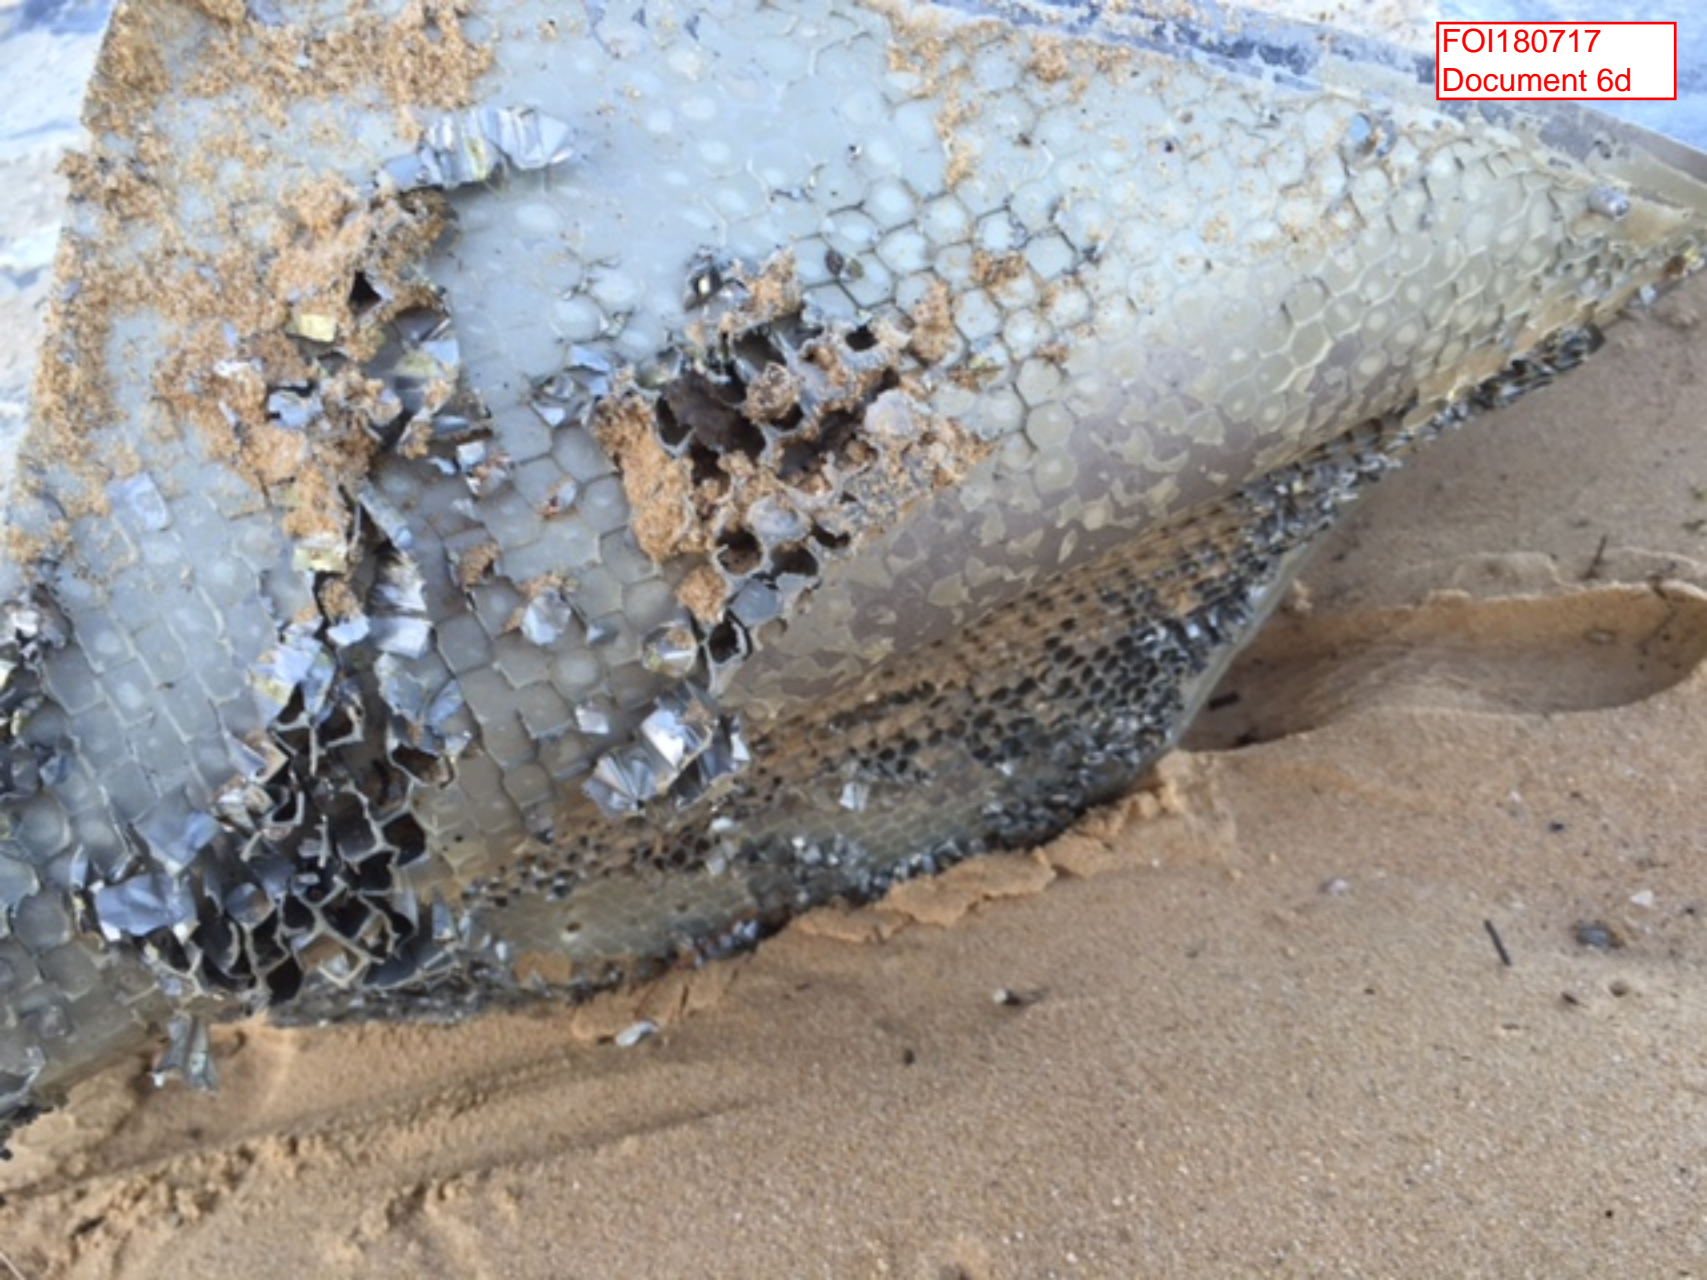
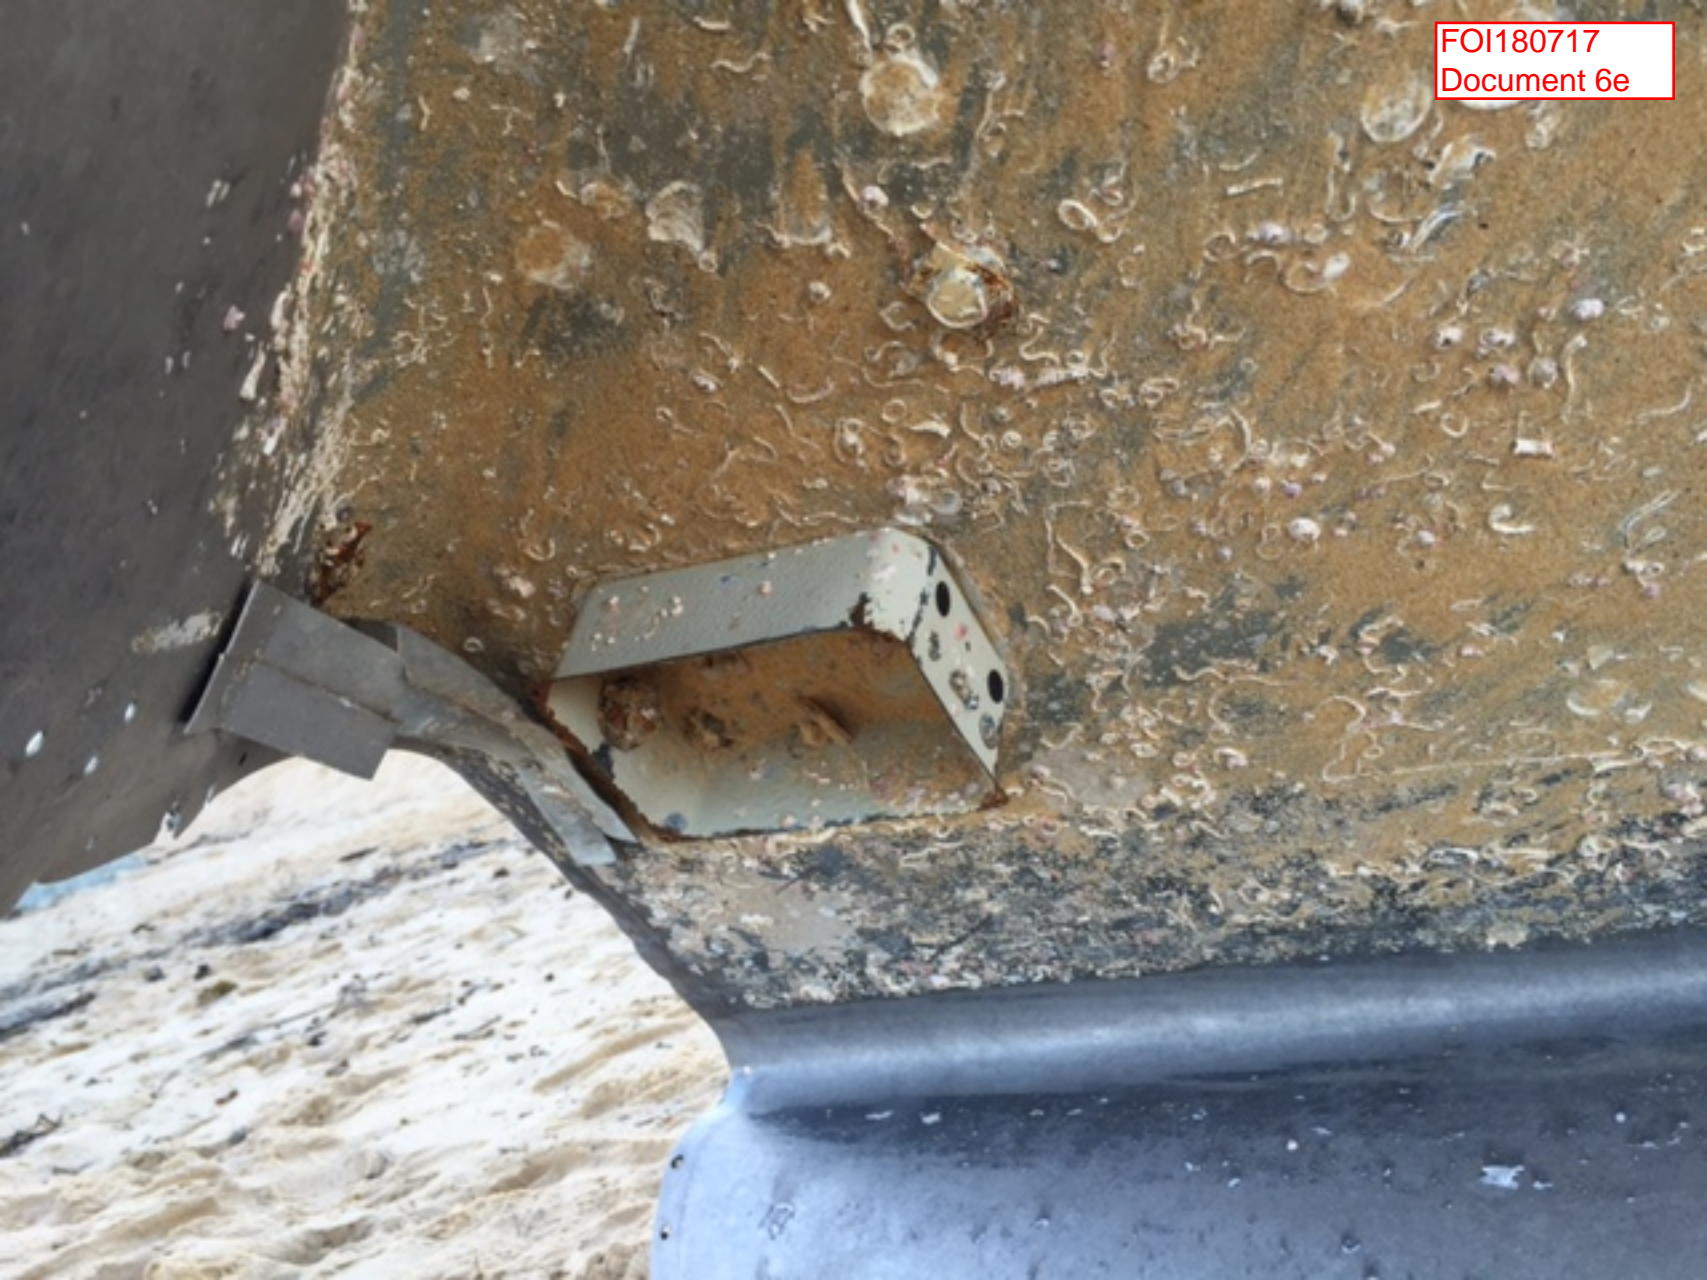
The debris has junction box bases and aluminium honeycomb panels similar to other Adelaide debris washed up on local beaches.
