Our Ref: DOC18/242527

s22(1)(a)(ii)

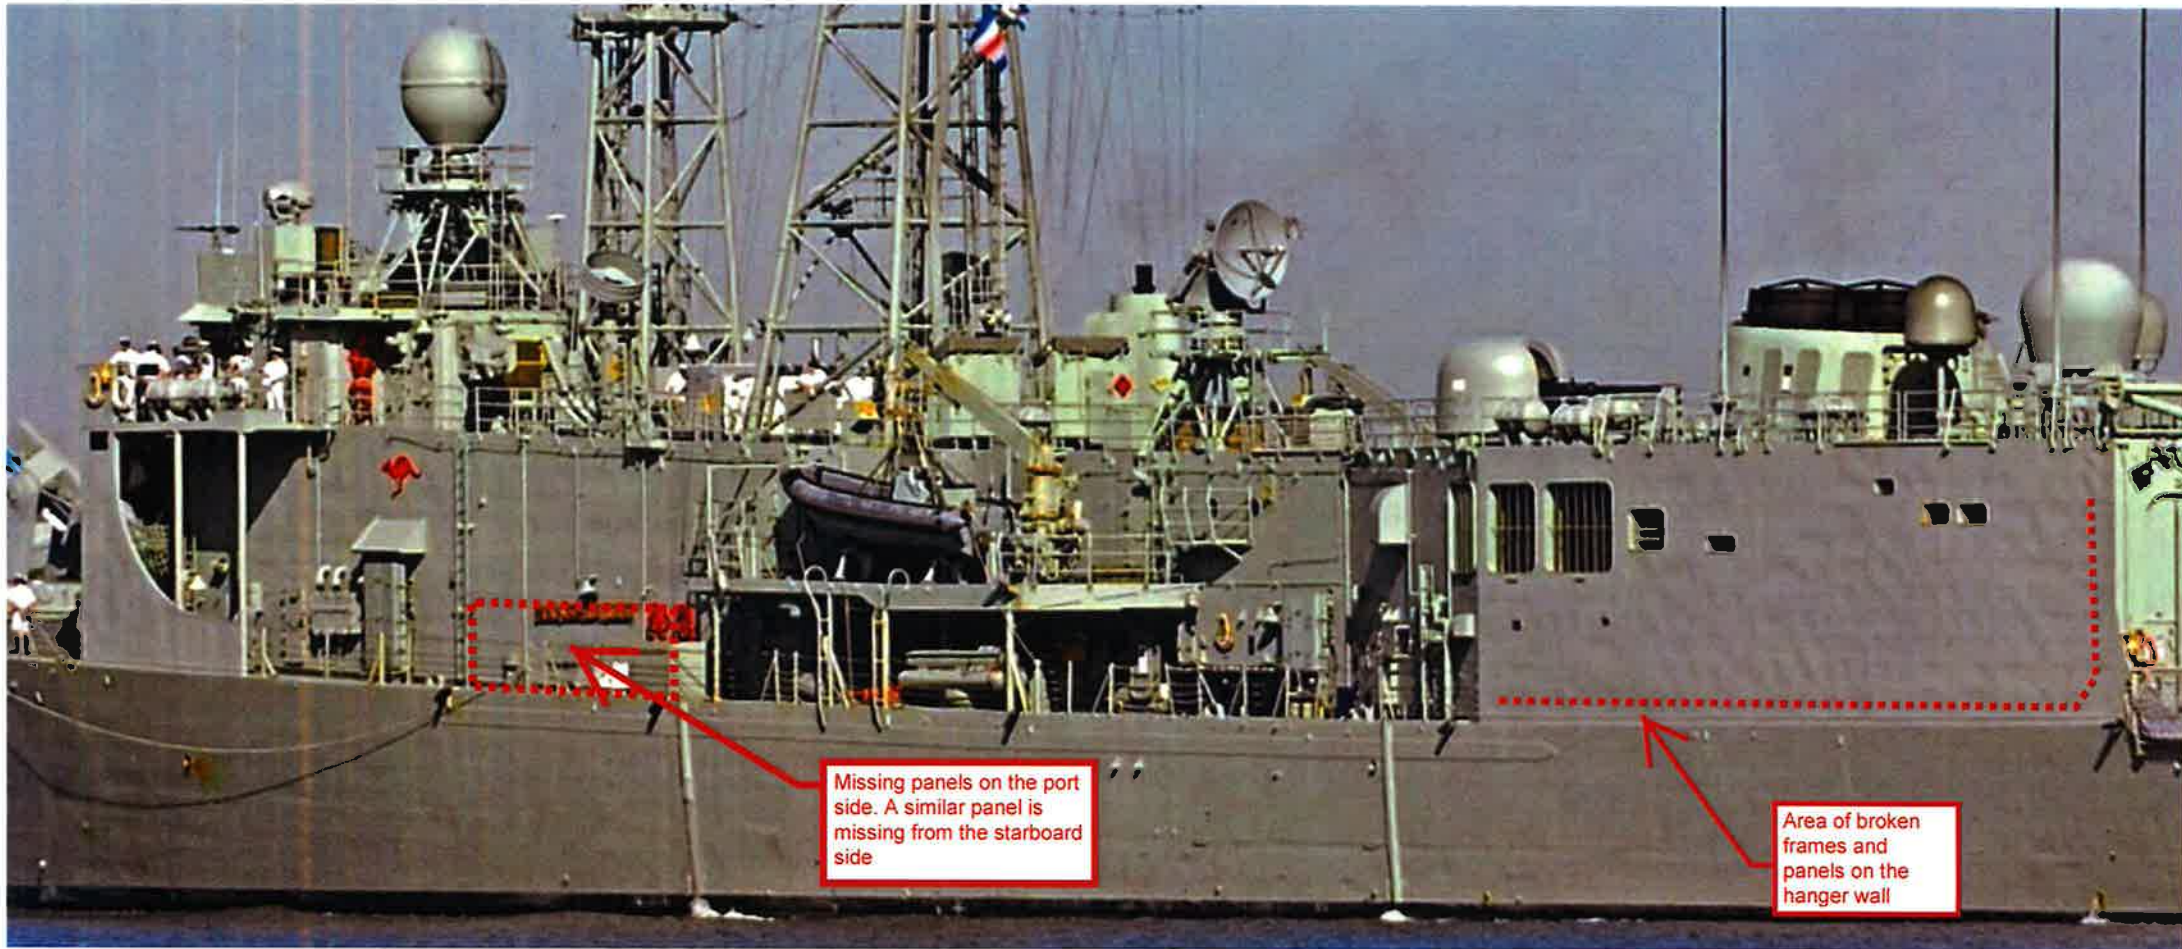
Missing panels on the port side. A similar panel is missing from the starboard side

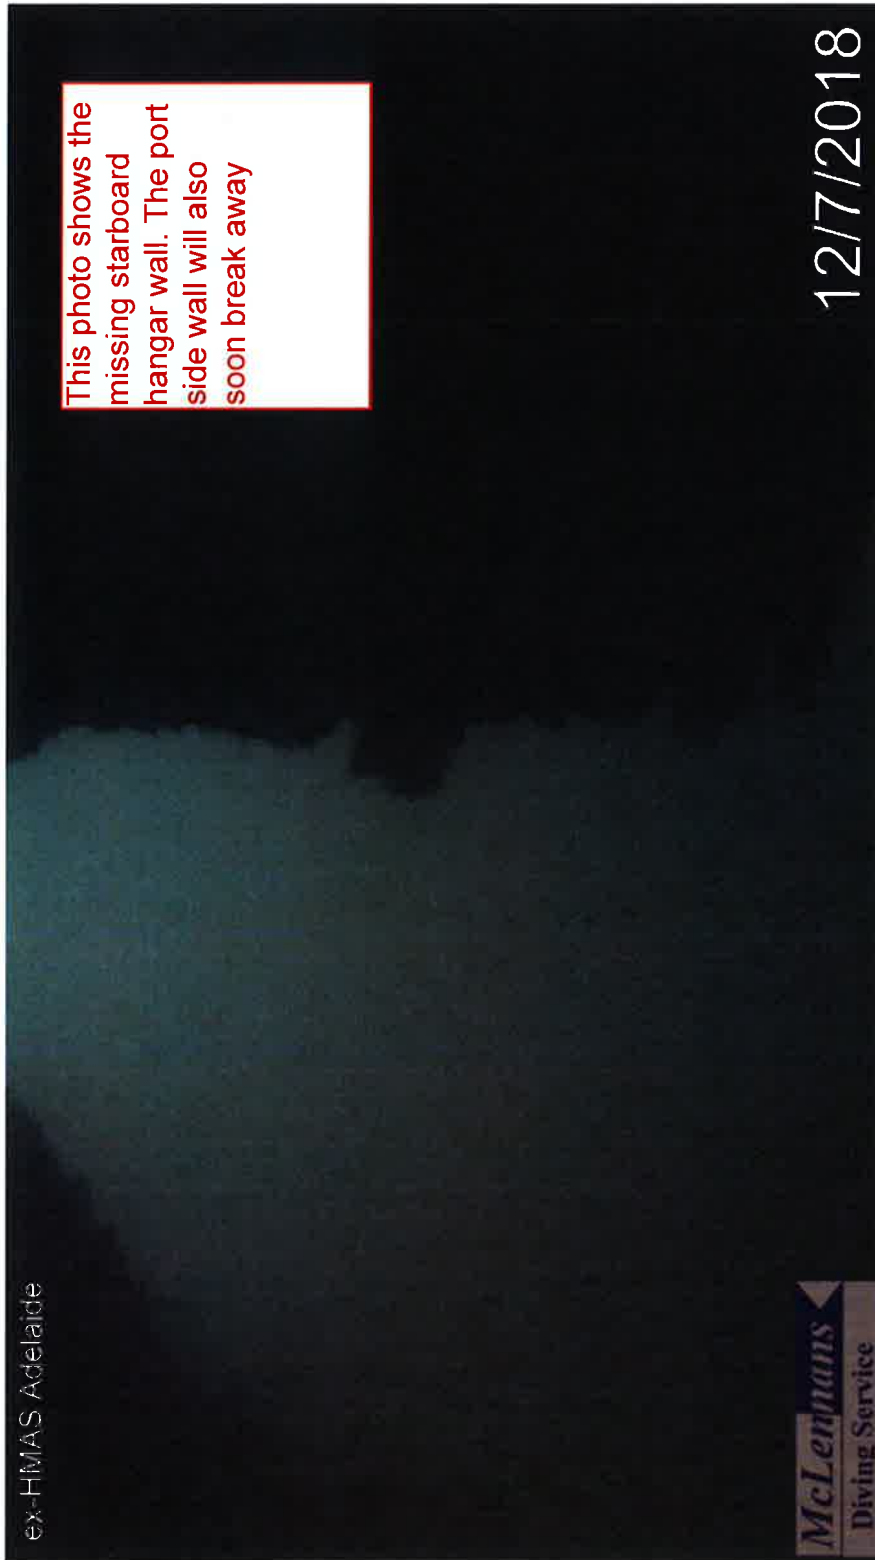
This photo shows the missing starboard hangar wall. The port side wall will also soon break away

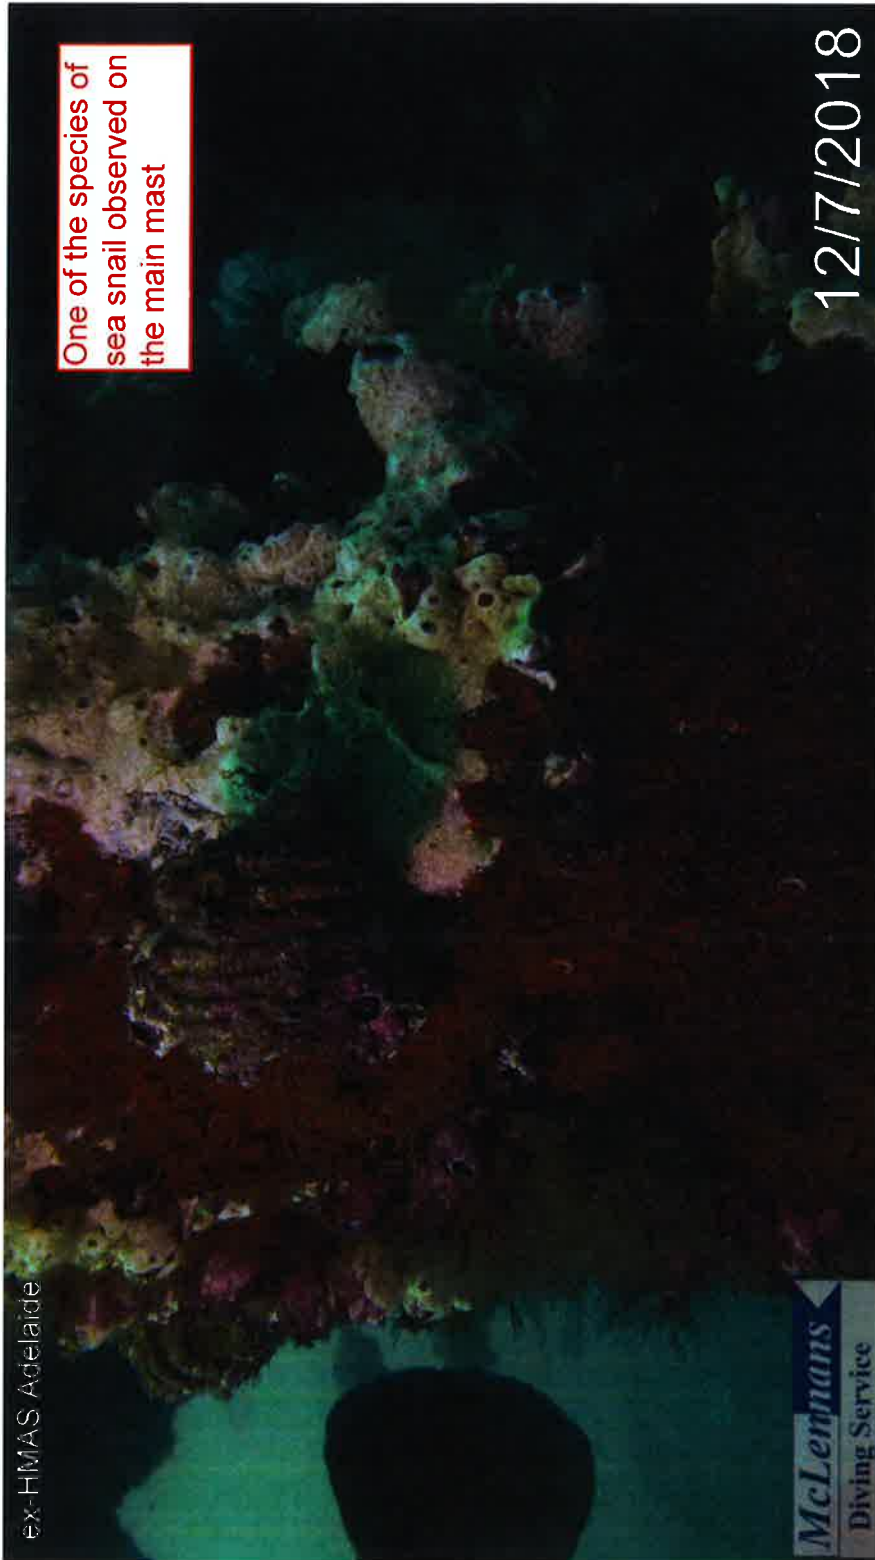
One of the species of sea snail observed on the main mast

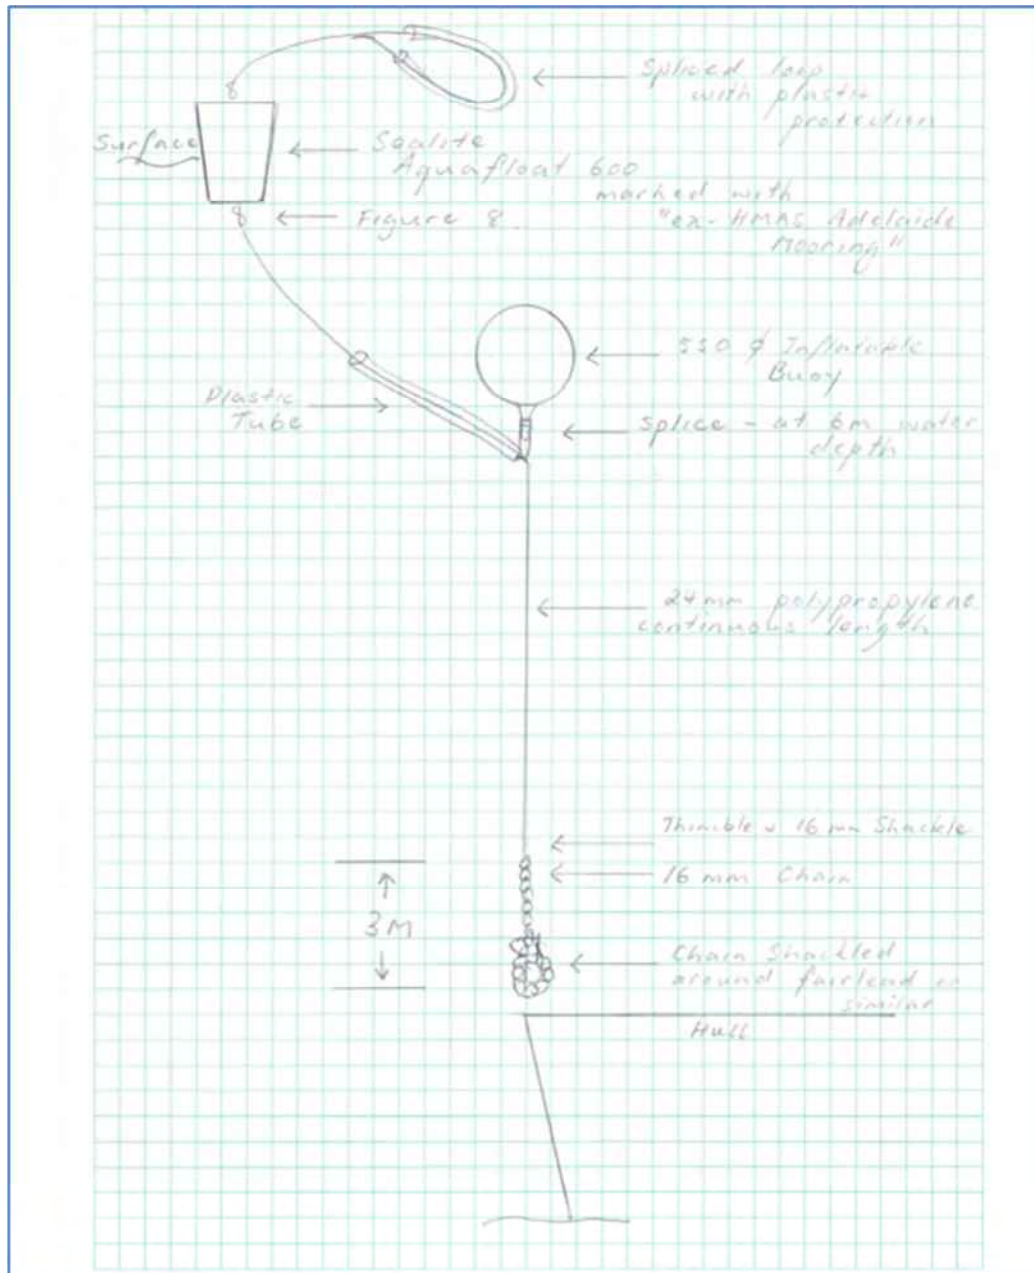
Figure 5-3 Design specifications for the mooring buoys on the Ex-HMAS Adelaide.

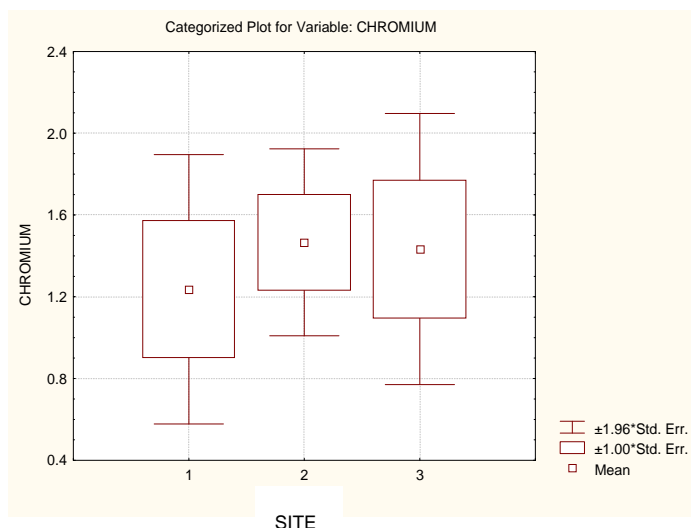
Concentrations of chromium, lead and zinc were detected above the level of reporting (LOR) in all samples analysed from the impact sites. A comparison of mean concentrations of metals in tissue between the three impact sites found that concentrations from the bow, stern and mid section were generally similar (**Figure 3.1, Table 3.1**). When data was combined, the impact samples had a mean chromium concentration of 1.4 mg/kg with a standard deviation of 0.47 mg/kg. Zinc was found to have a mean value of 178 mg/kg (standard deviation of 44.4 mg/kg). The mean concentration of lead in mussel tissues from the impact sites was 0.36 mg/kg and standard error was 0.05 mg/kg (**Table 3.2**). Overall, there were no significant differences in metal concentrations in tissues between the three impact sites at 6 weeks ($F_{6,8} = 1.67$, $p = 0.244$) (**Figure 3.1, Appendix 2**).

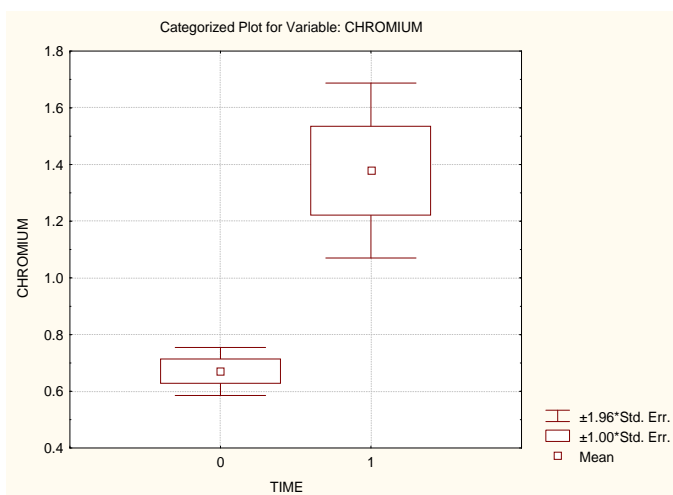
The mean concentration of all metals was higher at the impact sites than the zero control samples (**Figure 3.2, Table 3.2**). One way ANOVA was undertaken to assess the differences between concentrations of chromium, zinc and lead between the zero control and impact sites. Overall, there were significant differences in metals concentrations in mussel tissue between the zero controls and impact sites ($F_{3, 10} = 7.22$, $p = 0.007$). *Post hoc* testing showed that these differences were caused by differences in the concentrations of chromium and lead, however, no differences were apparent for zinc concentrations (refer to **Appendix 2**).

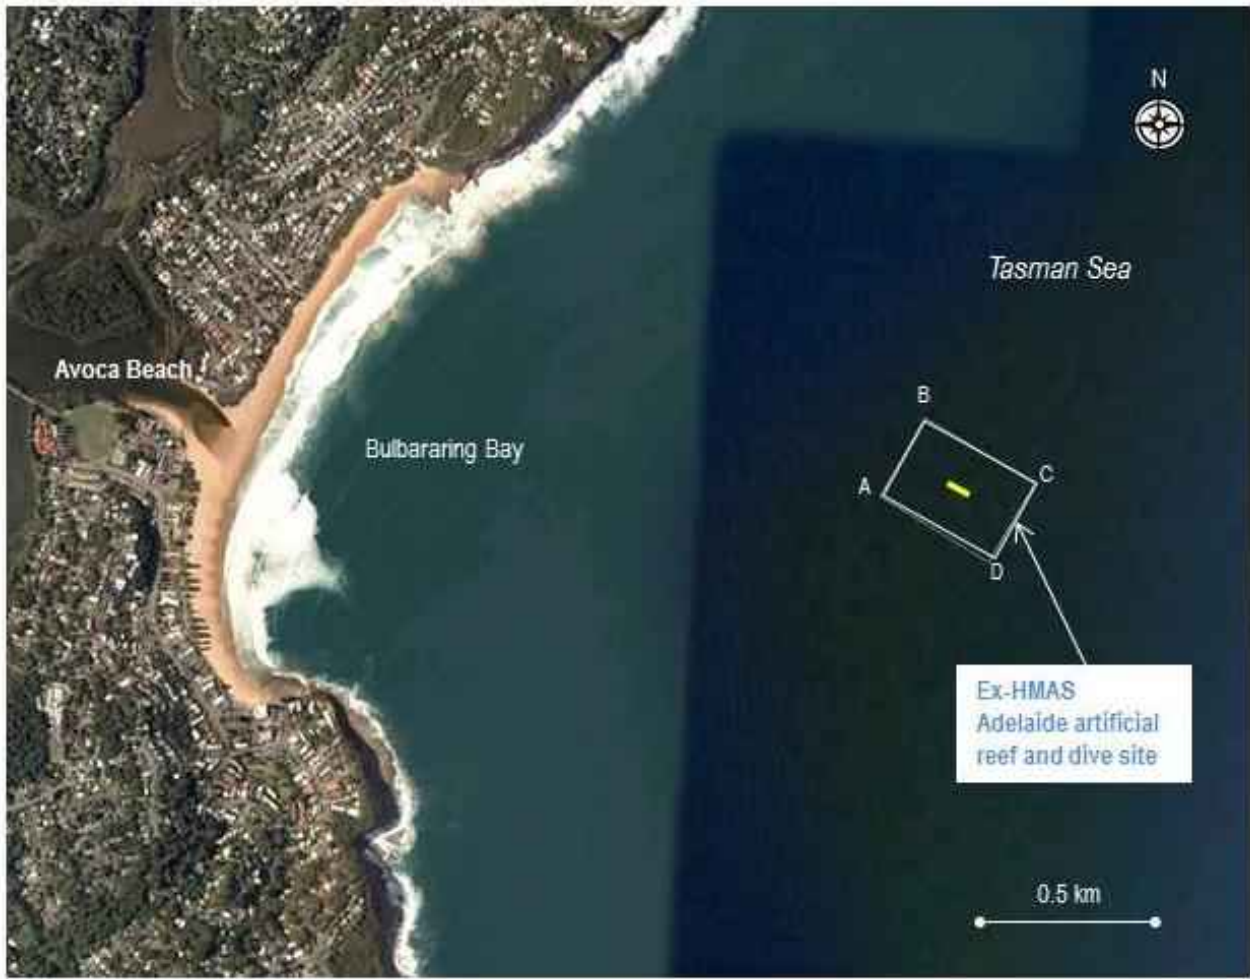
Boundary of Dive Site	Easting (MGA 94)	Northing (MGA 94)
A	356428.713	6296117.693
B	356538.438	6296341.142
C	356850.615	6296188.618
D	356742.410	6295963.310
