From: s22
To: s22 ; s22
Cc: [FOI Contact Officer](#); s22
Subject: RE: FOI 151012 - correspondence from applicant seeking information re: HMAS Adelaide scuttling – 2008/1062 [SEC=UNCLASSIFIED]
Date: Monday, 8 February 2016 10:23:56 AM
Attachments: [image001.gif](#)

Attachment B – Final Report McLennan’s Diving Service June 2015

From: s22
To: s22
Cc: s22
Subject: Ex-HMAS Adelaide Reserve: Compliance under Sea Dumping Permit (SD2008/1062) in response to east coast low weather event - June 2016
Date: Tuesday, 28 June 2016 3:24:44 PM
Attachments: [Final Structural Condition Assessment Report Ex-HMAS Adelaide June 2016.pdf](#)
[McLennans Diving Service - Post East Coast Low Divers Inspection Report - June 2016.pdf](#)

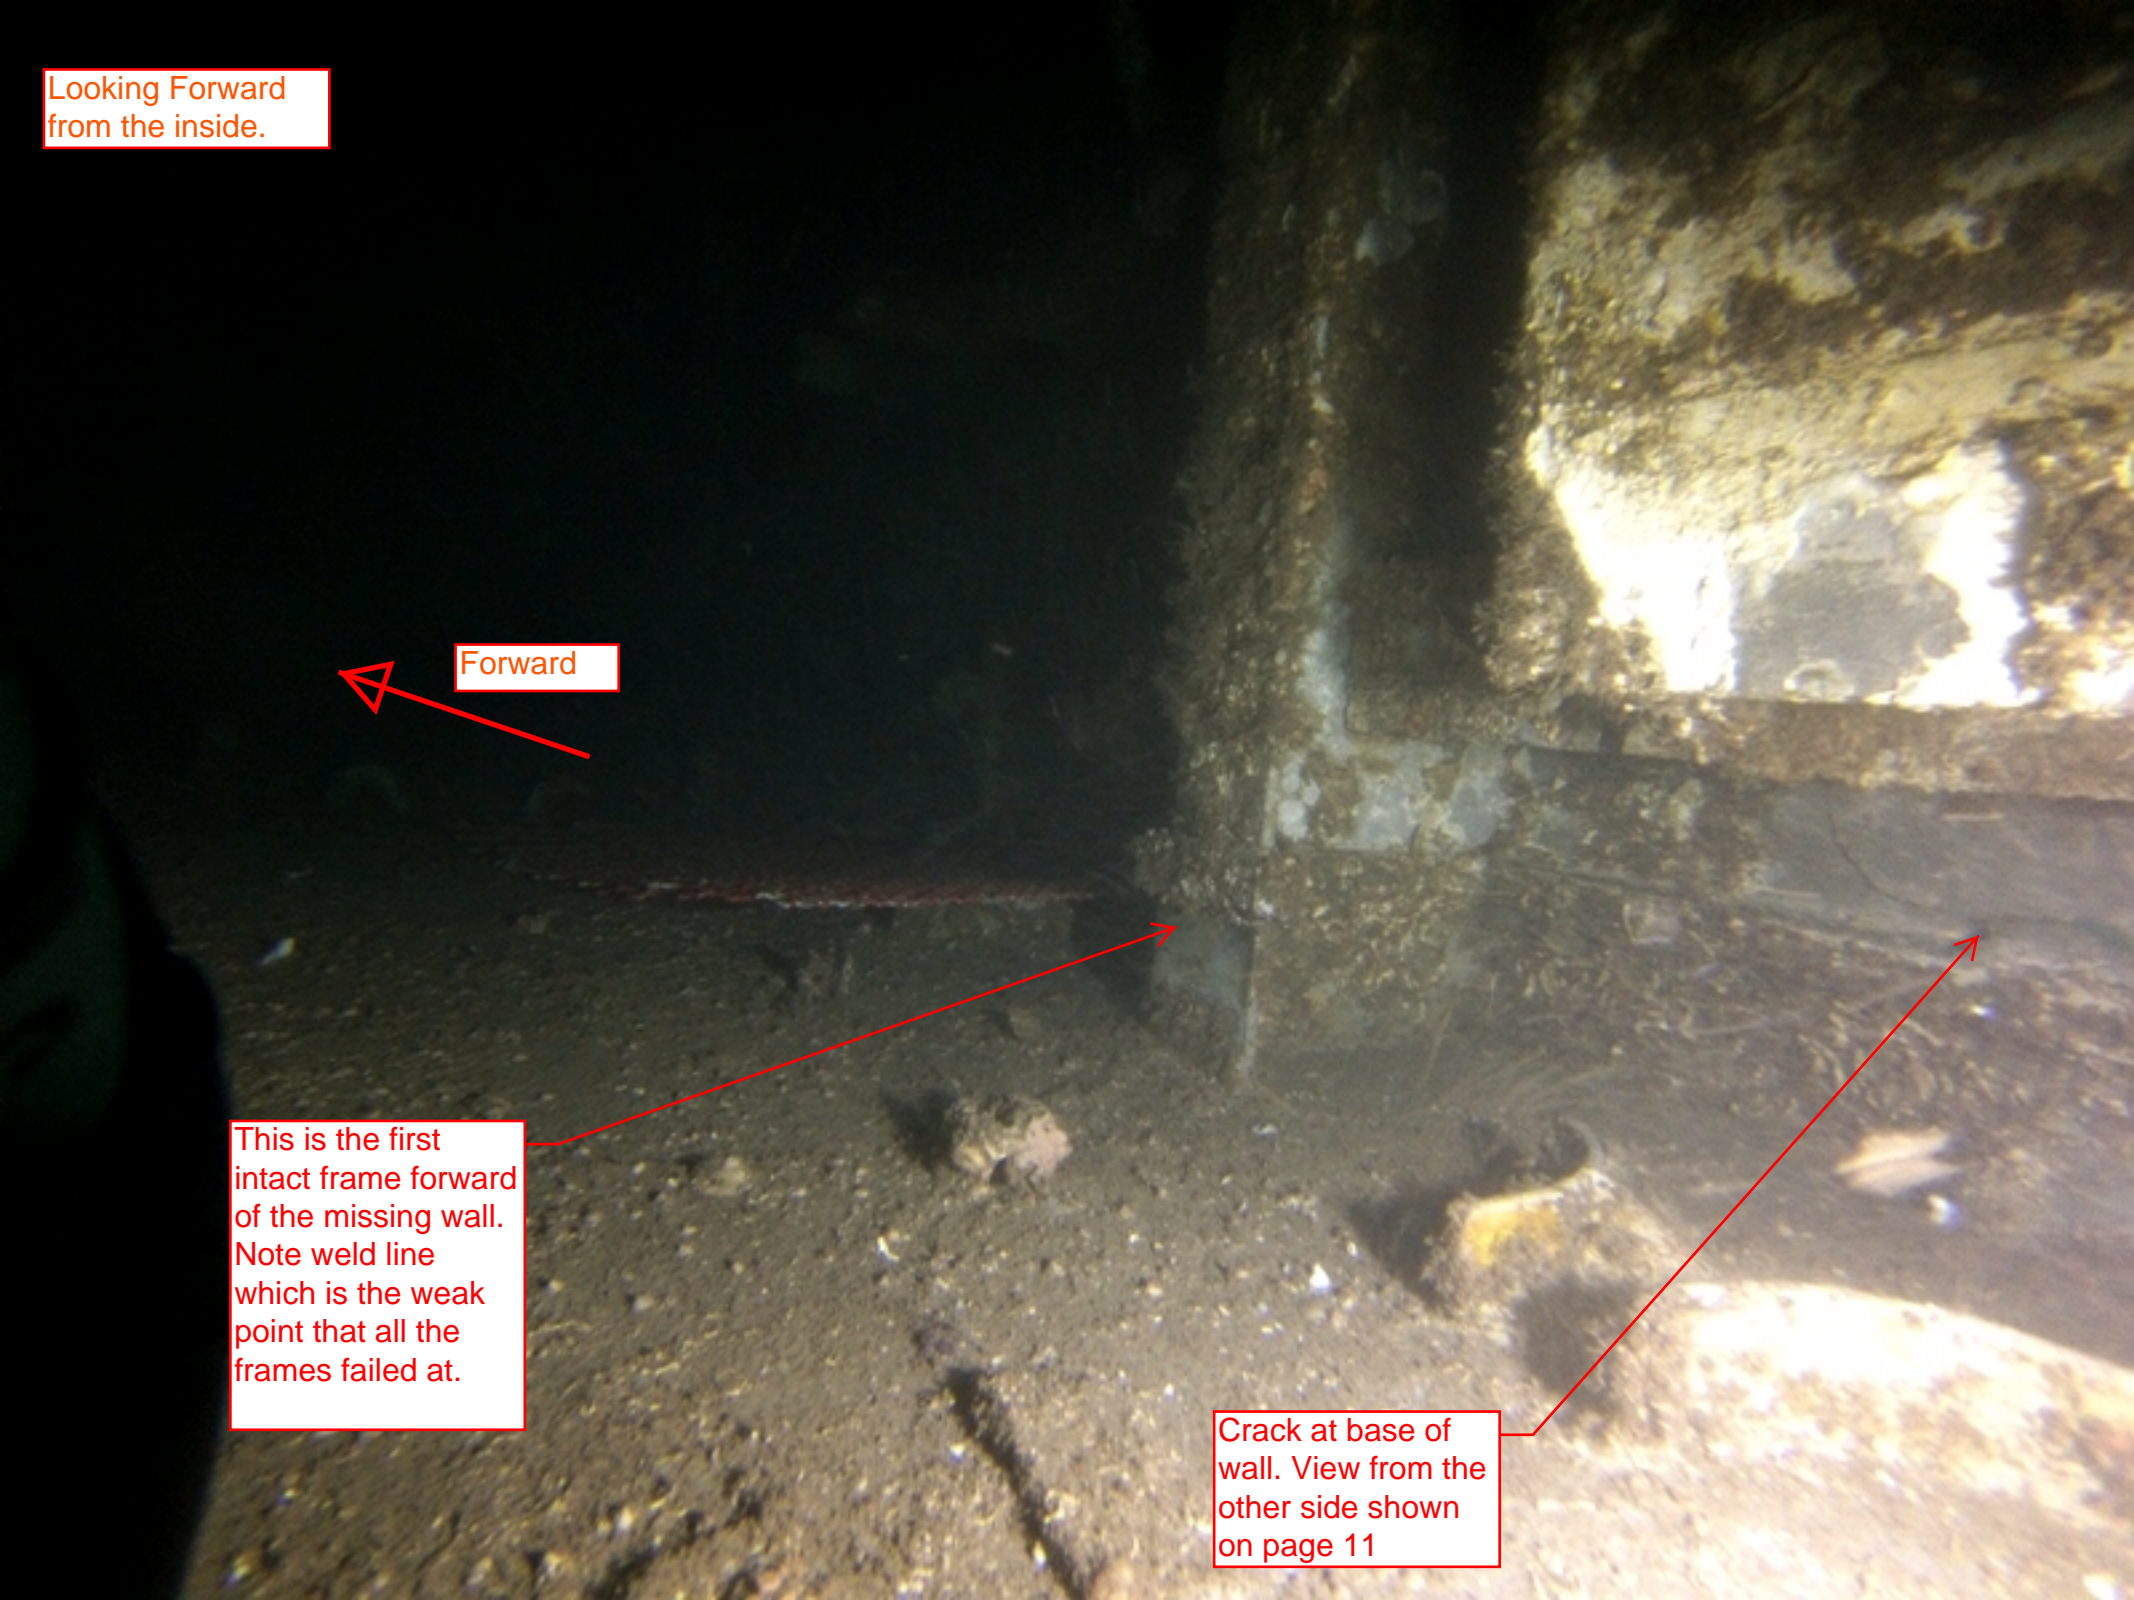
This is the first
intact frame forward
of the missing wall.
Note weld line
which is the weak
point that all the
frames failed at.

Crack at base of
wall. View from the
other side shown
on page 11
