**Dry and Wet season
aerial reconnaissance
of Magela Creek and
East Alligator River,
with brief notes on the
geomorphology of the
area**

MJ Saynor
WD Erskine

October 1998

This Internal Report describes both flights and comments on the photographs and slides that were taken. Notes on the geomorphology have been added to highlight particular landforms and their significance. The senior author was responsible for the photography.

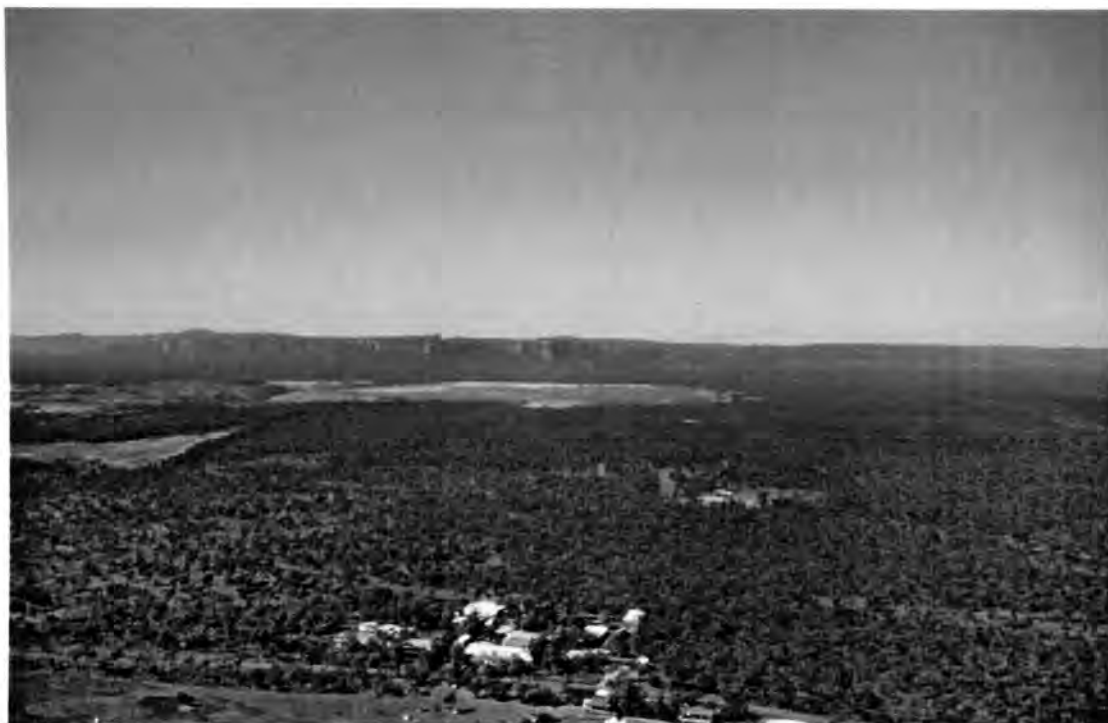
Plate 1: View of the tailings dam and Retention Pond 1 at Ranger Uranium Mine showing the Mt Brockman Escarpment in the background. Slide No 1: Mike Saynor, 2/6/97.

consistent with Williams' (1969a) findings that, near the East Alligator River, very little of the original Koolpinyah Surface remains because it has been extensively eroded. Nevertheless, the Koolpinyah Surface is an extremely old landscape and appears to be very stable (Galloway, 1976; East et al 1993; East, 1996). East et al (1993) recommended that rehabilitated mine structures associated with ERARM should be sited on this surface, as indeed they have been (Plate 1).

- No. 1** Aerial view of ERA Ranger Mine (tailings dam) showing Mt Brockman in the background (Plate 1).
- No. 2** Tailings dam at ERA Ranger Mine.
- No. 3** Georgetown Billabong, near Magela Creek, upstream of the mine (Plate 2).

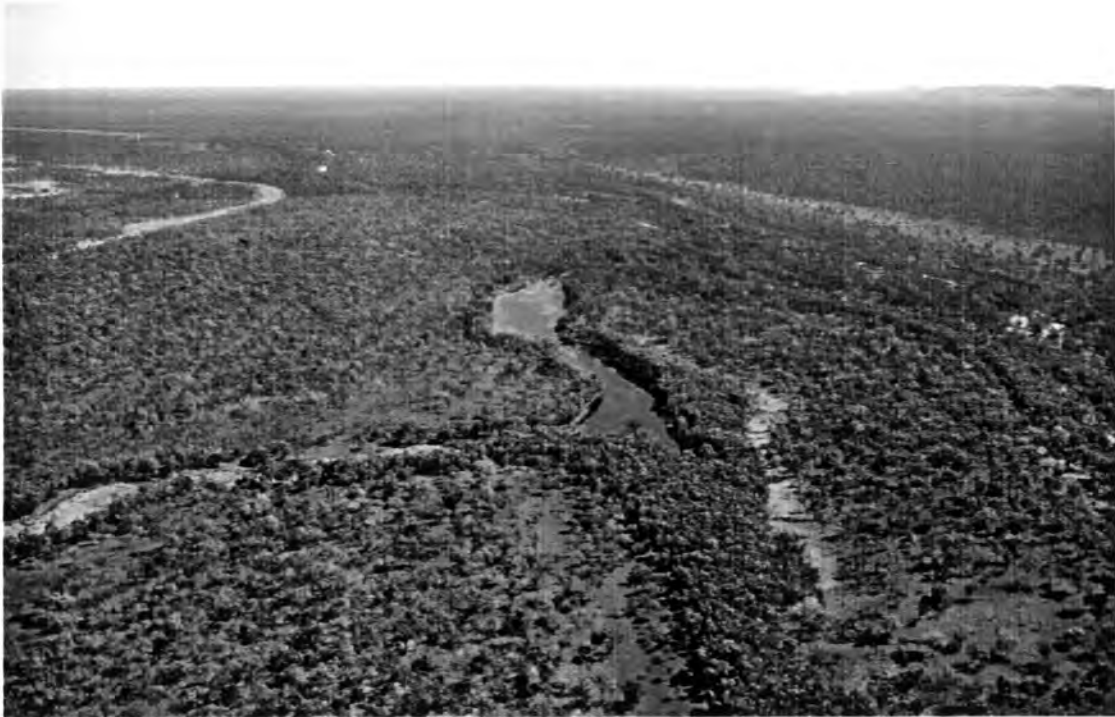
Plate 2: Georgetown Billabong, near Magela Creek, upstream of the mine. This is a backflow billabong or blocked valley lake (see Blake and Oliver, 1971; Hart & McGregor, 1980) formed by the damming of the outlet of Georgetown Creek by Magela creek deposits (Nanson et al 1993) The extensive lowland surrounding the billabong is the Tertiary Koolpinyah Surface of Hayes (1967). The soils of the area in the top left are described by Chartres et al (1991). Slide No 3: Mike Saynor, 2/6/97.

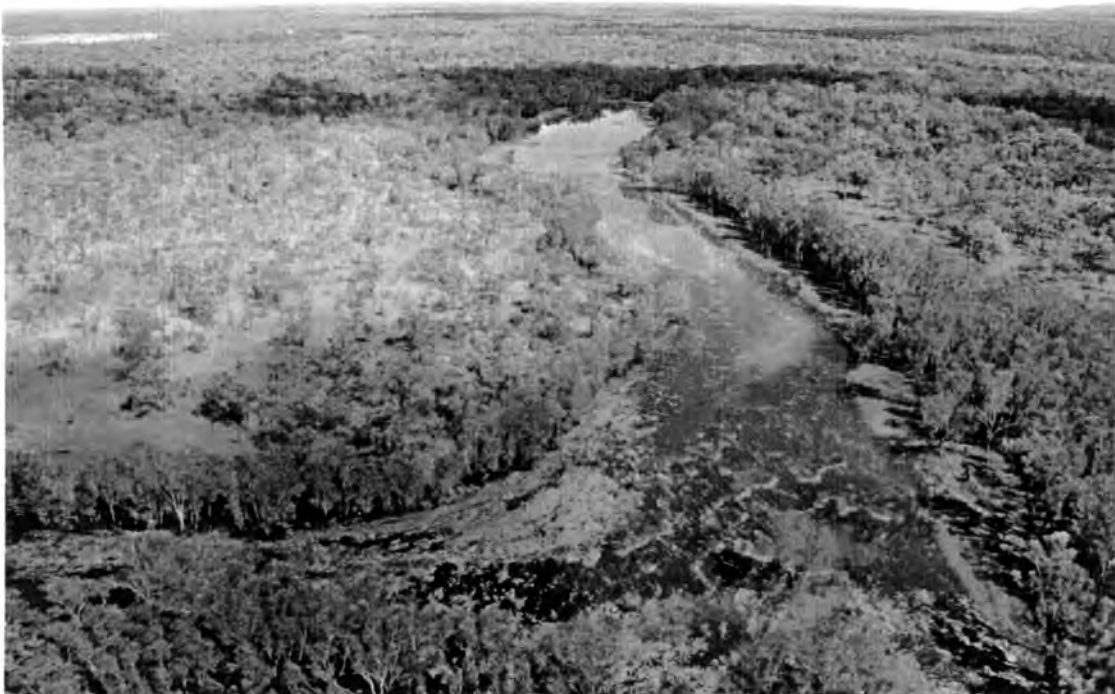
Plate 3: Georgetown Billabong near ERA Ranger Mine. Note higher water level than in Plate 2. Print No. 15 Mike Saynor, 22/2/98.

Georgetown Billabong near Ranger Mine. (Plate 3)

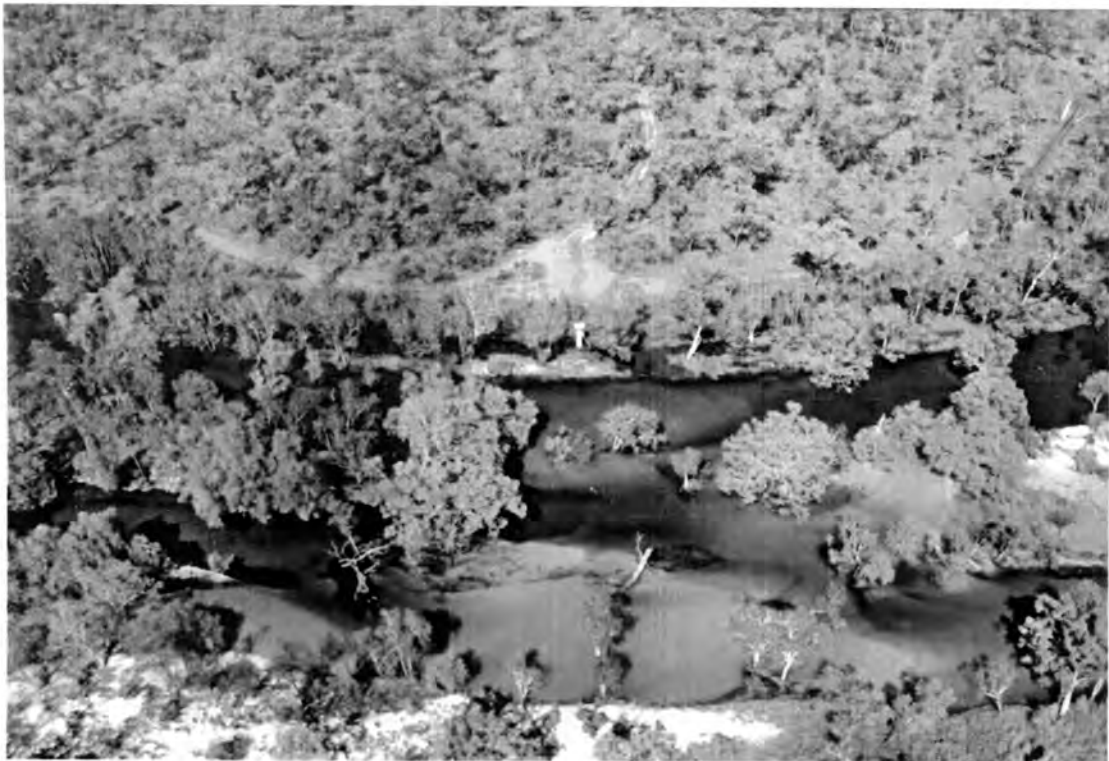
Plate 5: Gauging station 8210009 on Magela Creek. Magela Creek is a sand-bed anastomosing channel here. The individual channels are separated by vegetated, sandy islands. Many sediment transport measurements have been made here. Print No. 23 Mike Saynor, 22/2/98.

Gauging station 8210009 on Magela Creek (Plate 5).

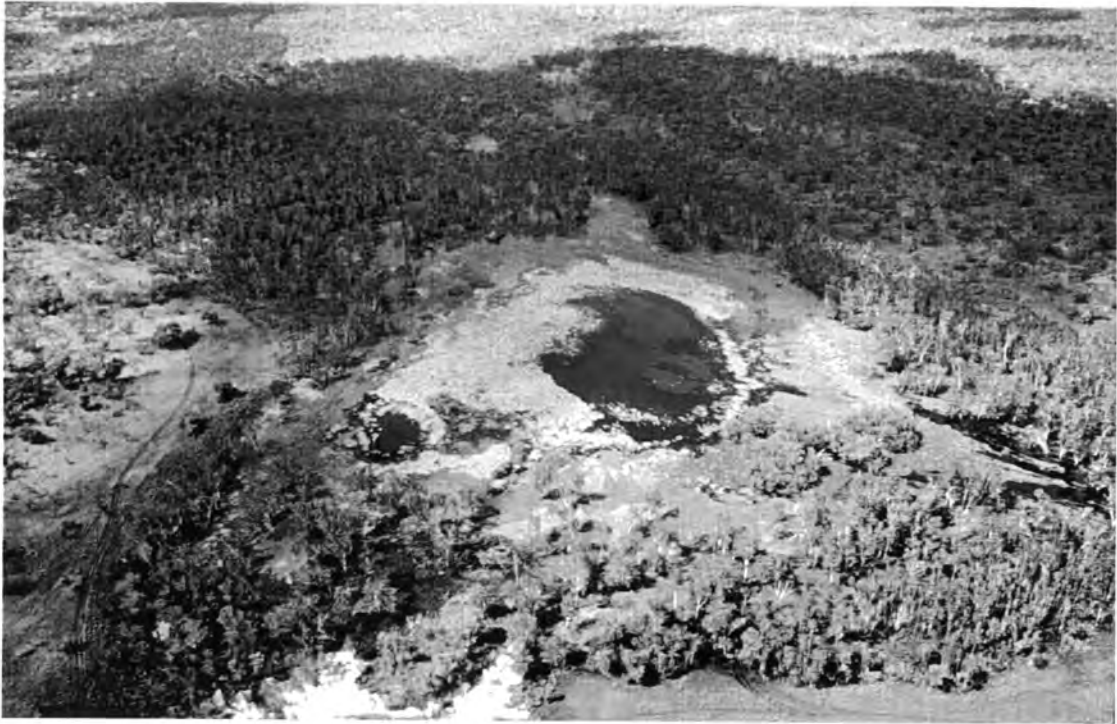
Plate 6: Gulungul Billabong to the west of Magela Creek. This is another backflow billabong downstream of the mine site. The sand in the bottom left of the image is part of a reverse delta extending from Magela Creek billabong. Slide No. 17 Mike Saynor, 22/2/98.

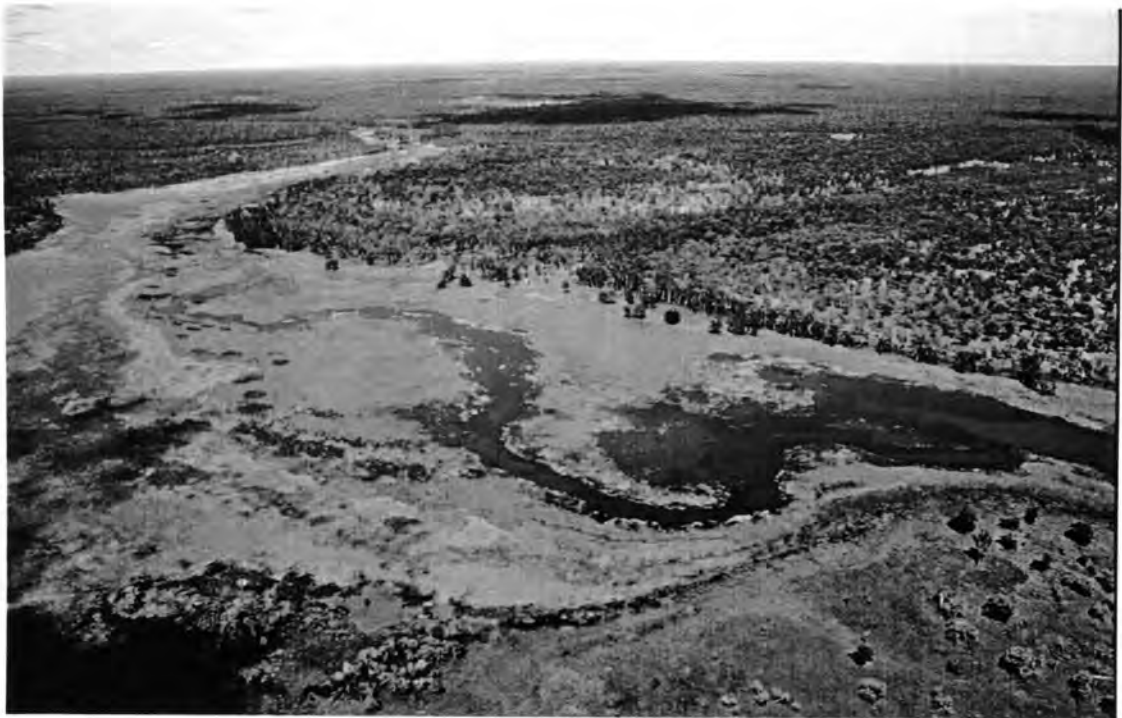
Plate 7: Corndorl Billabong to the west of Magela Creek. This is another backflow billabong occupying a shallow valley cut into the Koolpinyah surface. Slide No. 18 Mike Saynor, 22/2/98.

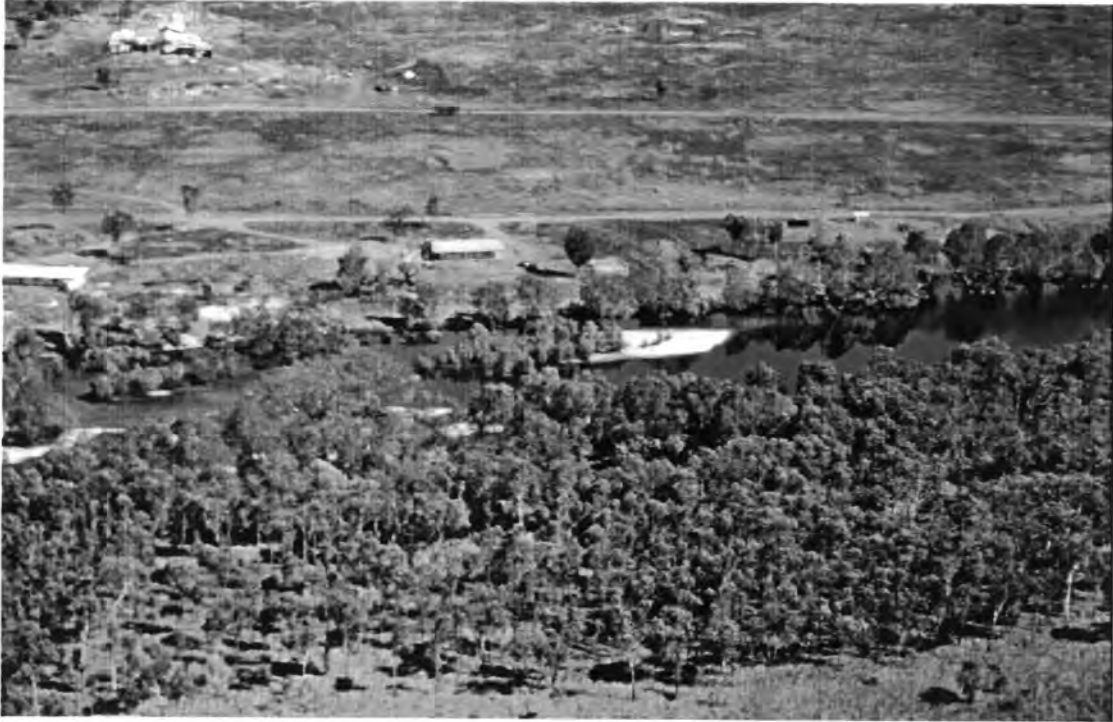
Plate 8: Sand delta at upstream end of Mudginberri Billabong. This marks the present downstream limit of the sand anastomosing zone of Magela Creek. The buildings are located on the Koolpinyah Surface. Slide No. 8 Mike Saynor, 2/6/97.

- No. 7** Gulungul (small round) and Corndorl (larger and longer) billabongs to the west of Magela Creek.
- No. 8** Sand delta at upstream end of Mudginberri Billabong, (Plate 8).

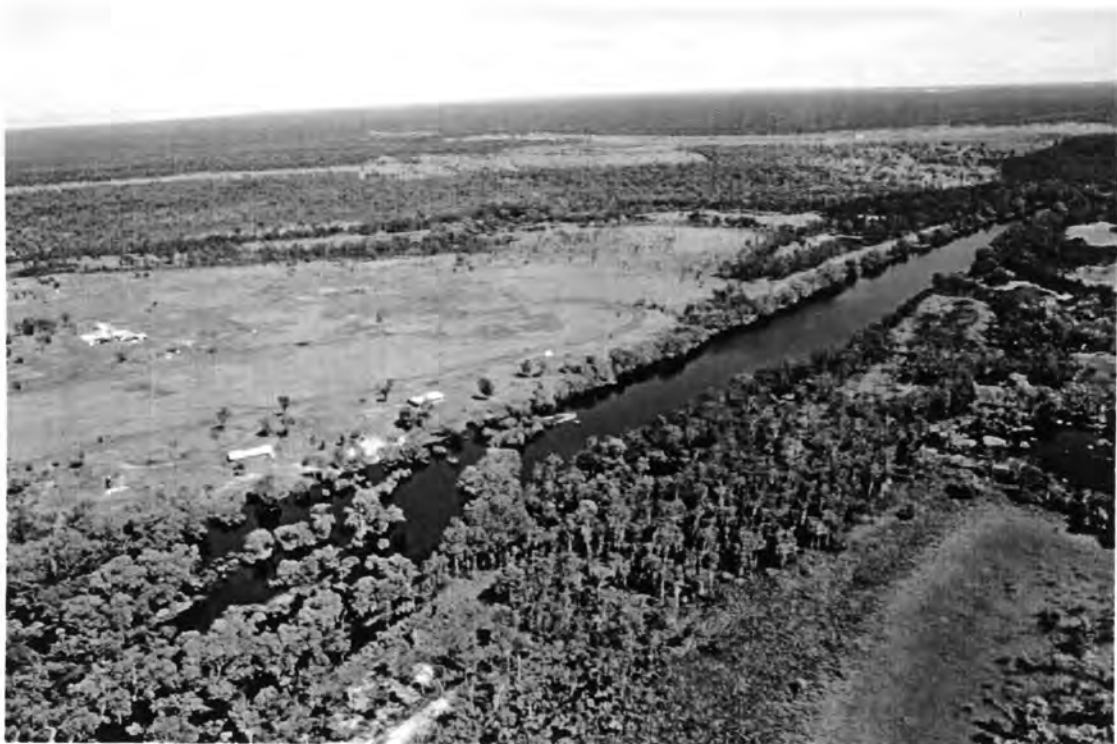
Plate 9: Sand anastomosing section of Magela Creek terminating at the upstream end of Mudginberri Billabong. The billabong will be eventually infilled with sand but the sedimentation rates are low (Roberts 1991). Slide No. 22 Mike Saynor, 22/2/98.

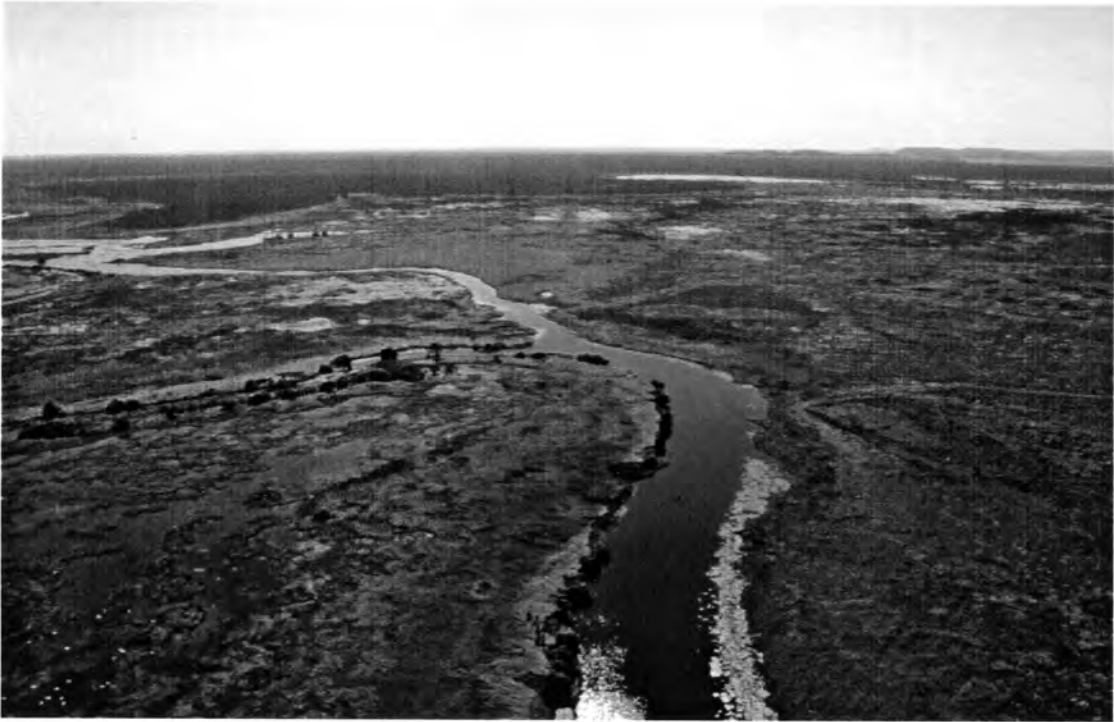
Plate 10: Palaeochannel on Magela floodplain to the west of Jabiluka Billabong. This channel is a remnant of the former tidal channel that functioned during the mid Holocene (Wasson 1992). Slide No. 13 Mike Saynor, 2/6/97.

- No. 12** Magela Floodplain looking back towards Jabiluka escarpment and Jabiluka Billabong.
- No. 13** Palaeochannel on Magela floodplain (Plate 10).
- No. 14** Palaeochannel on Magela floodplain between Jabiluka Billabong and the tidal section of Magela Creek. (Plate 12).

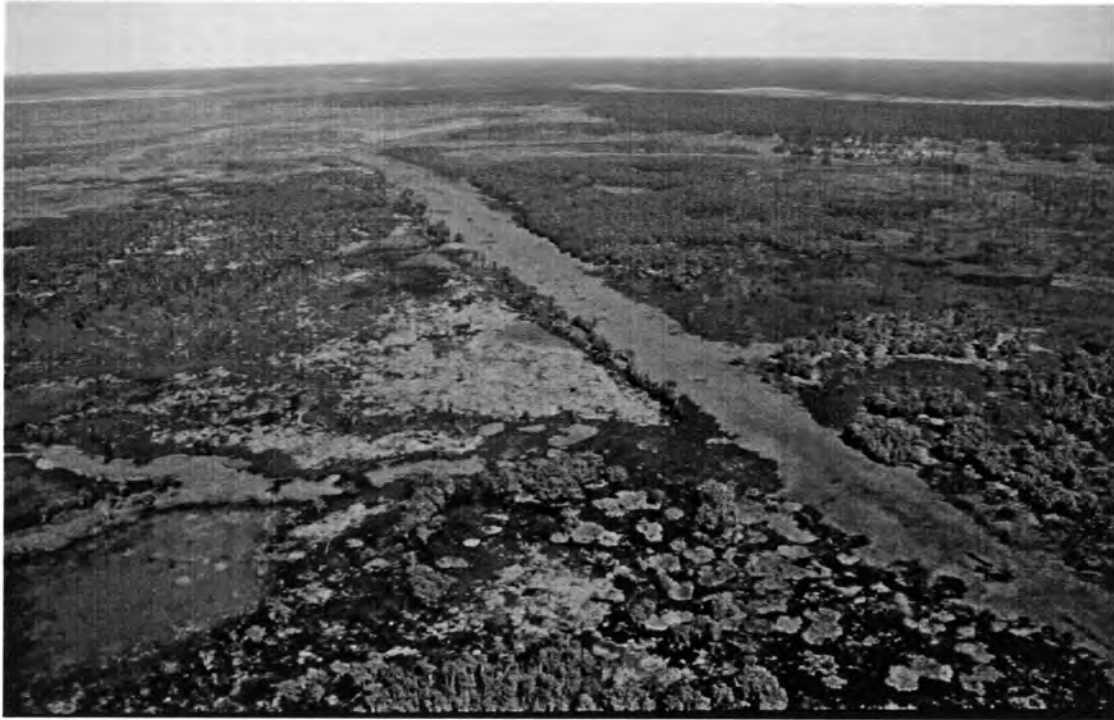
Plate 12: Palaeochannel on Magela floodplain between Jabiluka Billabong and the tidal section of Magela Creek. This infilled channel is a remnant of the former tidal channel that functioned during the mid Holocene (Wasson, 1992). It is now located in an extensive area of freshwater wetlands. Slide No. 14 Mike Saynor, 2/6/97.

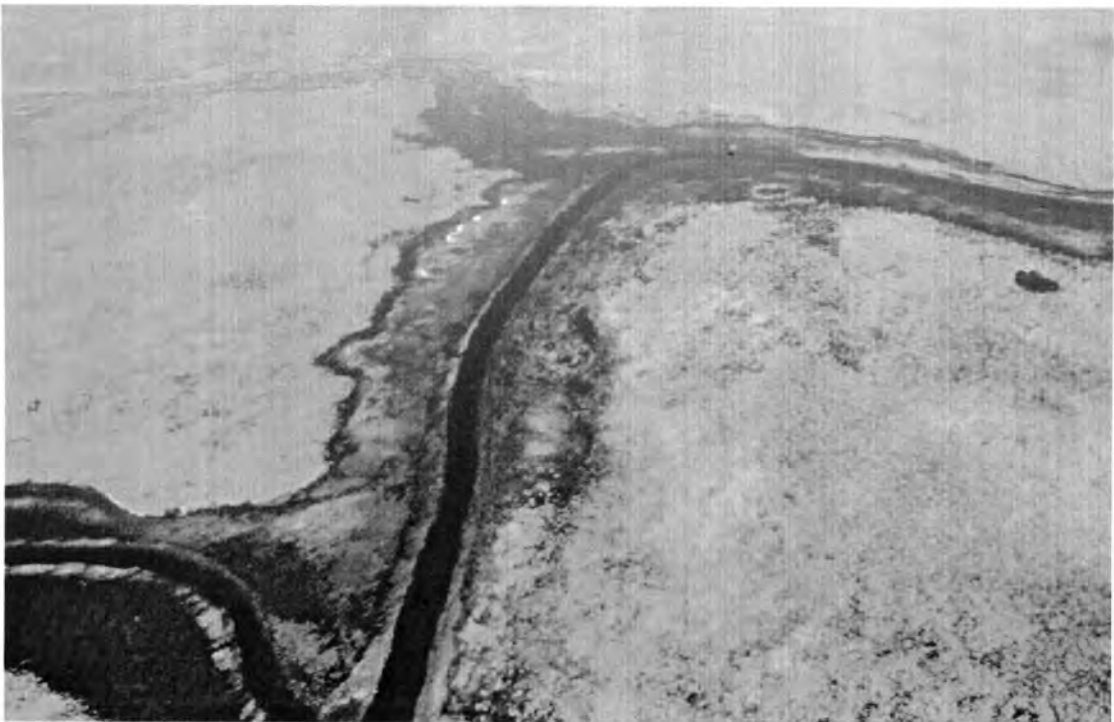
Plate 13: Channels flooded with clear water just upstream of the tidal section of Magela Creek. Clear, sediment-free water is discharging from the wetlands back into the outlet channel. Mangroves are present on the downstream section of channel. Slide No. 39 Mike Saynor, 22/2/98.

Clear water just up stream of the tidal section of Magela Creek (Plate 13).

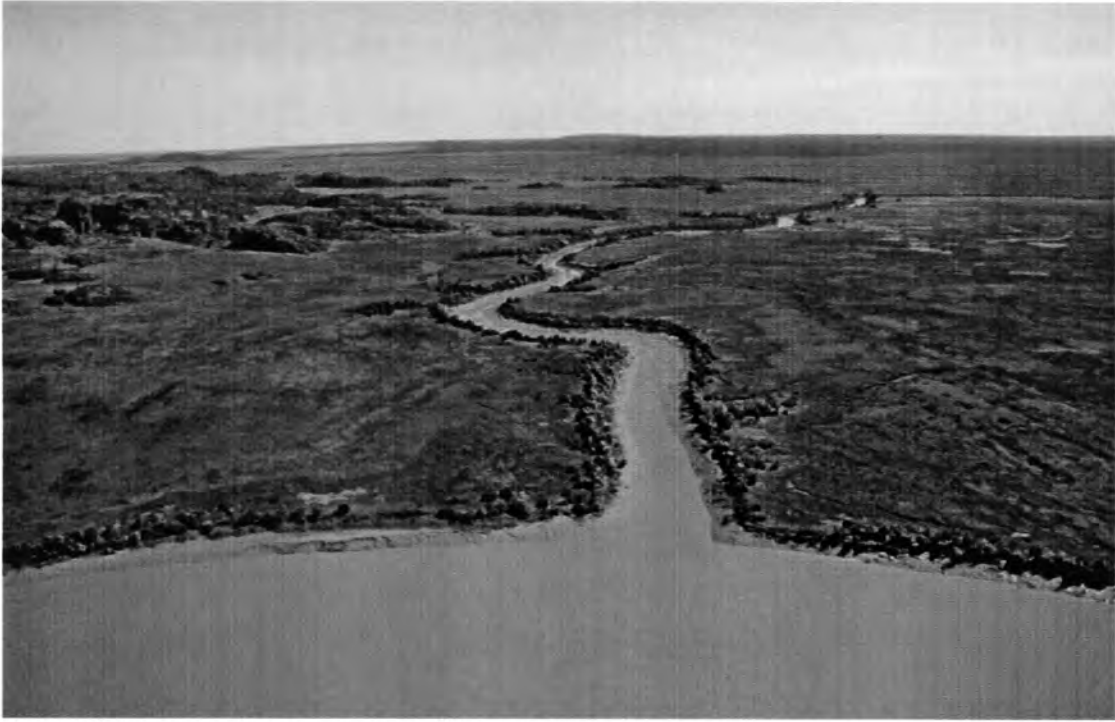
Plate 16: Tidal creek entering the East Alligator River, upstream of Turkey Dreaming and the Magela Creek mouth. Note the high turbidity of the estuary during the Dry season. Slide No. 16 Mike Saynor, 2/6/97.

- No. 15** Tidal section of Magela Creek (Plate 14).
- No. 16** Creek entering the East Alligator River, upstream from Turkey Dreaming (right bank) and the Magela Creek mouth (left bank), (Plate 16).

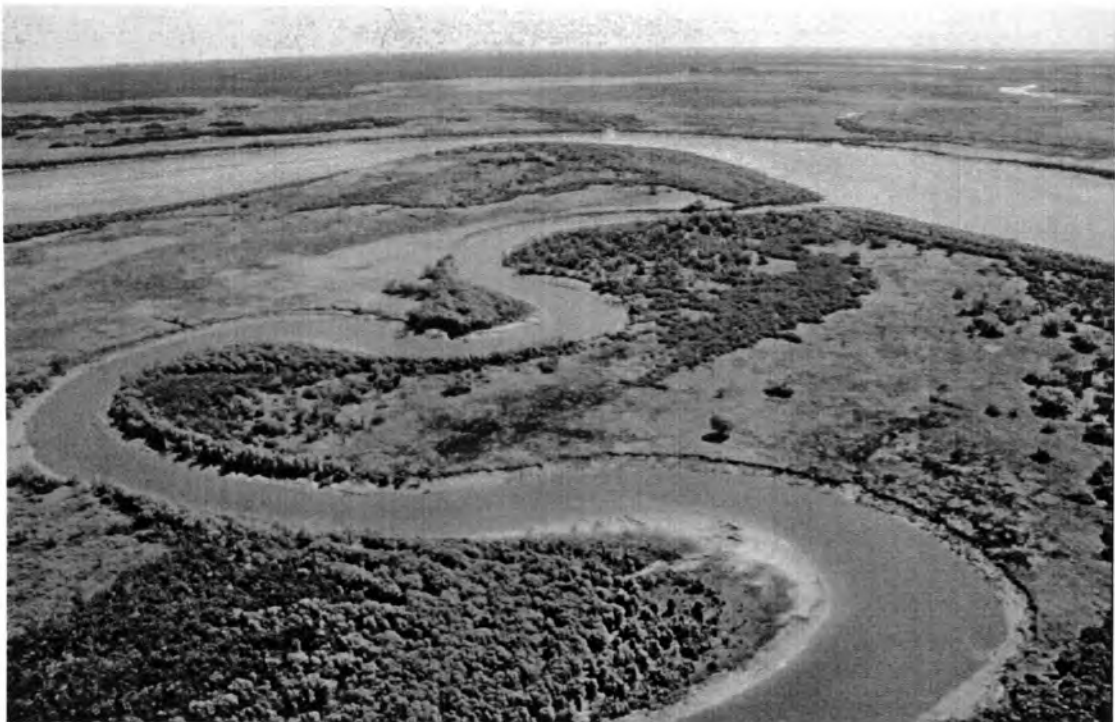
Plate 17: Meandering section of Magela Creek entering the East Alligator River (Point A, Fig 1). Note the lower turbidity of the estuary during the Wet Season. Slide No. 44 Mike Saynor, 22/2/98.

Extensive *deltaic estuarine floodplains* are present on the lower South Alligator, West Alligator and East Alligator Rivers. These estuaries exhibit four distinct channel types, which, in upstream sequence are the estuarine funnel, sinuous reach (Plate 17), cusped reach and the upstream reach (Woodroffe et al 1986; 1989). Each channel type is also associated with a distinctive stratigraphy (Woodroffe et al 1986; 1989). The deltaic estuarine plain developed in three major phases over the last 8 ka as sea level rose from about -14 m AHD to its present level after 5.8 ka BP (Woodroffe et al 1986; 1987; 1989). The "transgressive phase" (8-6.8 ka BP) marked the final marine flooding of the prior valley and the development of mangrove forests. Then the "big swamp phase" (6.8-5.3 ka BP) occurred as sea level stabilised around its present level and mangrove forests became established over most of the present floodplain. The "sinuous/cusped phase" began about 5.3 ka BP and was characterised by the establishment of a meandering estuarine channel flanked by a marginal zone of mangroves. Freshwater swamps developed and overbank deposits were laid down on the floodplain surface over the last 4-1.5 ka BP. The Holocene depositional history of the deltaic estuarine plain on Magela Creek is discussed in detail by Clark et al (1992b). While there is a coastal plain fronting van Diemen Gulf (East, 1996; Bayliss et al 1997), it is not relevant to the present discussion.

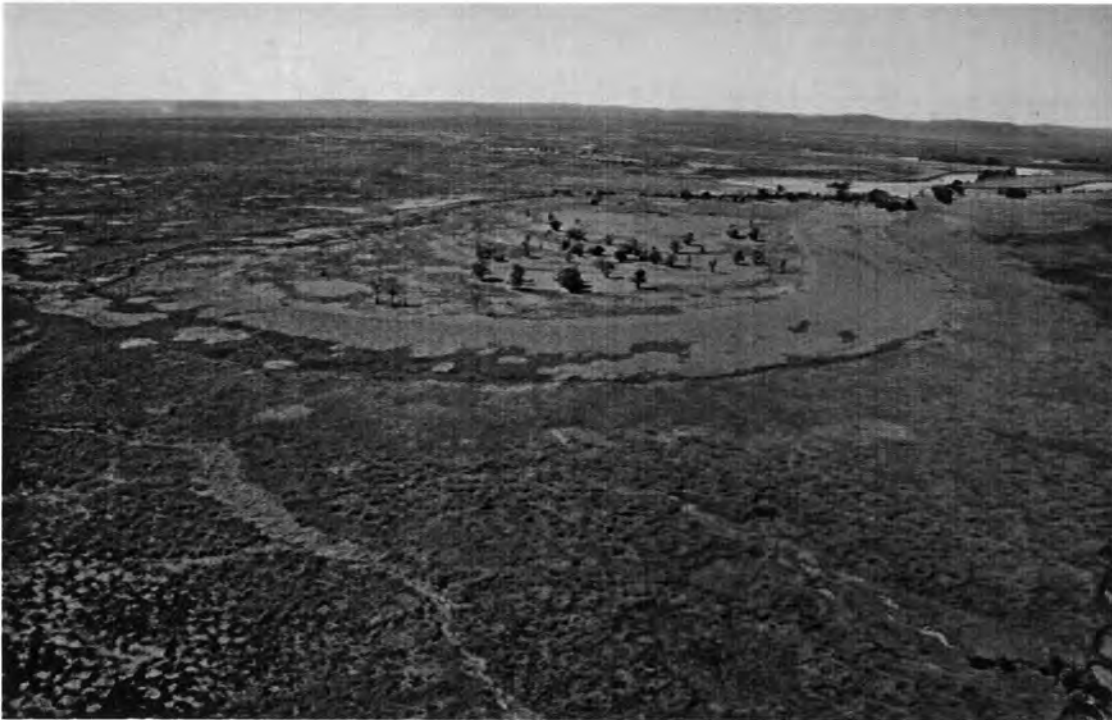
Plate 18: Palaeocutoff at "The Switchback", East Alligator River during the Dry Season. Location shown as Point B in Figure 1. This is a neck cutoff of Erskine and Melville (1982). Convex ridges in the meander core were formed by lateral migration and subsequent point bar formation. Slide No. 18 Mike Saynor , 2/6/97.

- No. 17** Point bar in the cusped section of the East Alligator River upstream from the Magela Creek mouth.
- No. 18** Palaeocut-off near the Switchback, East Alligator River (Plate 18).

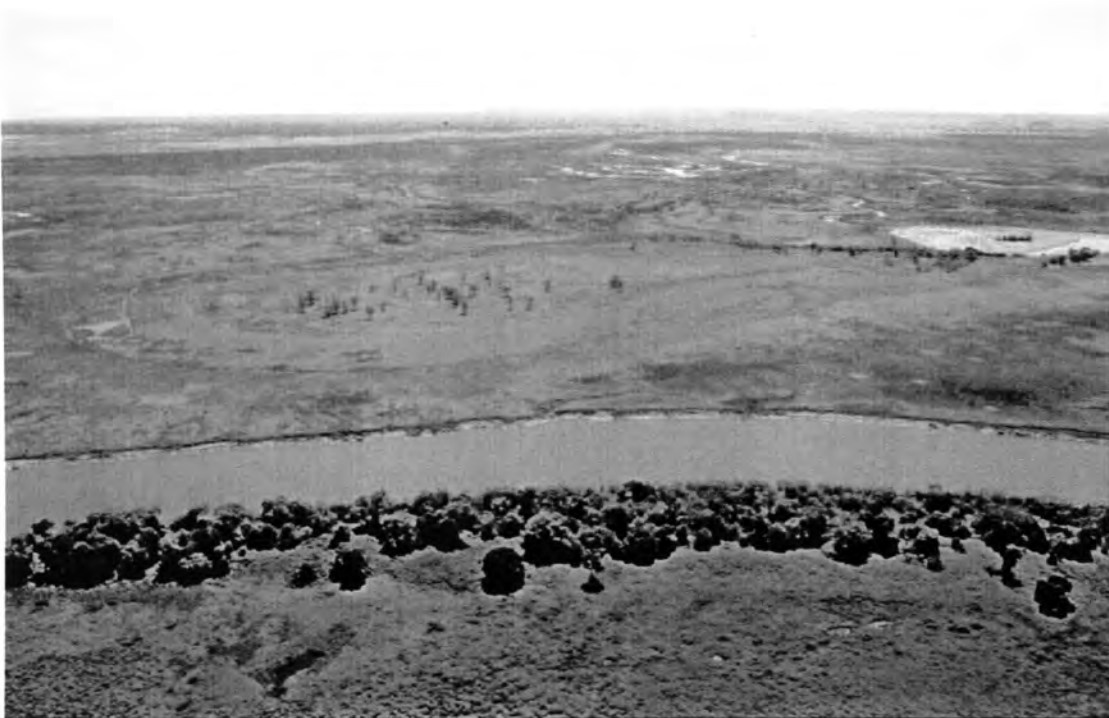
Plate 19: Palaeocutoff at "The Switchback", East Alligator River during the Wet Season . Location shown as Point B in Figure 1. Same neck cutoff as in Plate 18. Slide No. 52 Mike Saynor, 22/2/98.

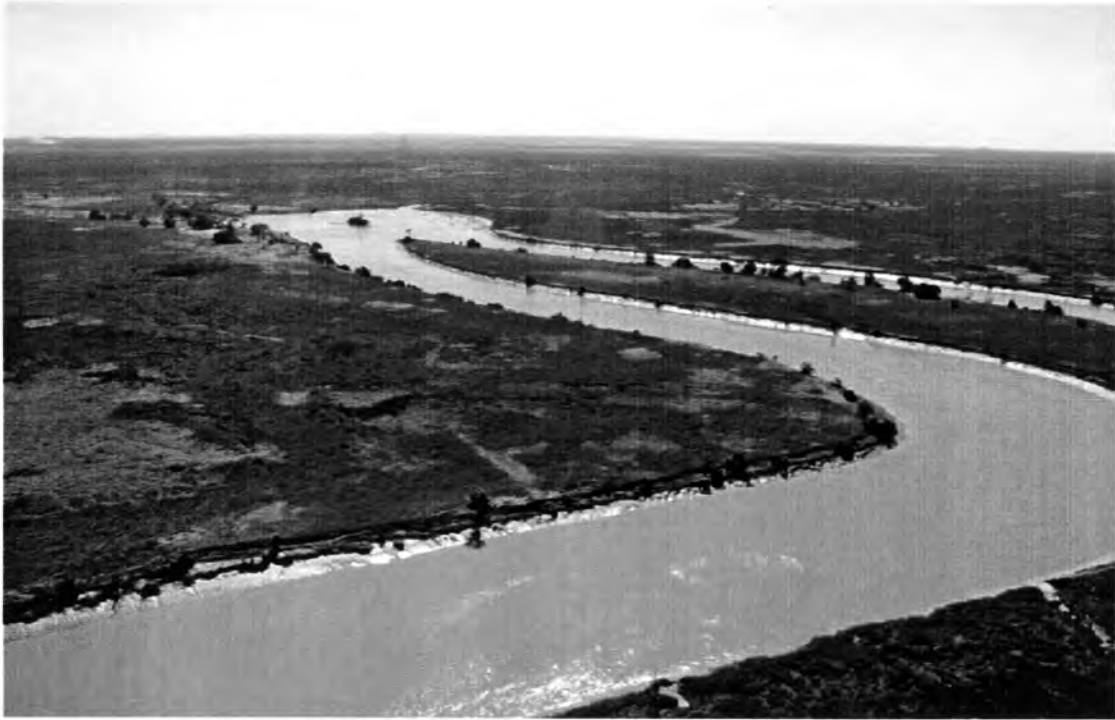
Plate 20: Dry Season view of the 1996/97 cutoff (formerly called "The switchback"). This is also a neck cutoff of Erskine and Melville (1982). Location shown as Point B in Figure 1. Slide No. 19 Mike Saynor, 2/6/97.

- No. 19** Contemporary cut-off, (formerly called the switchback) formed during the 1996/97 Wet Season (Plate 20).
- No. 20** Palaeochannel on the right bank of the East Alligator River (Plate 22).

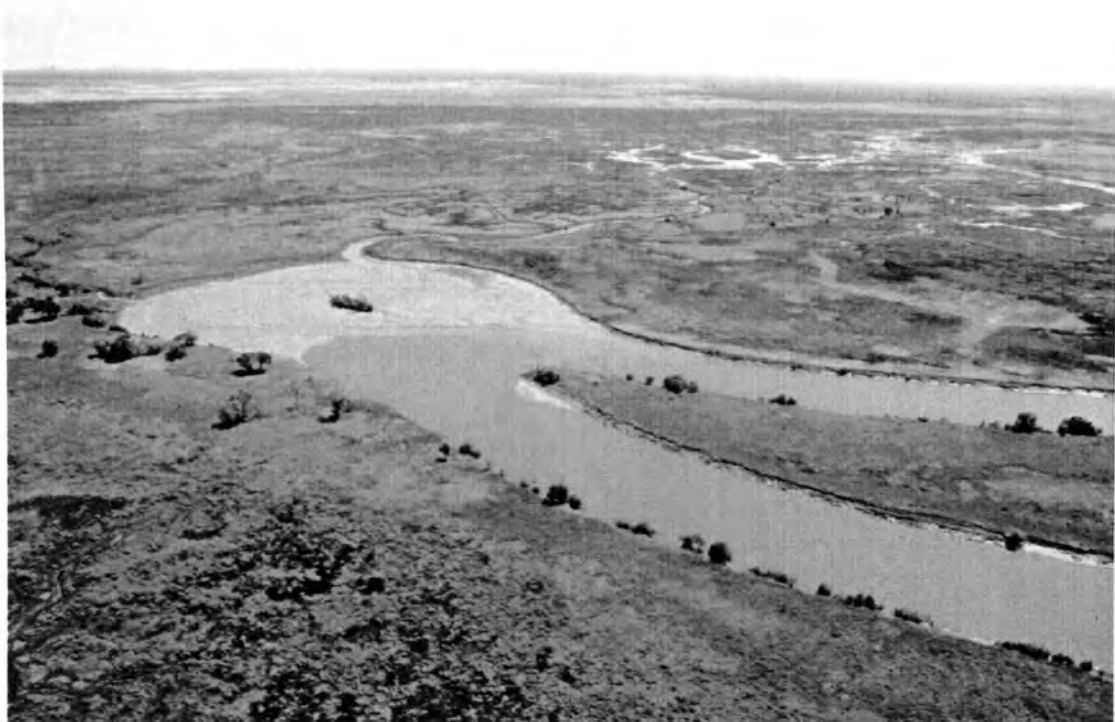
Plate 21: Wet Season view of the 1996/97 cutoff, (formerly called "The switchback"). The entrance to the cutoff has been entirely closed by sedimentation but an outlet has been maintained through the downstream end because of the tributary which discharges into the cutoff. Note that a small point bar is present on the inside bank of the bend only downstream of the bend apex. Slide No. 53 Mike Saynor, 22/2/98.

The helicopter followed the East Alligator River upstream to Cahills Crossing, passing over the sinuous tidal channel. The slides and photographs indicate that the recent cutoff (Point B, Fig. 1) at the "switchback" had experienced substantial infilling since abandonment during the 1996/97 Wet season. The helicopter continued upstream passing vast floodplains on each side of the river, some with still water, others with dense vegetation. The causeway at Cahills Crossing was not visible due to the high flow passing over it, although the approach roads could be seen. In the photographs it looks as though there has been some deposition of sediment in the car park at Cahills Crossing and the downstream boat ramp.

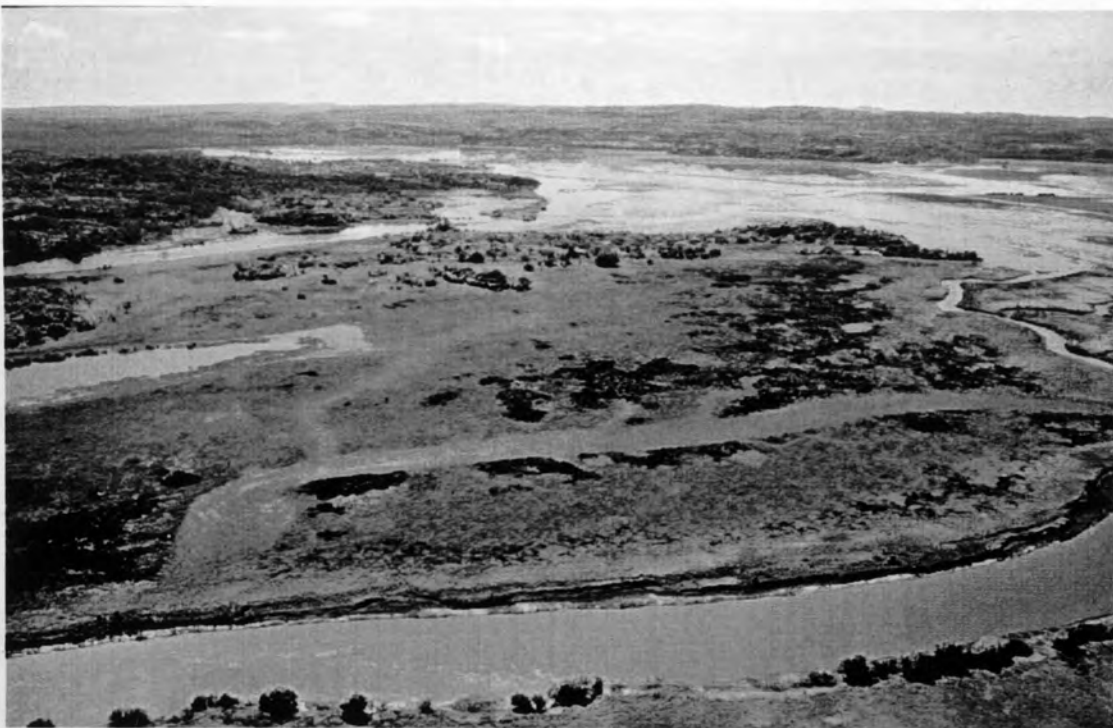
Plate 23: Palaeochannel in foreground and wetlands in the background on the right bank of the East Alligator River upstream of Point B in Figure 1. Slide No. 59 Mike Saynor, 22/2/98.

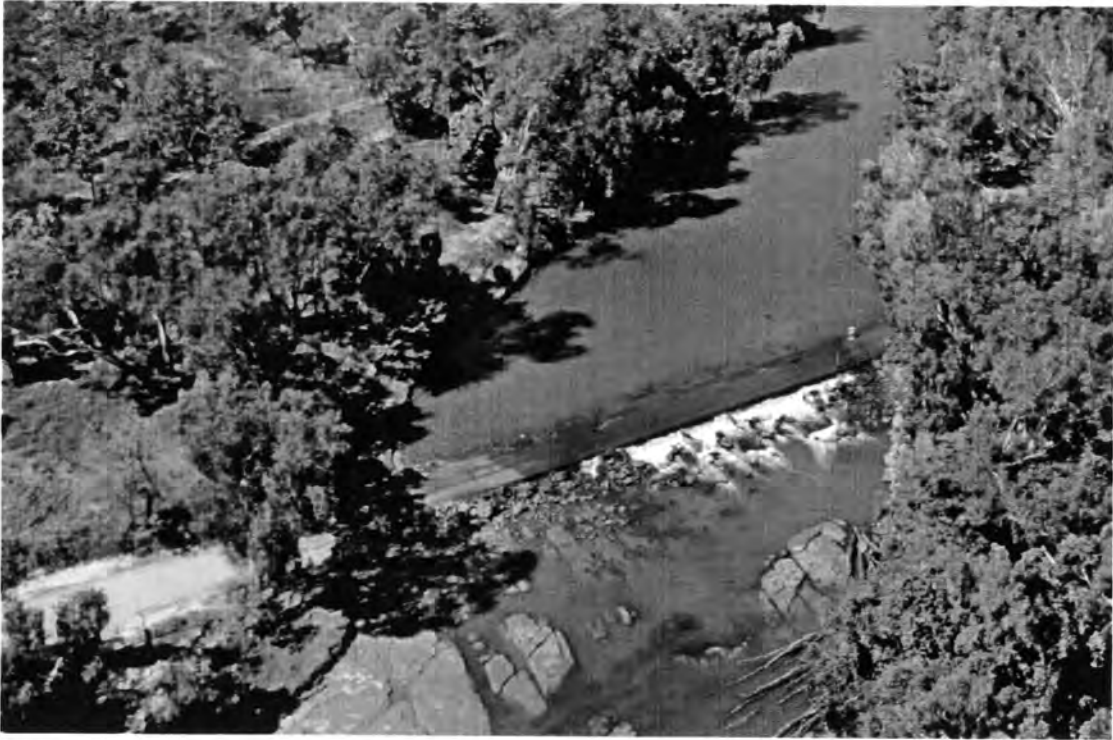
Plate 24: Cahills Crossing, East Alligator River during the dry season. Note that the crossing has been built on a foundation of bedrock and acts as a weir during the lower part of the tidal cycle. Slide No. 21 Mike Saynor, 2/6/97.

- No. 21** Cahills Crossing, East Alligator River (Plate 24).
- No. 22** Sand rocks and water on the right bank of the East Alligator River, Wet season flood chute.

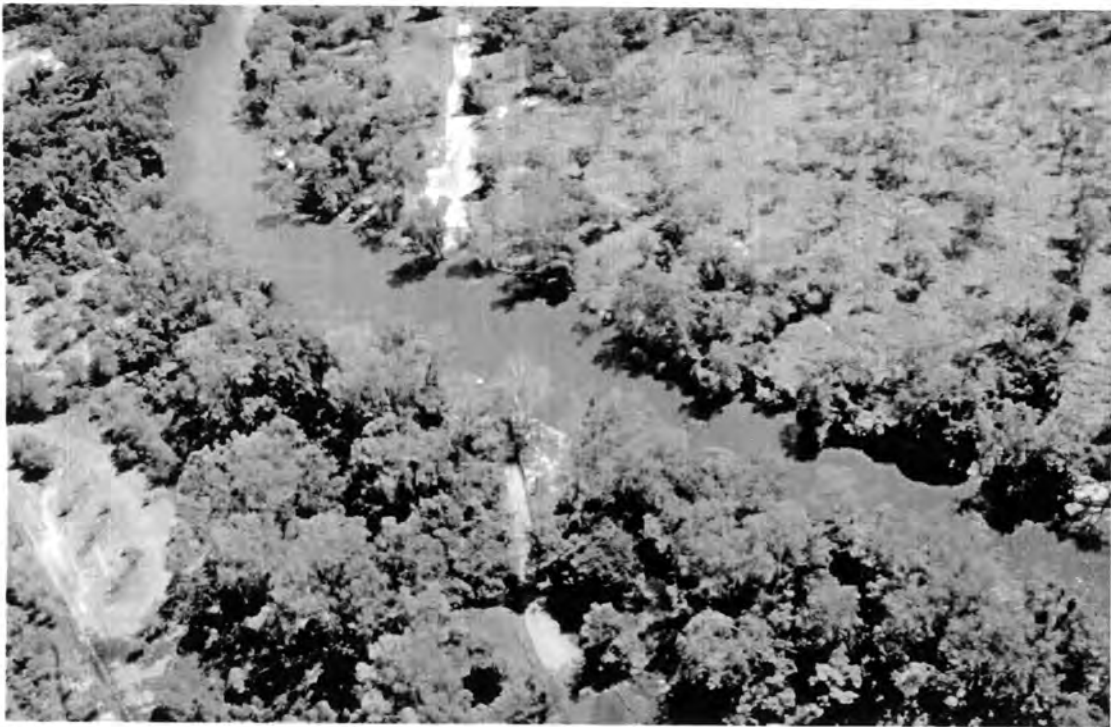
Plate 25: Cahills Crossing, East Alligator River during the Wet season, 22/2/98. Slide No. 65 Mike Saynor.

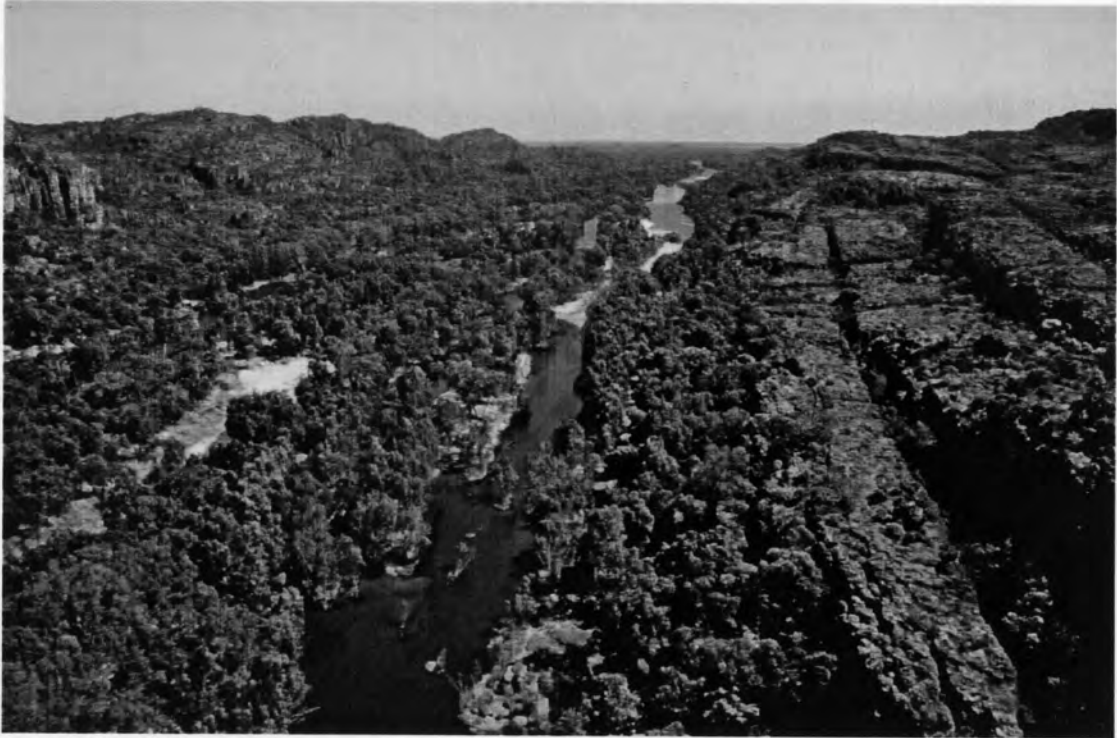
Plate 26: Dry season Gorge country, East Alligator River. Sand-bed anastomosing river confined between the sandstone valley sides. Vegetated sand islands are present between the individual channels. Slide No. 24 Mike Saynor, 2/6/97.

- No. 23** Sand bar on the East Alligator River, about 4 km upstream of Cahills Crossing.
- No. 24** Gorge country, East Alligator River (Plate 26).
- No. 25** Sand delta in the gorge section of East Alligator River (Plate 28).

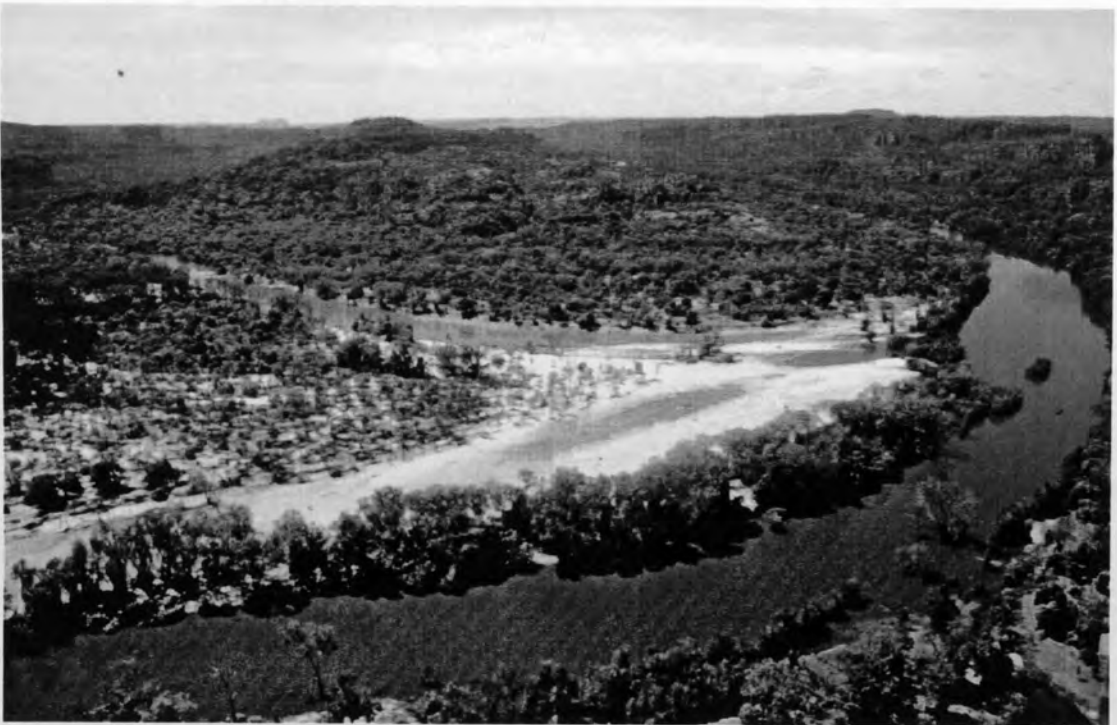
Plate 27: Sand bar and chute on the right bank of the East Alligator River (Point C, Fig 1). This is a palaeochannel which is still activated by current flood flows. Slide No. 68 Mike Saynor, 22/2/98.

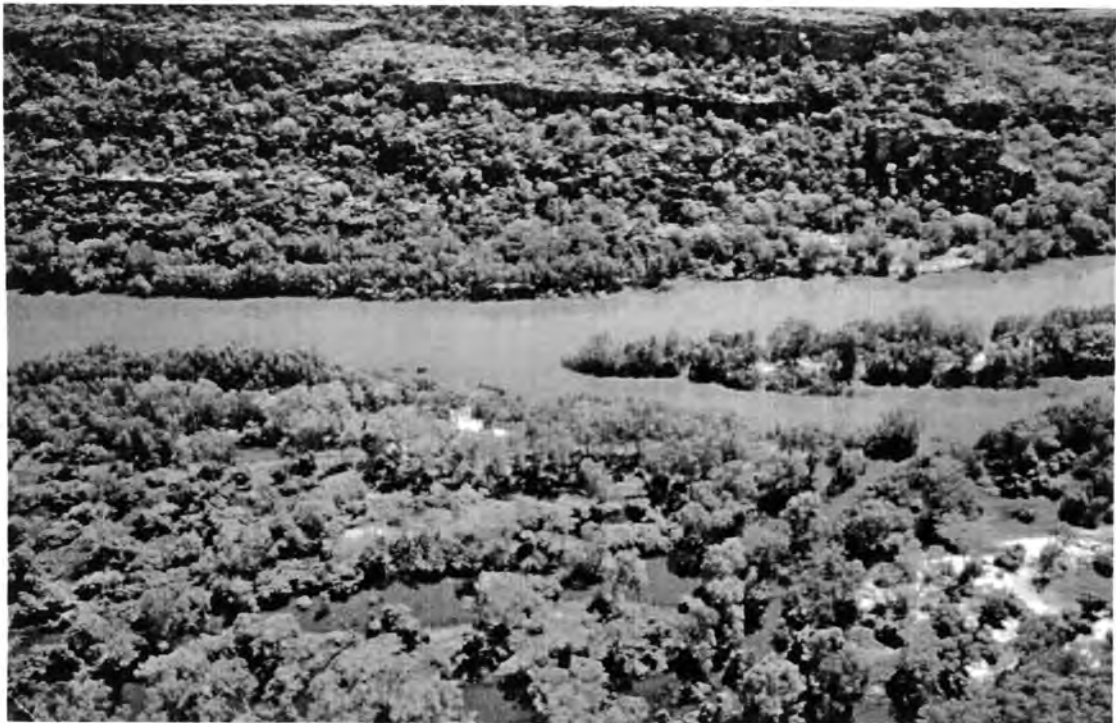
Plate 29: Same channel confluence as in Plate 28 in the gorge section of East Alligator River. No delta visible. View from left bank. Slide No. 75 Mike Saynor, 22/2/98.

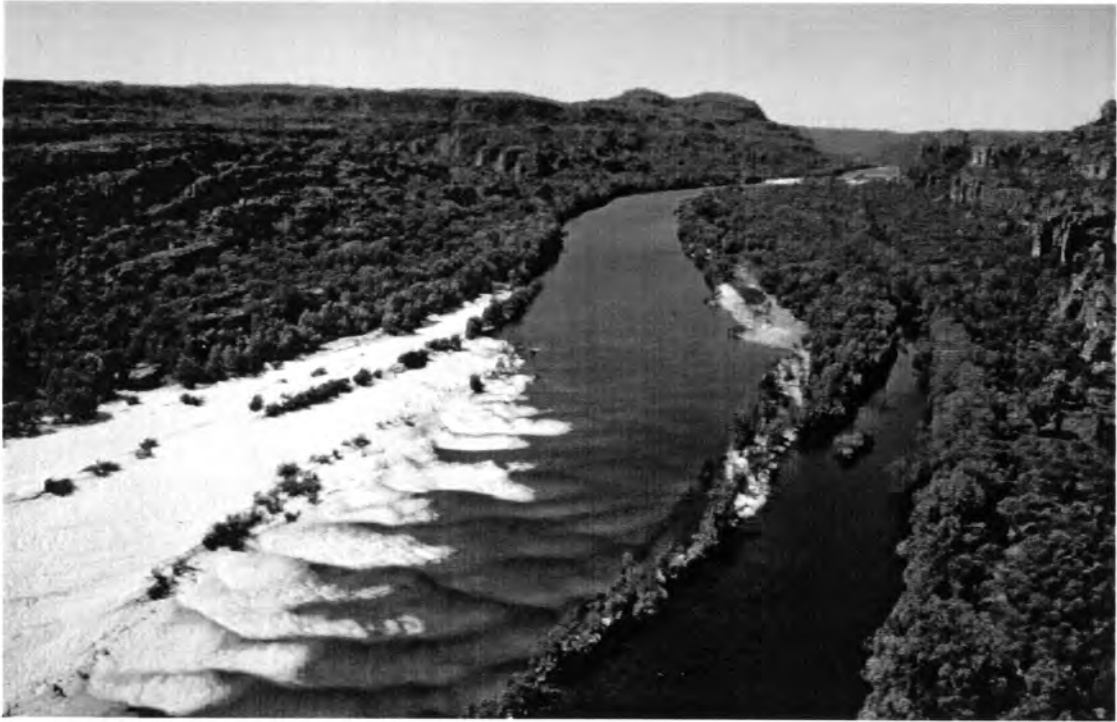
Plate 30: Sandy bedforms (large scale ripples) in the bed of the East Alligator River. Slide No. 29 Mike Saynor, 2/6/97.

- No. 29** Sandy bedforms, East Alligator River (Plate 30).
- No. 30** Gorge section of the East Alligator River, first bedrock cascade or waterfall travelling upstream (Plate 32).
