**Dry and Wet season
aerial reconnaissance
of Magela Creek and
East Alligator River,
with brief notes on the
geomorphology of the
area**

MJ Saynor
WD Erskine

October 1998

This Internal Report describes both flights and comments on the photographs and slides that were taken. Notes on the geomorphology have been added to highlight particular landforms and their significance. The senior author was responsible for the photography.

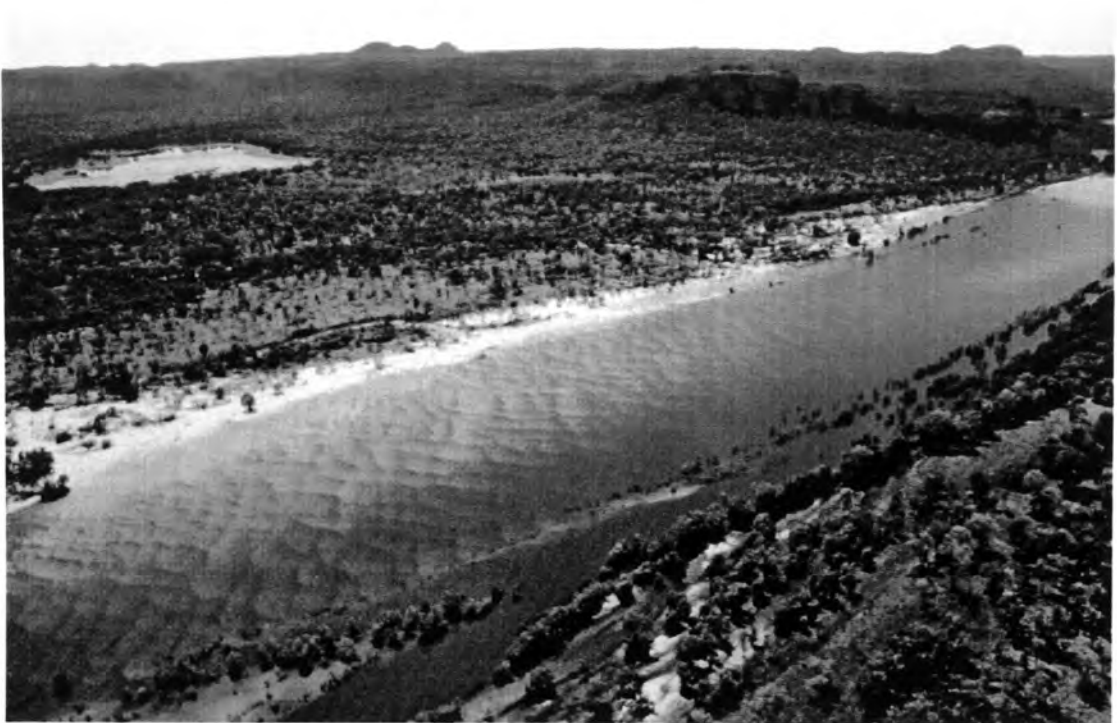
Plate 31: Sandy bedforms (large scale ripples) in the bed of the East Alligator River. Slide No. 83 Mike Saynor, 22/2/98.

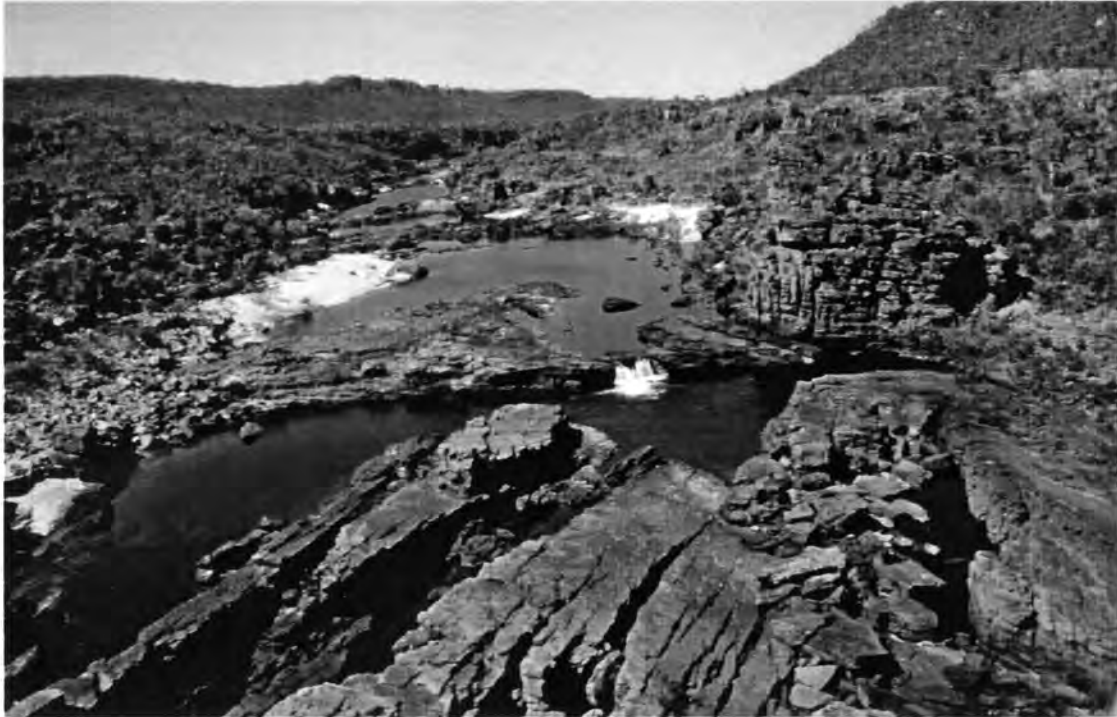
Plate 32: Gorge section of the East Alligator River showing the first bedrock cascade or waterfall upstream of the sand zone. The Channel is cut into sandstones of the Kombolgie Formation. Slide No. 30 Mike Saynor, 2/6/97.

- No. 29** Sandy bedforms, East Alligator River (Plate 30).
- No. 30** Gorge section of the East Alligator River, first bedrock cascade or waterfall travelling upstream (Plate 32).

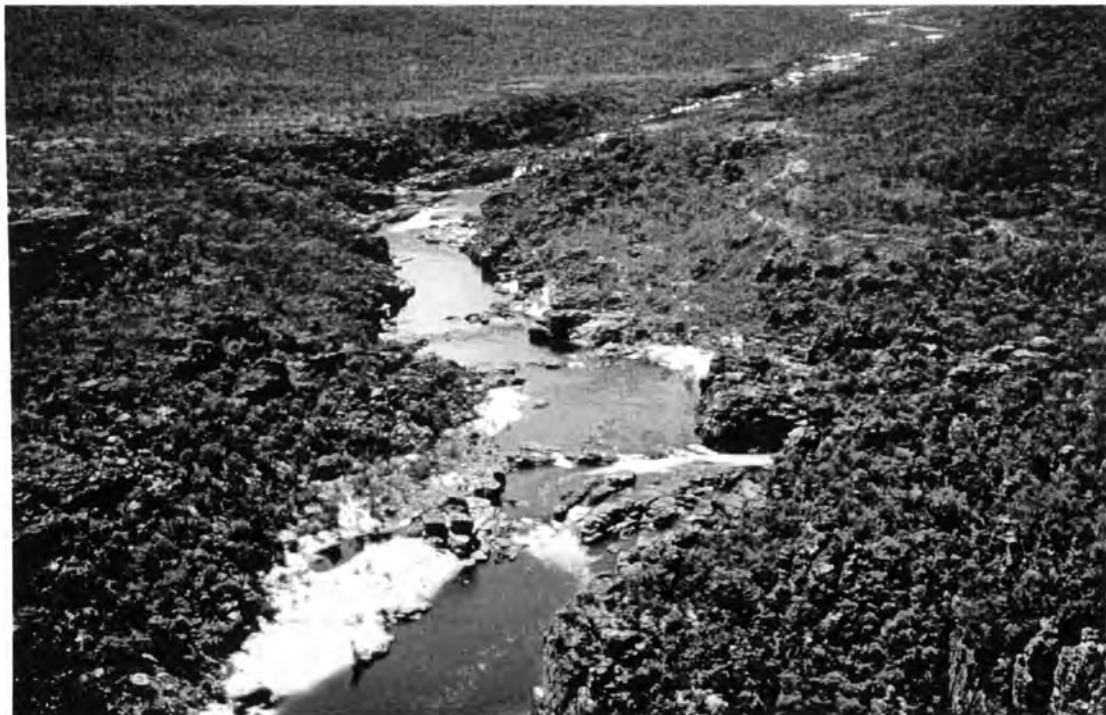
Plate 33: Gorge with bedrock cascades and sandy marginal deposits in the East Alligator River. Slide No. 110 Mike Saynor, 22/2/98.

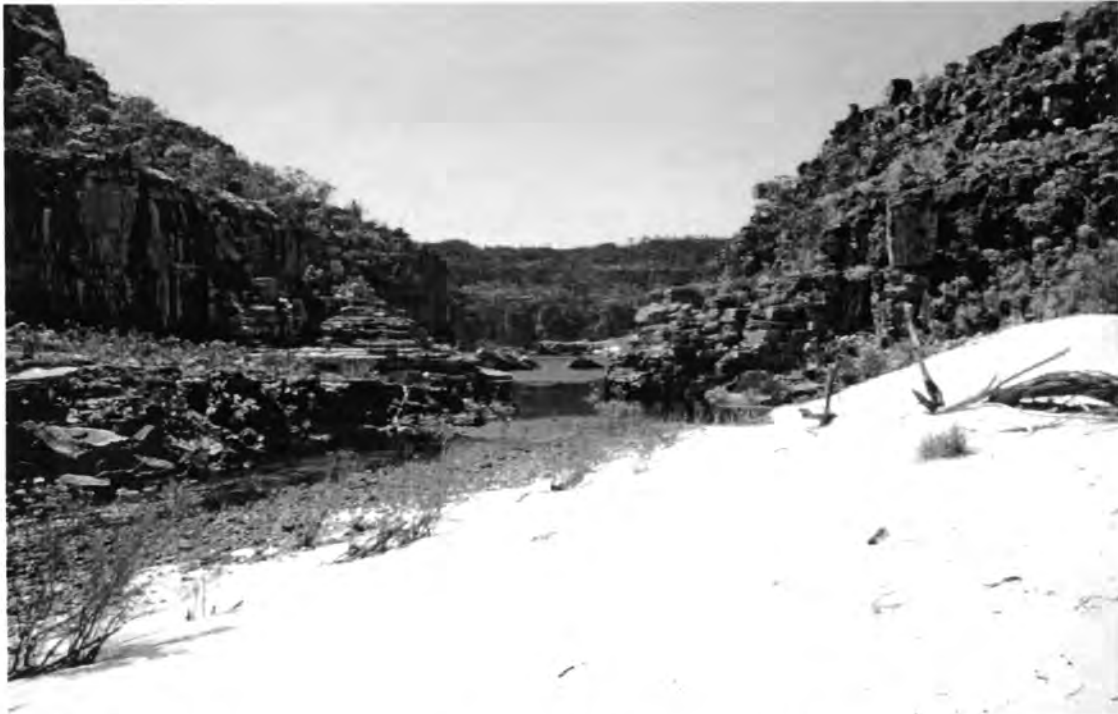
Plate 34: Sandy slackwater deposits in a flood chute across the inside of the bed (Point E, Fig. 1) that the helicopter landed on in the gorge section of the East Alligator River. Slide No. 31 Mike Saynor, 2/6/97.

- No. 31** Sandy slackwater deposits (Plate 34) in the gorge section of the East Alligator River, on which the helicopter landed.
- No. 32** Sandy slackwater deposits in the gorge section of the East Alligator River, on which the helicopter landed.

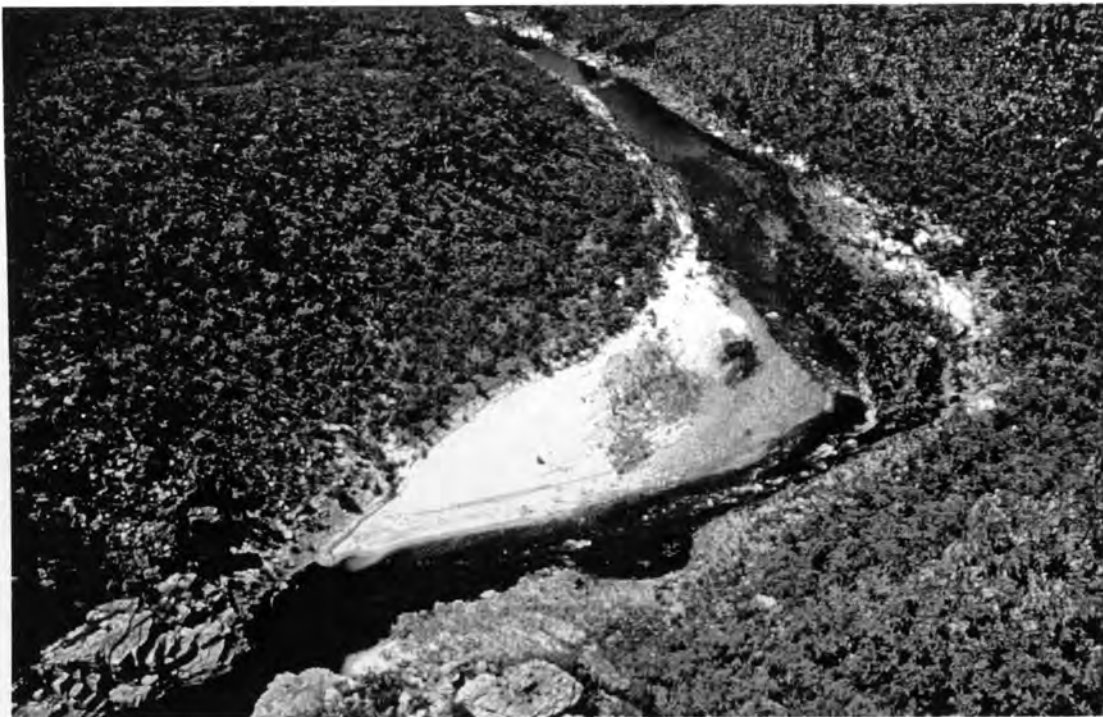
Plate 35: Aerial shot of the sandy chute and slackwater deposits, that the helicopter landed on in June 1997. East Alligator River. The inside of valley bends are favoured sites for slackwater deposition. Slide No. 128 Mike Saynor, 22/2/98.

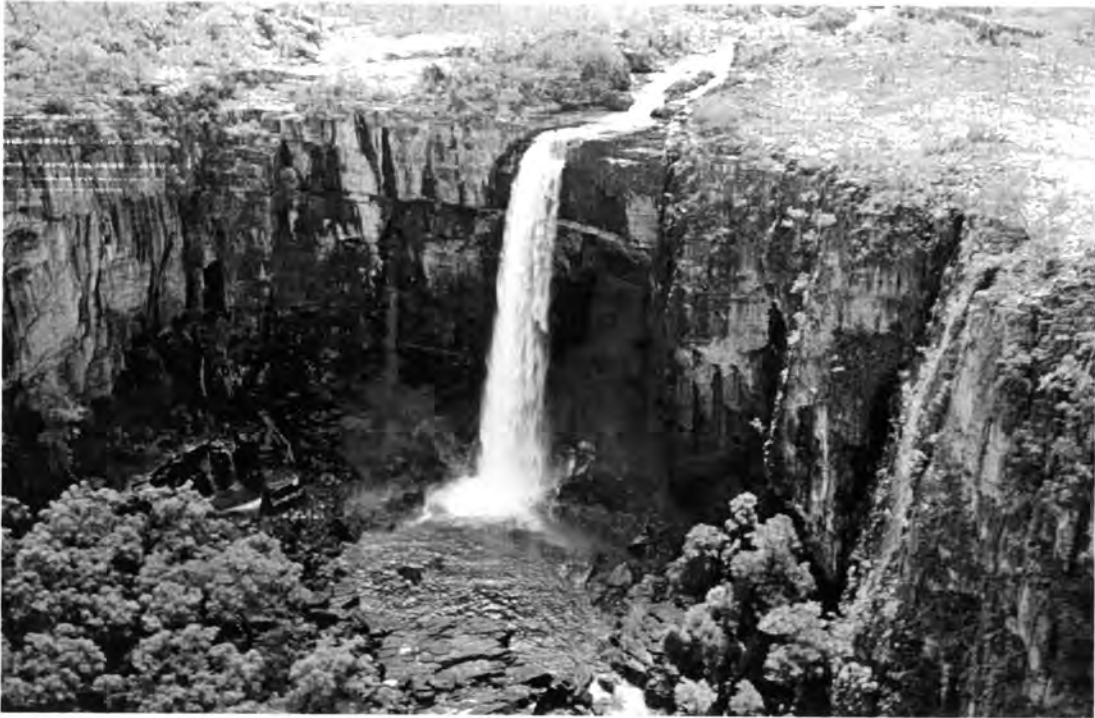
Plate 36 : Magela Falls on Magela Creek. Significant plunge pool at the base of the waterfall. Waterfall retreats by basal undercutting followed by toppling of the more coherent caprock. Slide No. 139 Mike Saynor, 22/2/98.
